CALIFORNIA CONSTRUCTION AUTHORITY

31st DAA Ventura County Fairgrounds Physical Assessment

CCA Project: 031-22-133

Date: December 21-22, 2022

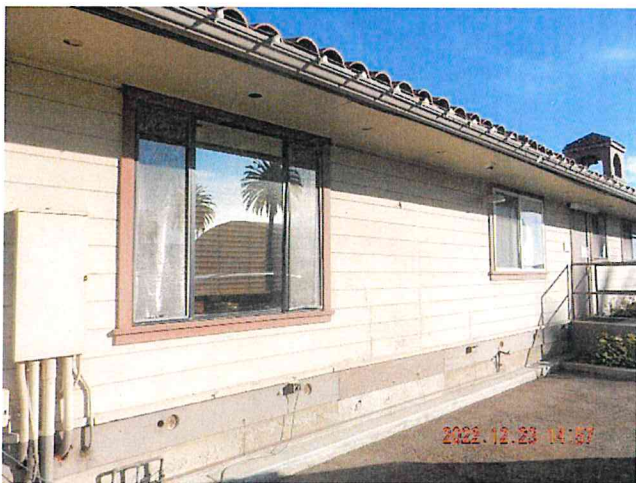
3. Administration Building west elevation wooden siding aging and deteriorating

- Siding renovation over the next three years to include updating windows.
- Evaluate the exterior exposed electrical components life and safety protection by the licensed electrical contractor:
 - Outlet covering and exposed conduits
 - Box coverings
 - Electrical junction box electrical dead front covers

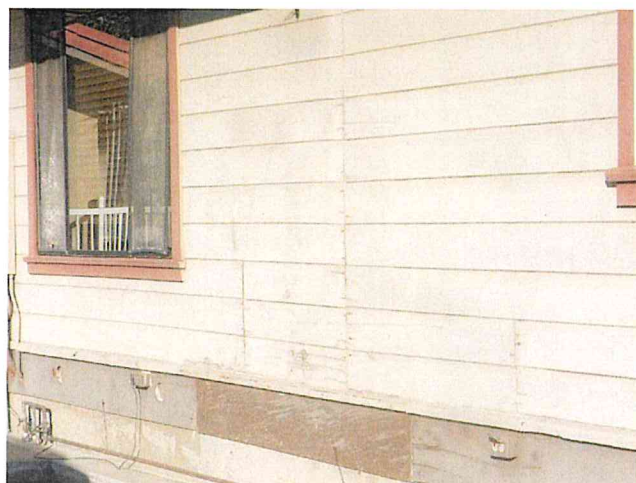
4. Administration Building west elevation wooden siding aging and deteriorating

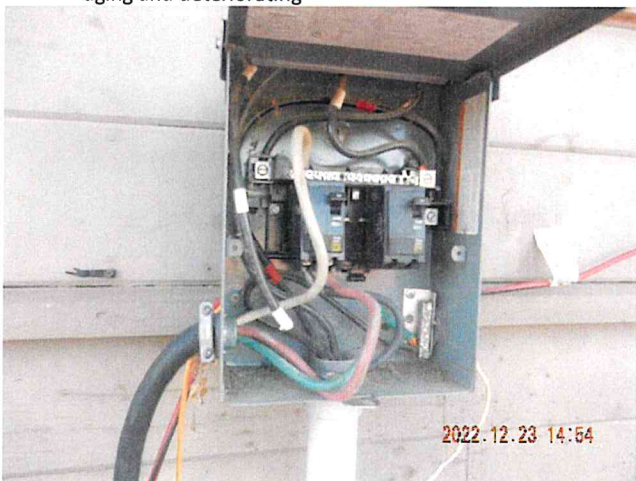
5. Administration Building east elevation circuit breaker box needs a dead front cover, and the wire running behind the cabinet needs to be in conduit

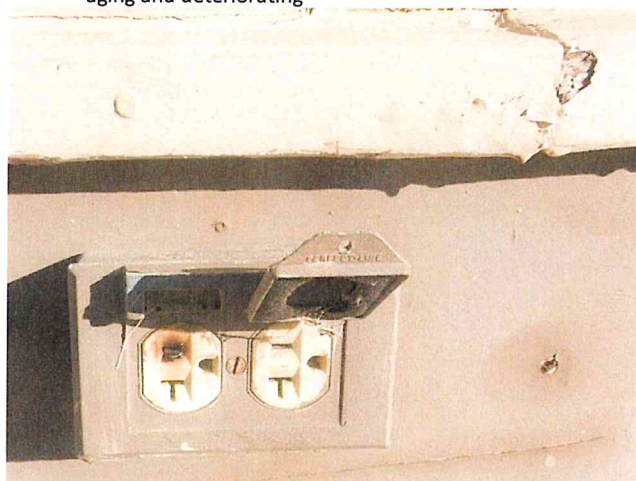
6. Administration Building indication of an electrical short and damaged wall outlet.

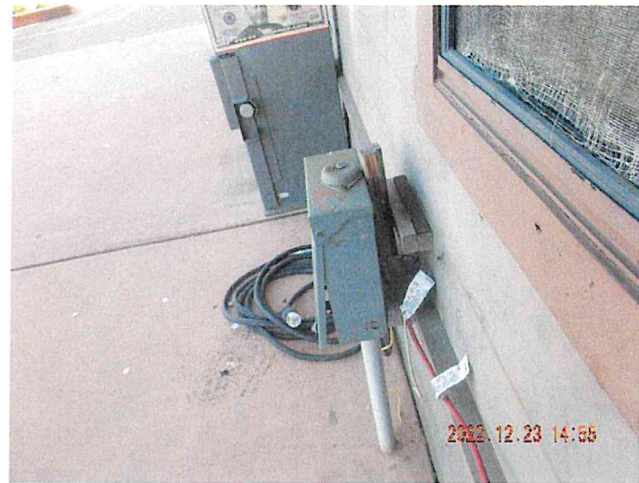
8. Exterior conductor needs to be within a conduit, junction boxes need to be properly secured

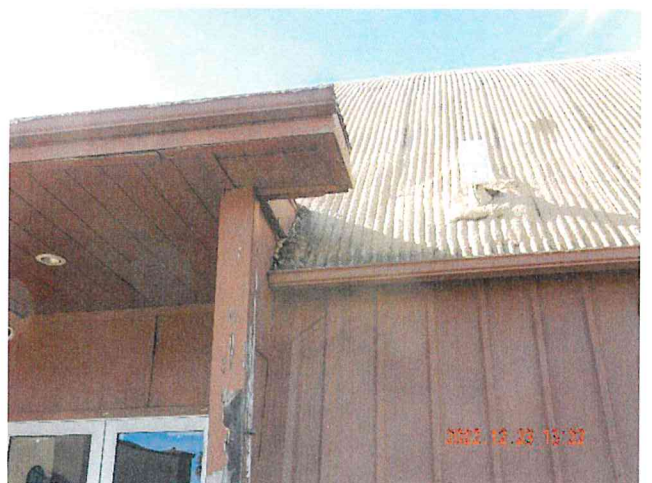
6. San Miguel Hall east entry damage and roof deterioration.

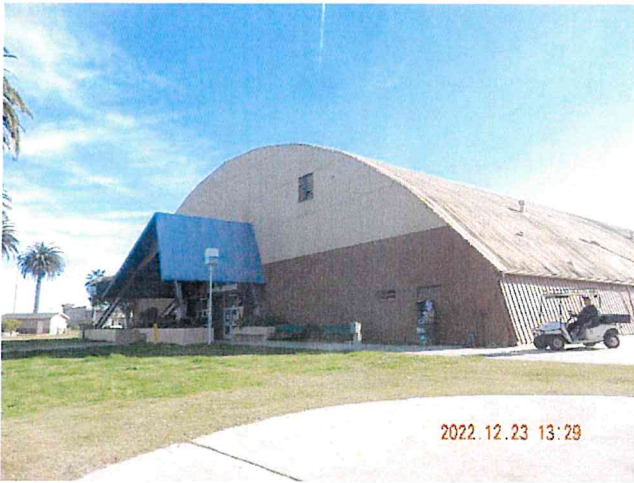
7. San Miguel Hall canopy at northwest corner wall elevation note roof and walls deterioration

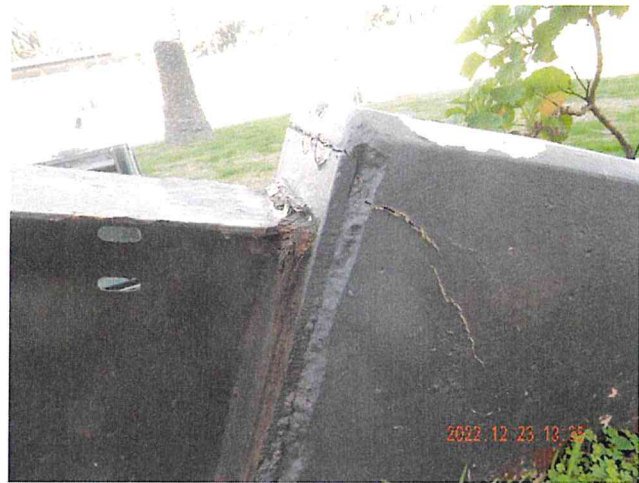
8. San Miguel Hall canopy at north entry weld deterioration and possibly structural concrete crack

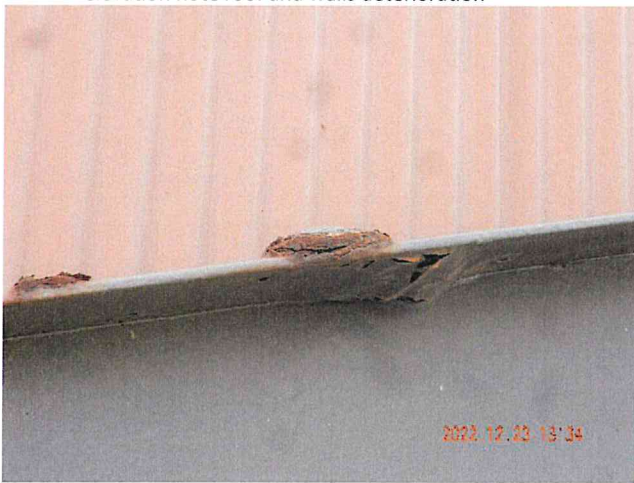
9. San Miguel Hall canopy at the north entry roofing material deteriorated

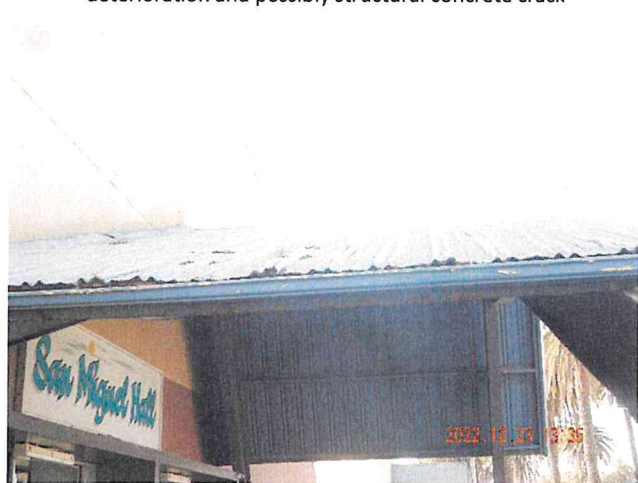
10. San Miguel Hall canopy at the north entry roofing material deteriorated

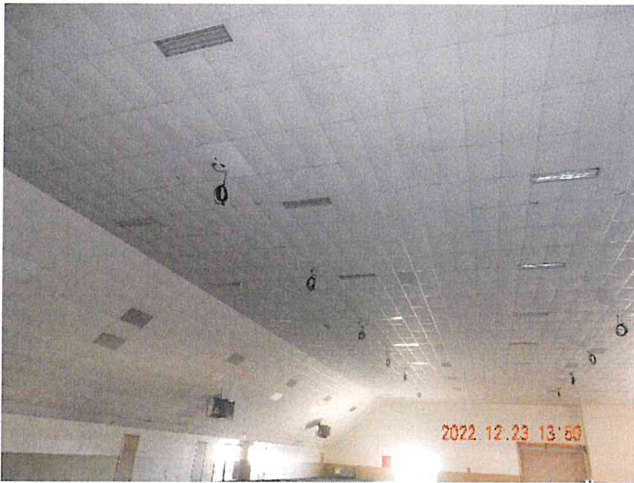
14. San Miguel Hall ceiling staining and damage

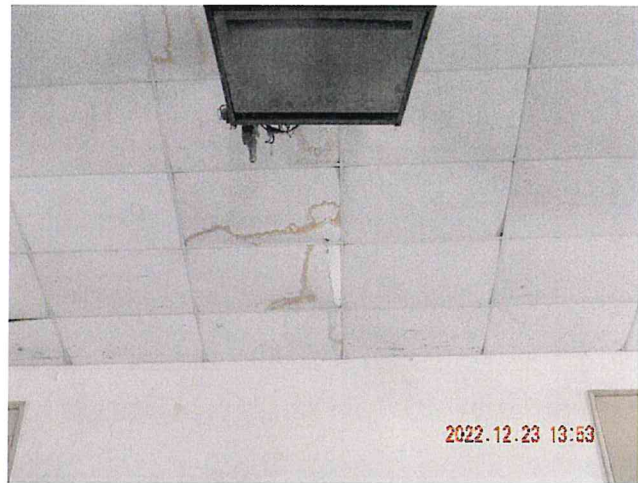
15. San Miguel Hall ceiling and wall staining and damage

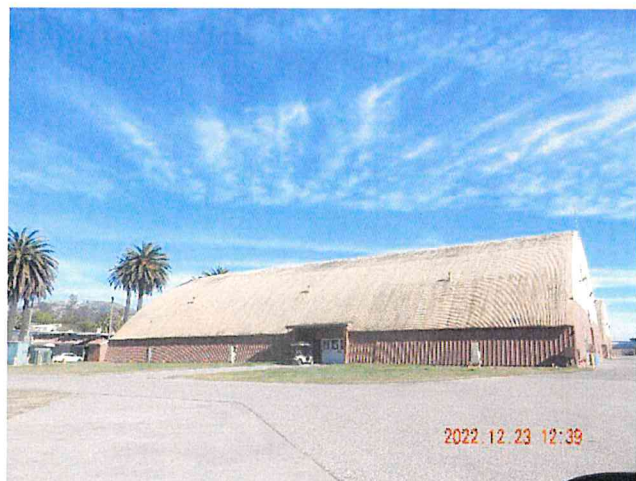
4. Anacapa Hall west elevation roof deterioration

- The Quonset hut corrugated steel skin applied foam is deteriorating and no longer offers protection to the steel skin.
- Roofing system: Immediate evaluation needed restoration repairs or replacement of the roofing system cover; to maintain or prolong the structure's remaining useful life.
- The north main entry vestibule structural elements are compromised with corrosion and deteriorated. The vestibule covering poses a risk of failure in the event of seismic activity. Further evaluation by an engineer is warranted for consideration of restoration or demolition. Recommend demolition for public safety.
- The west and east vestibule portals to the interior need evaluation for repairs to continue their useful life within the next two years.

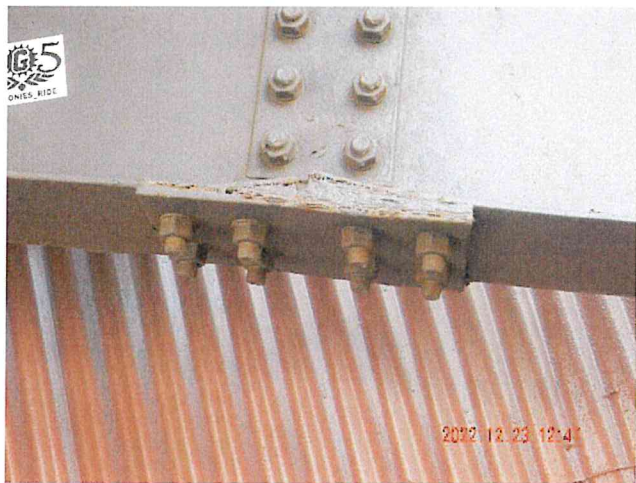
10. Anacapa Hall north elevation canopy beam structural connection delamination deterioration

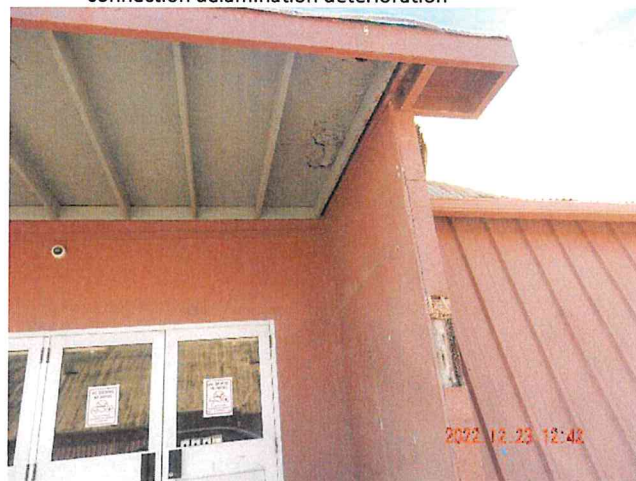
12. Anacapa Hall west elevation entryway deterioration

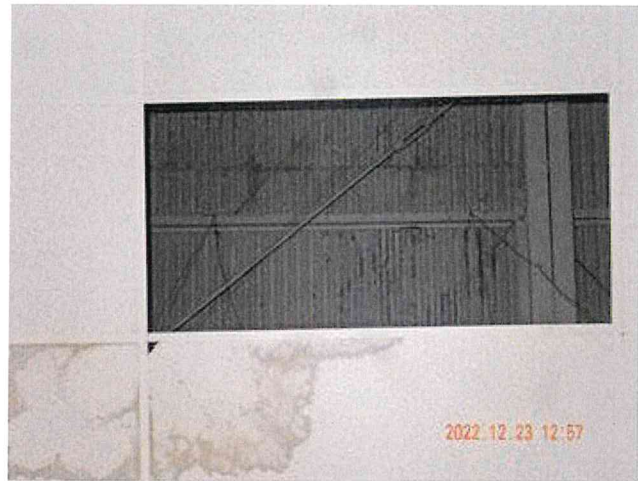
14. Anacapa Hall metal dome roof decking, moisture stained

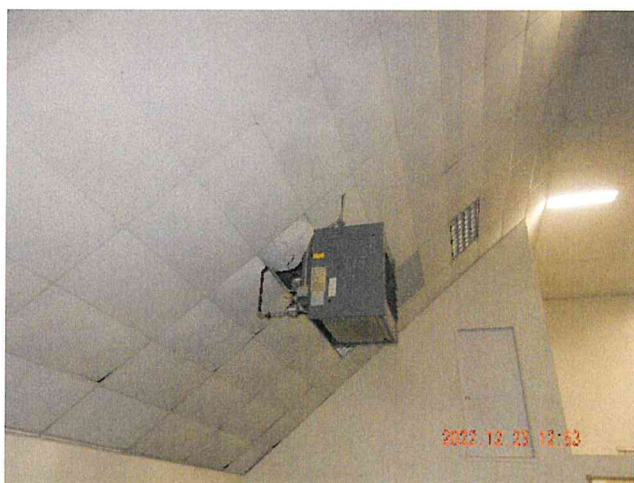
18. Anacapa Hall, moisture damaged at area space heater

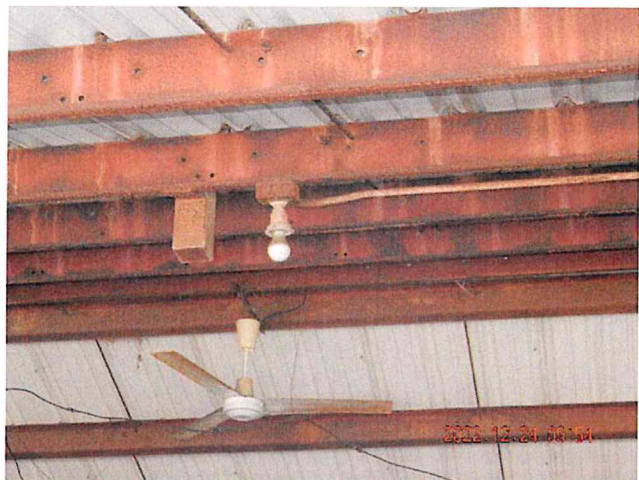
4. Barns 100, 200, and 300 typical roof framing corrosion

- Observation of the steel framed barns found corrosion and deterioration in need of corrosion mitigation (sandblasting and paint) of components within the open-air elements.
- The metal roof system found deteriorating components. Recommend evaluating within two to five years for significant repairs or renovation.
- The exterior wood siding needs maintenance repair and component replacement.
- The visible electrical system needs evaluation for immediate electrical repairs and/or renovation.
- Further evaluation of the buildings is warranted. The electrical system and components were not thoroughly evaluated and warrant further investigation.

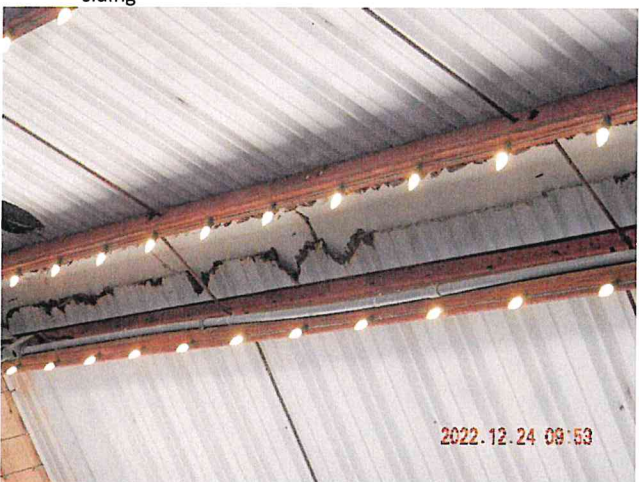
5. Barns 100, 200, and 300 example of metal roof corrosion

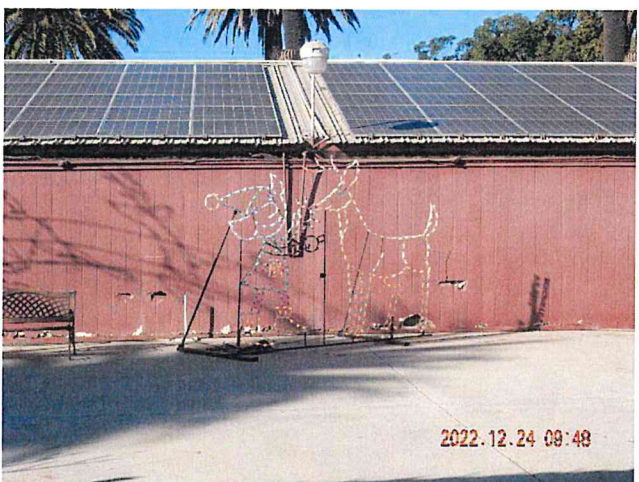
6. Barns 100, 200, and 300 example of unmaintained siding

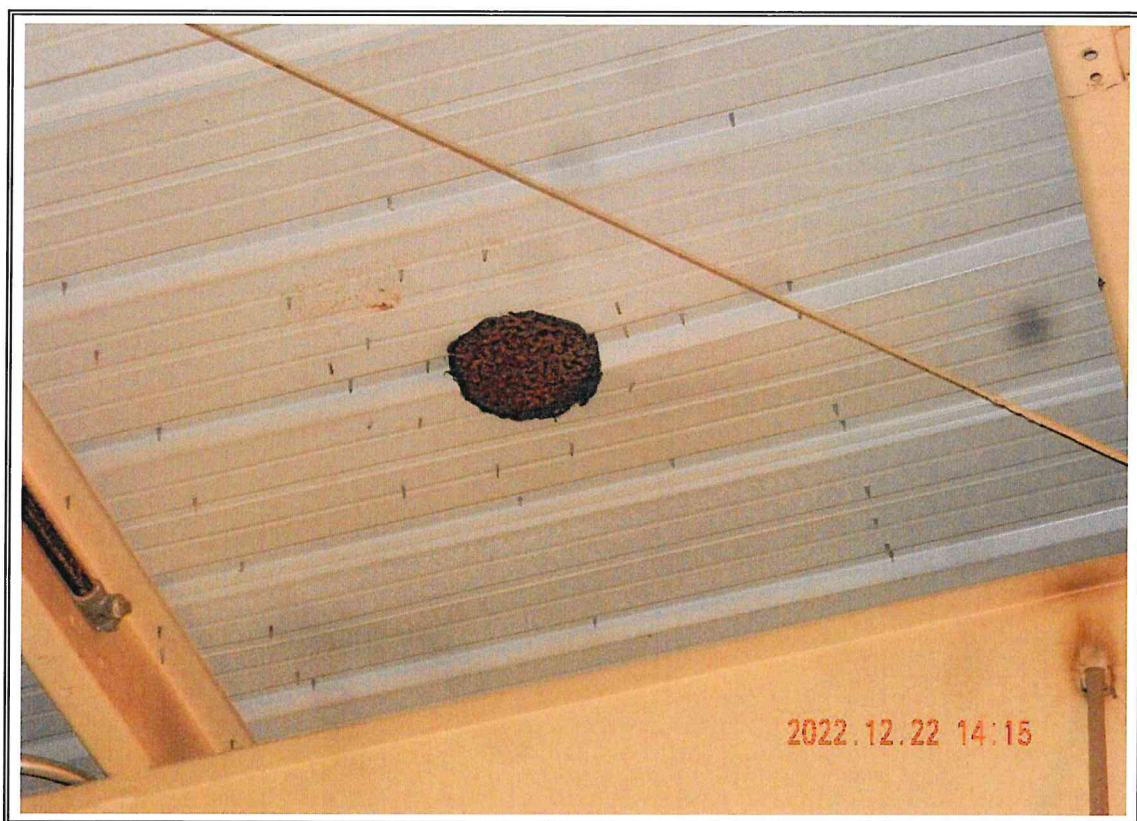
- The two maintenance buildings were found to be in reasonably maintained condition. Observed ceiling moisture stains and the occupant reported minor roof leaks.
- Roof warrants further evaluation for the remaining useful life.

2. Maintenance building moisture staining

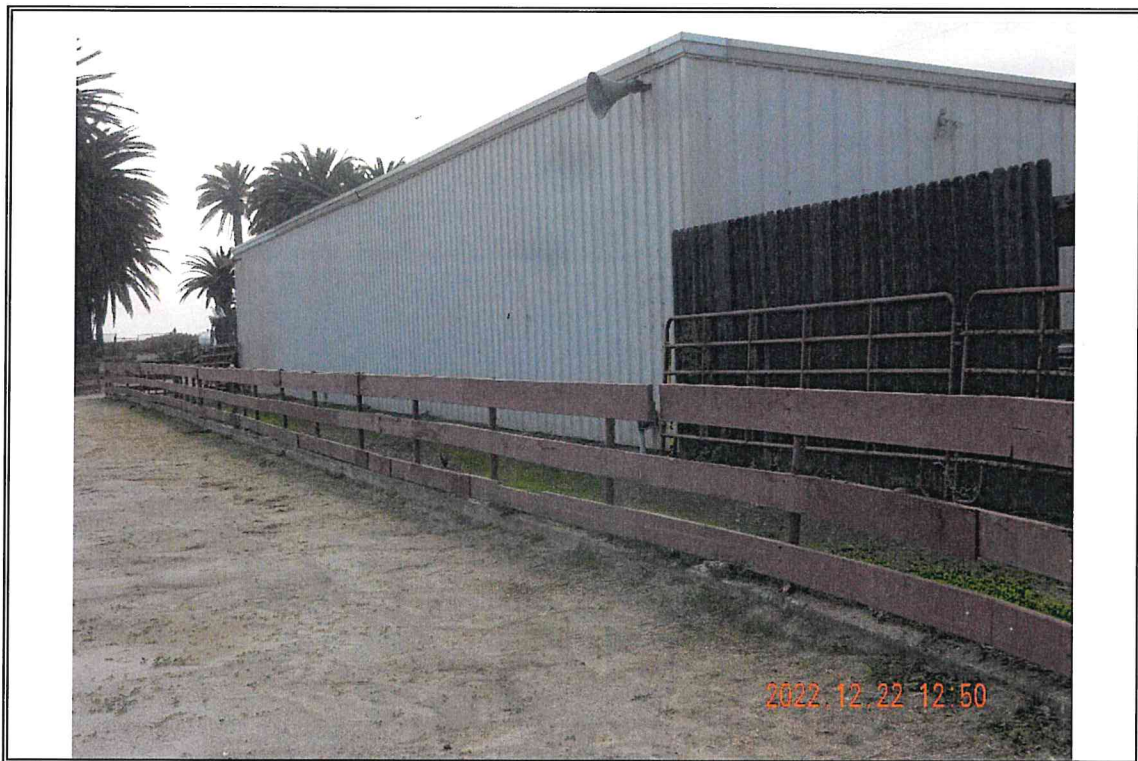
2. Morgan Horse Arena fencing needs repairs and/or renovation

- Deferred maintenance in need of increased maintenance repairs and/or renovation or replacement.
- The Arena railing needs repairs or evaluation for replacement.
- The electrical system serving the Arena needs further evaluation for repairs and/or renovation.

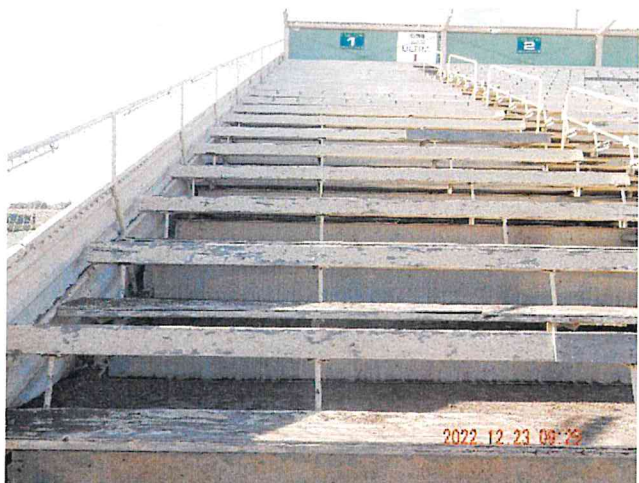
4. Ventura Raceway Grandstands bleachers worn

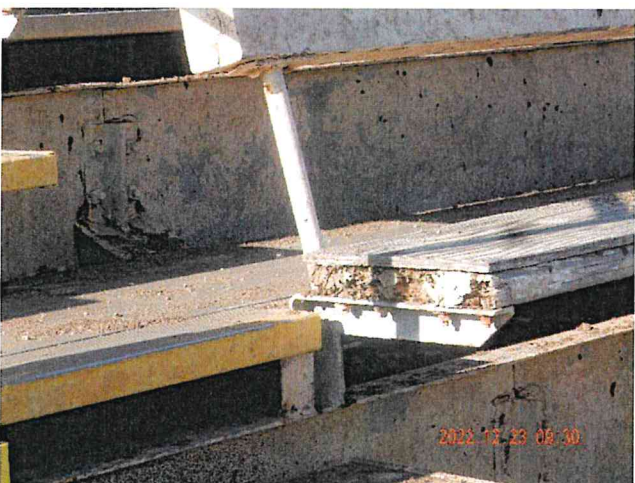
5. Bleacher's wooden seating deteriorated

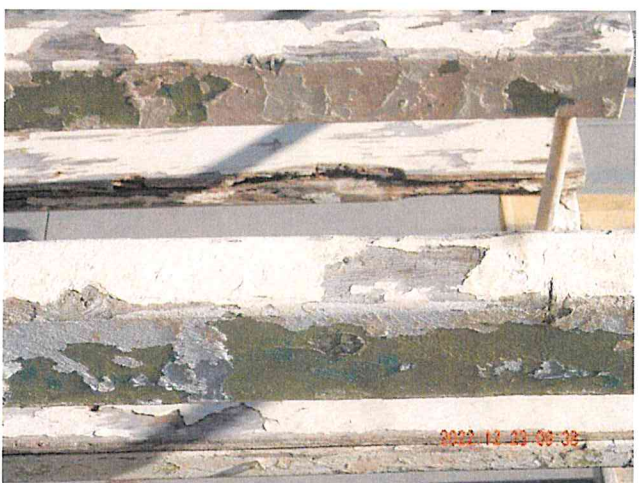
6. Bleacher's wooden seating deteriorated.

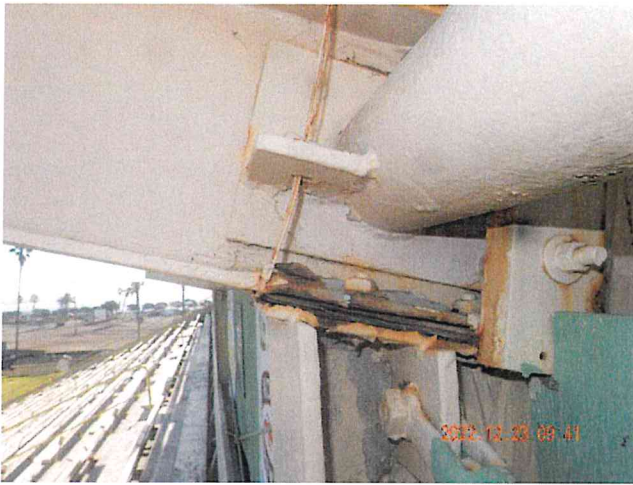
7. Grandstands upper connection plated indication of delamination

- Evaluation by an engineer is warranted. A significant amount of corroded, worn, and aged components and connections has rendered the Grandstands hazardous and unsafe condition for public usage. Observation of corrosion-generated holes within the structural elements and throughout the supporting elements and delaminating structural elements warrant further evaluation by an engineer.
- Recommend further evaluation of the Grandstands concession booths regarding the noted moisture damage.
- An in-depth evaluation of the Grandstands electrical system is warranted for safety, due to observed corroded/deteriorated junction boxes and outlets face surfaces.

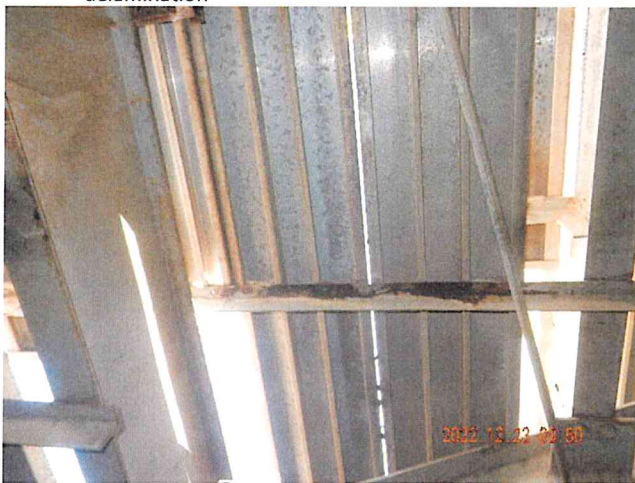
9. Bleacher walkway supports corroded

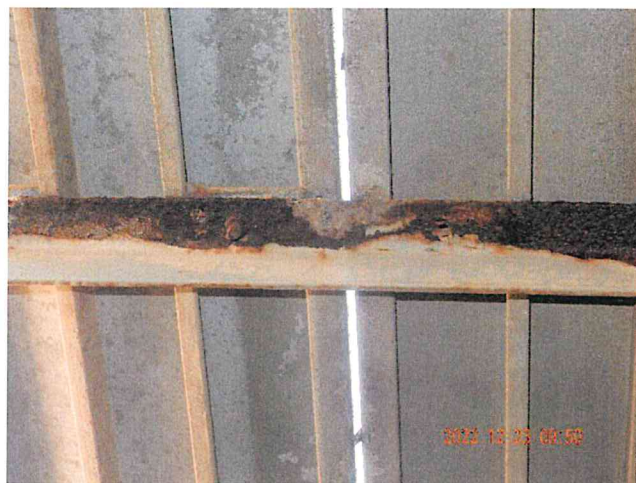
10. Bleacher walkway supports corroded

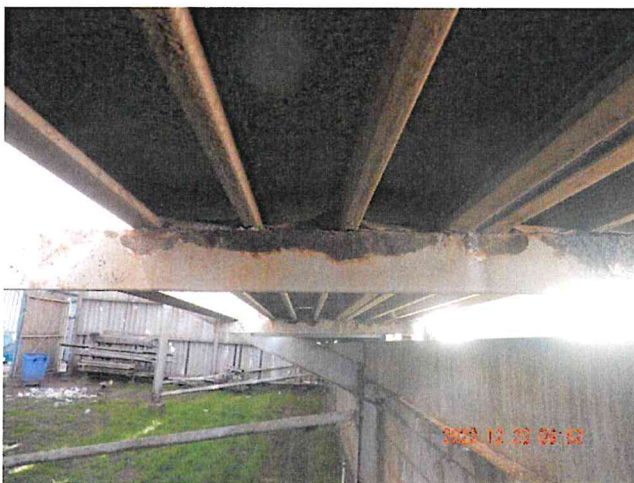
11. Bleacher walkway supports corroded

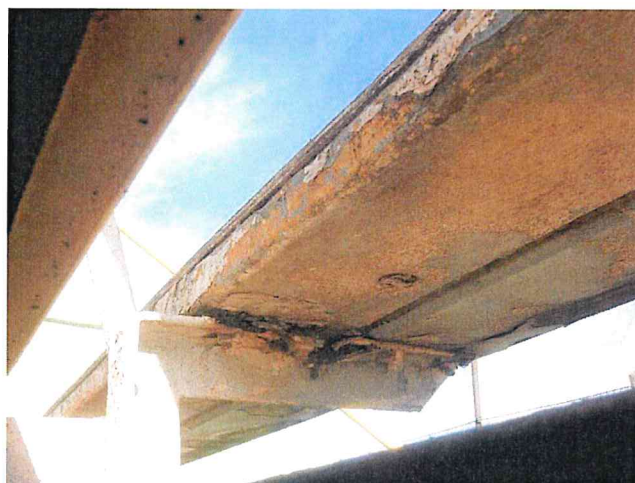
12. Bleacher seating supports corroded

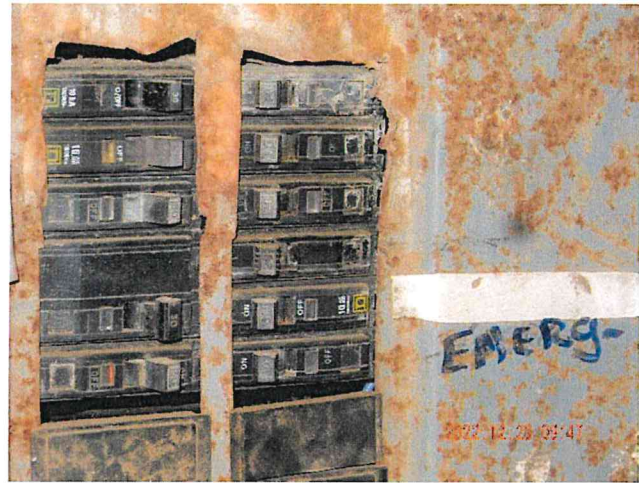
14. Under the Grandstands electrical box corroded

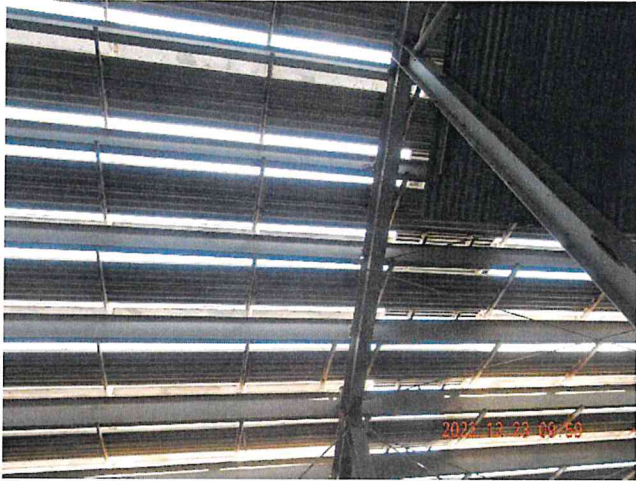
19. Under Grandstands bleacher support show indication of significant corrosion

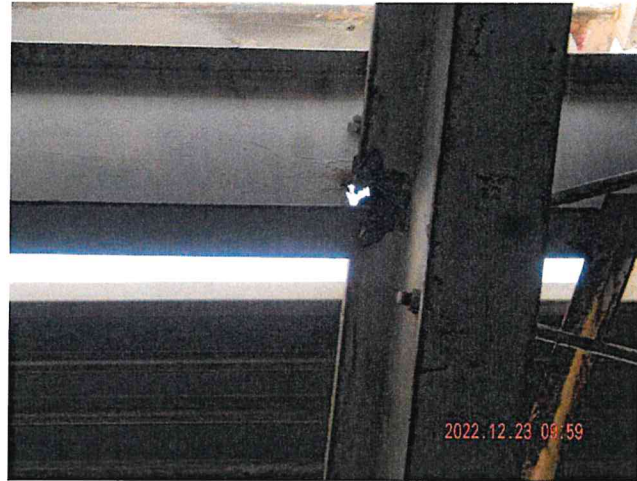
20. Under Grandstands bleacher support show indication of significant corrosion at the connection

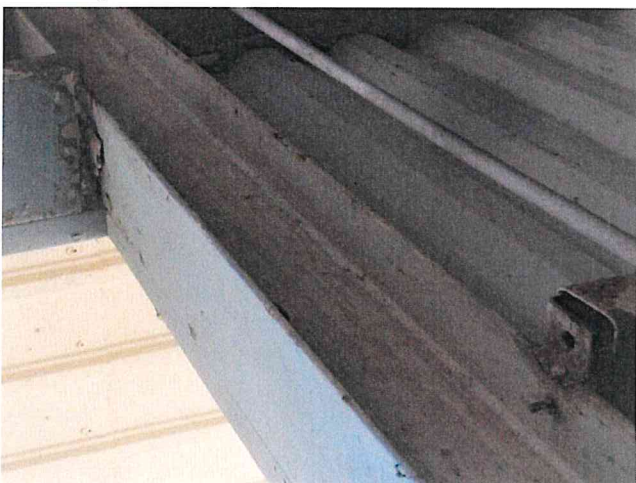
23. Under Grandstands bleacher support shows indication of corrosion at the connection

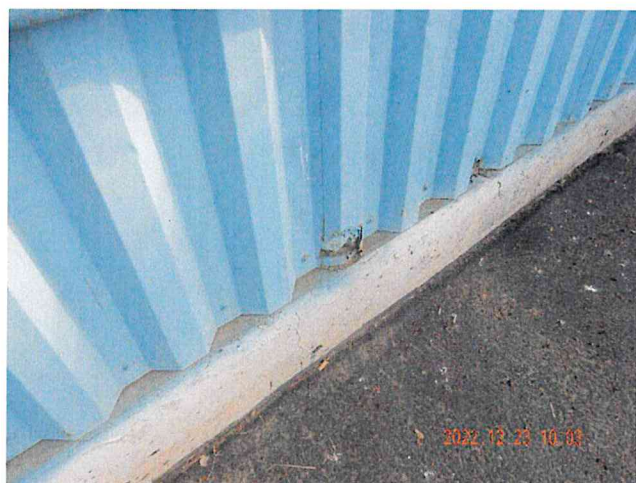
24. Grandstands exterior metal siding noted some corrosion.

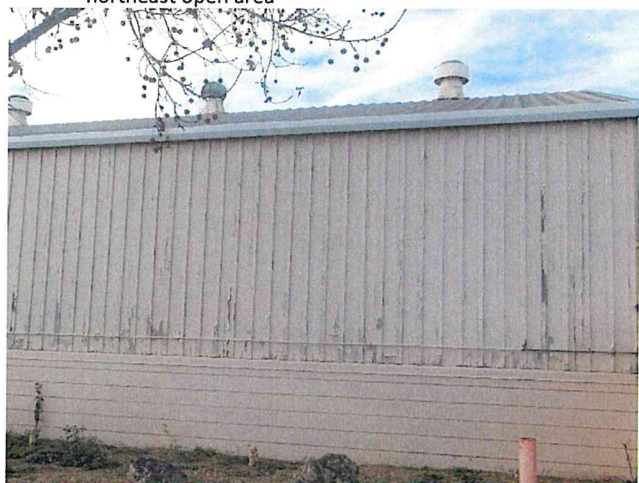
4. Floriculture southeast wall elevation typical wood siding deterioration

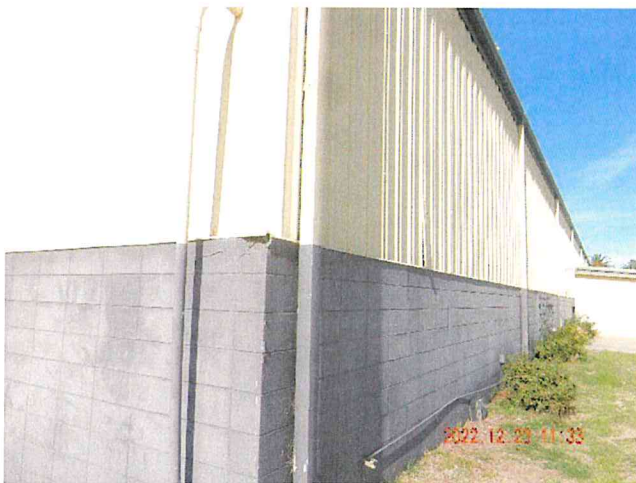
3. Santa Cruz Hall southeast wall elevation damage CMU

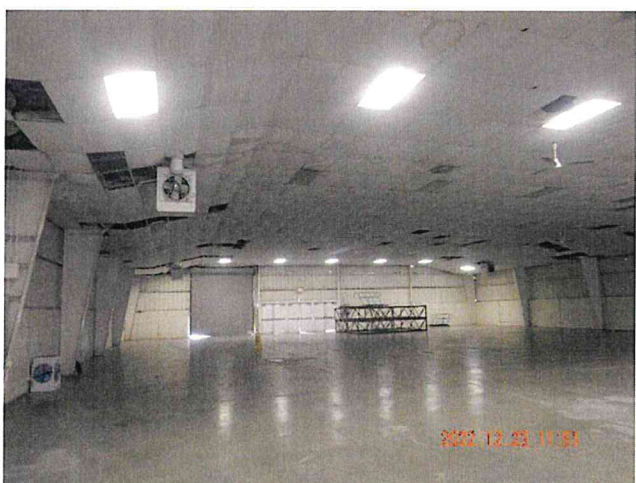
6. Interior ceiling moisture staining, damaged and/or missing ceiling tiles

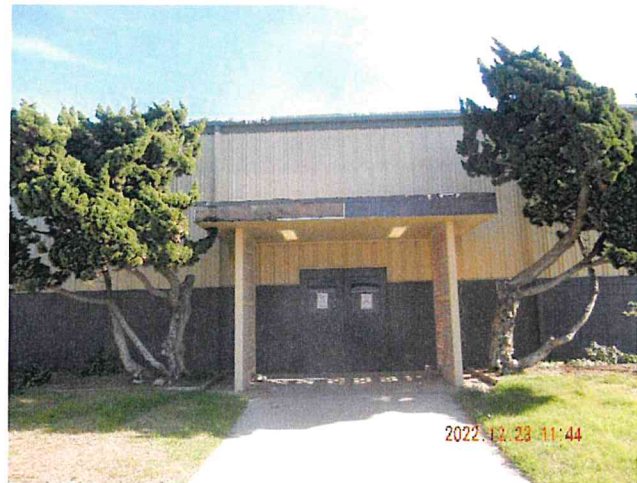
8. Santa Cruz Hall west wall elevation moisture damaged entry

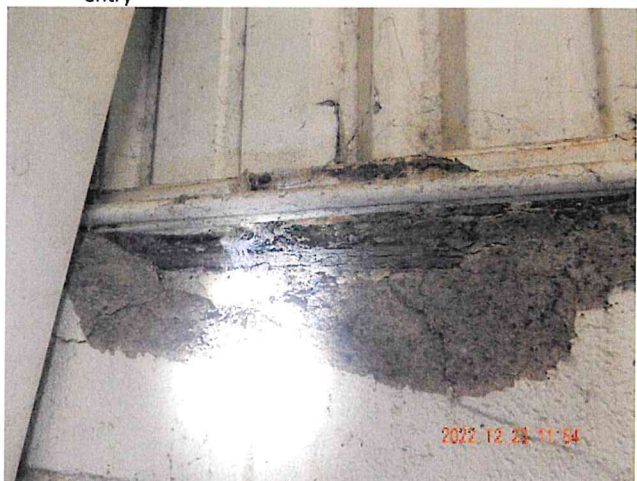
10. Interior damaged CMU with exposed rebar.

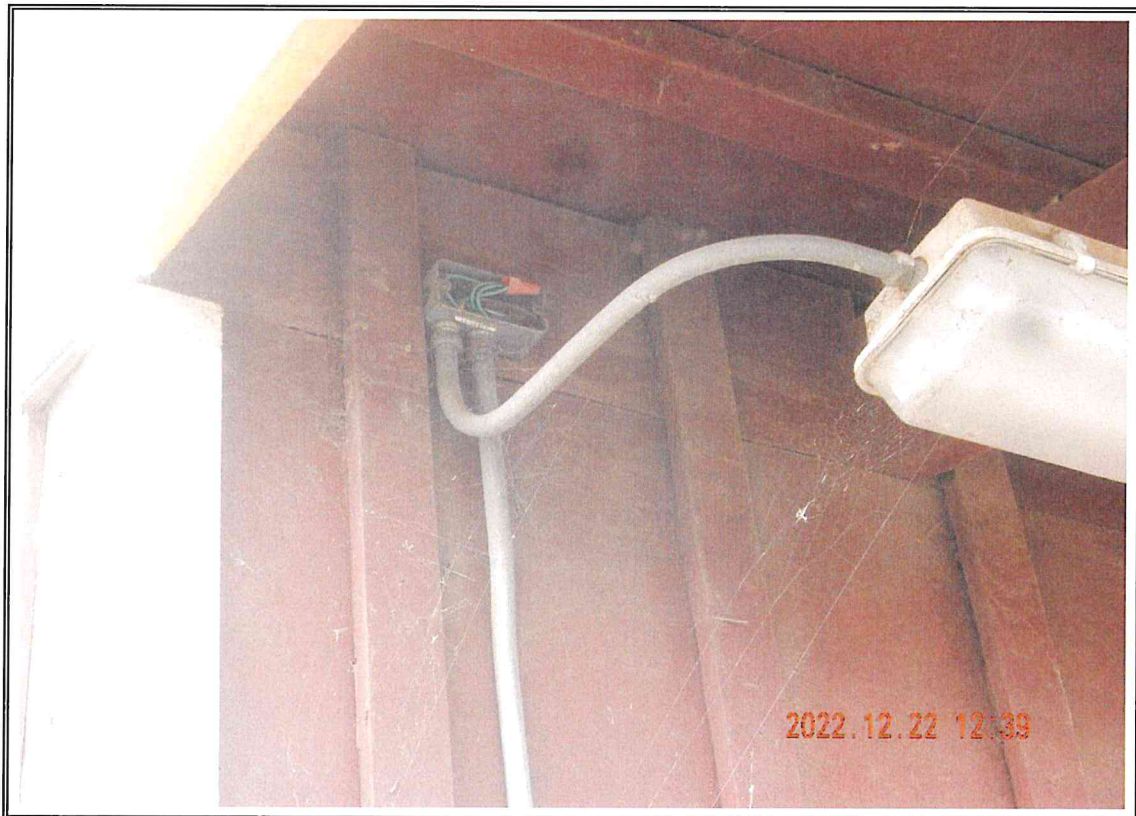
2. Typical electrical repairs needed

- The exterior electrical systems throughout the Barns are in immediate need of evaluation of electrical repairs and/or renovation. The exterior electrical components that were observed (outlets, conduits, and light fixtures) need to be restored to a safe condition.
- The Barns' roofs need further evaluation for repairs and/or renovation over the next one to five years. Several roofs are in need of immediate repair.
- The Barns' exterior siding and doors need repair. Evaluation for repairs and/or renovation is warranted.

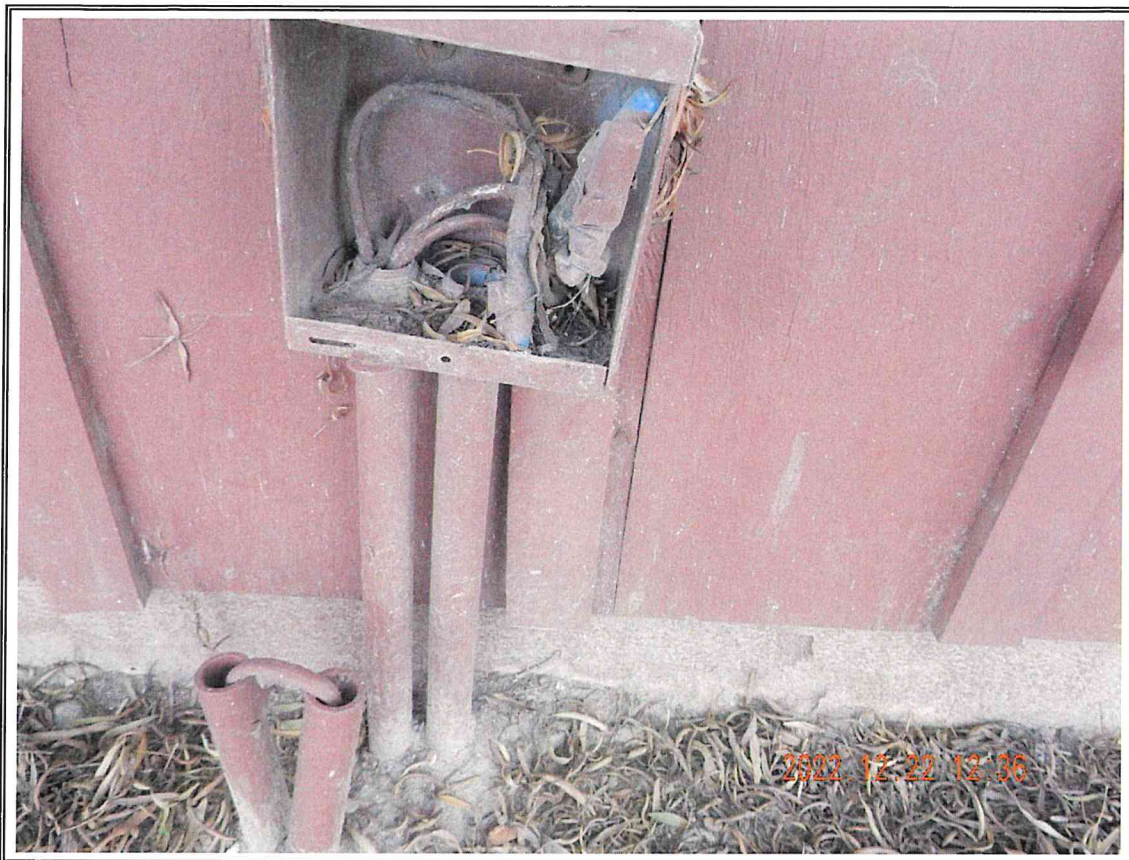
3. Typical electrical repairs needed

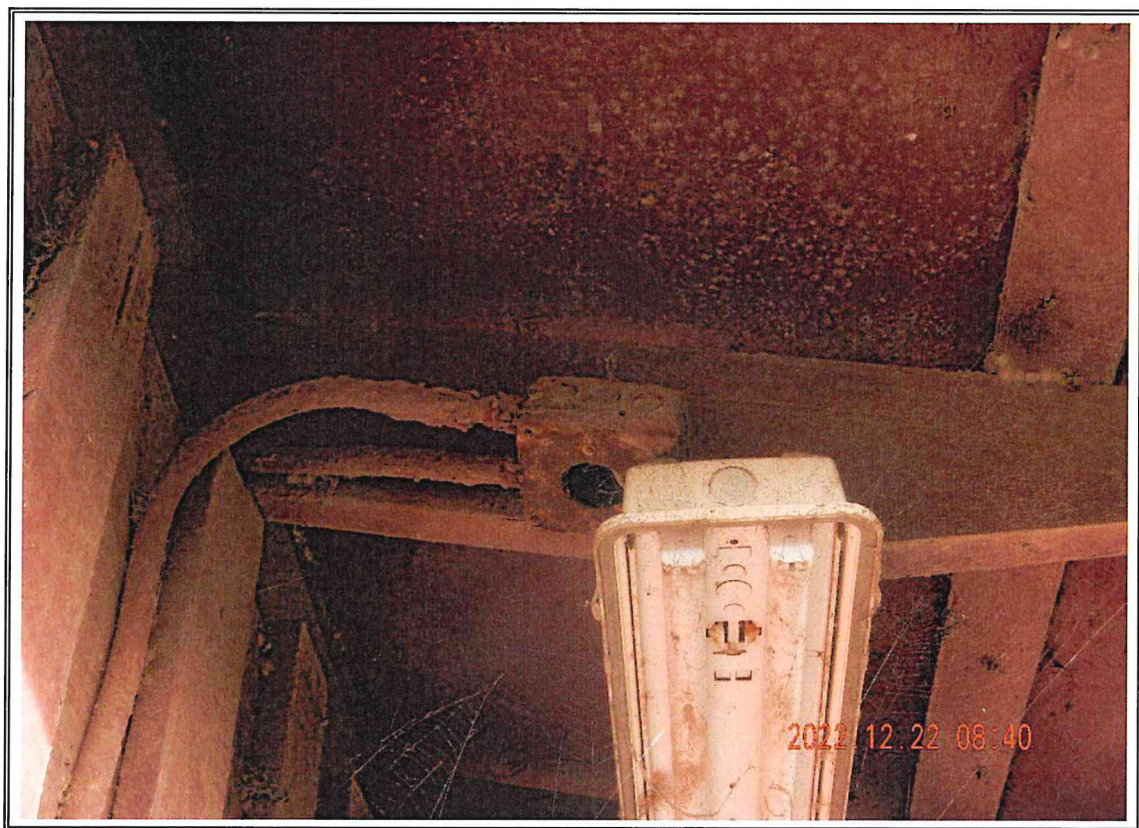
4. Typical electrical repairs needed

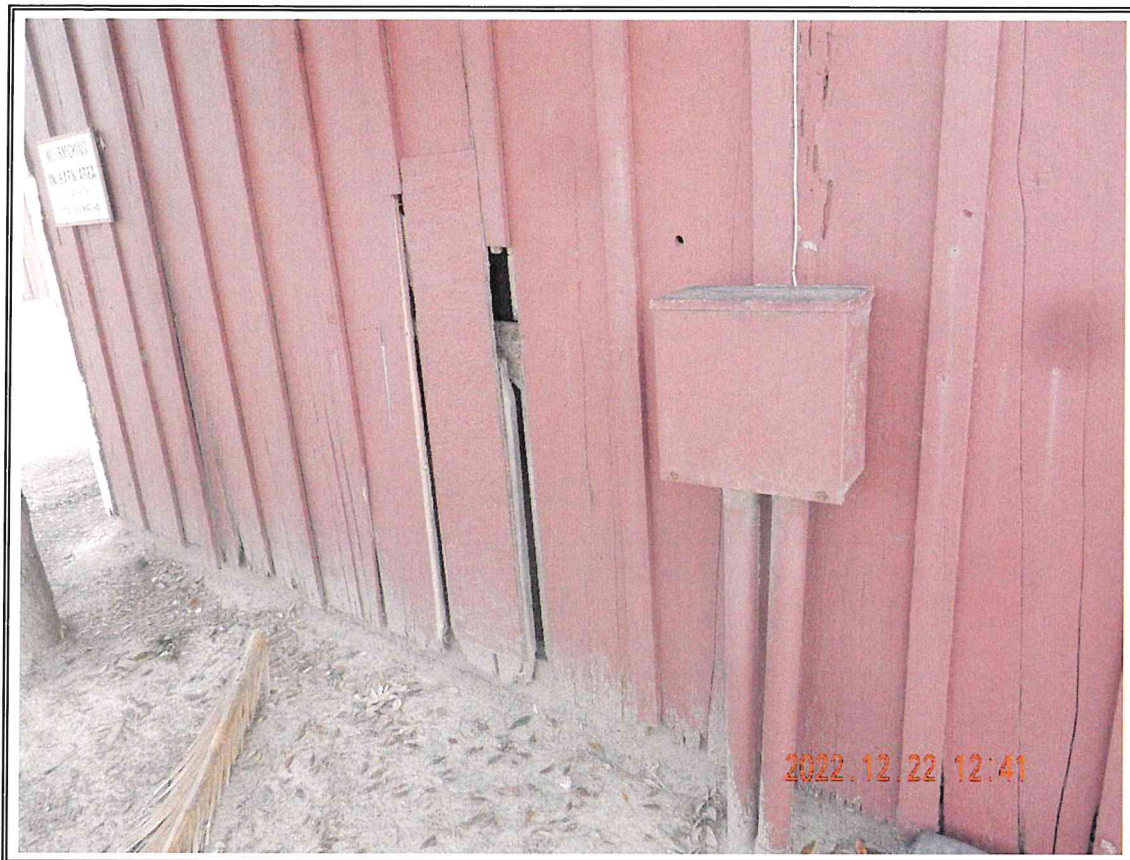
5. Typical siding repairs needed

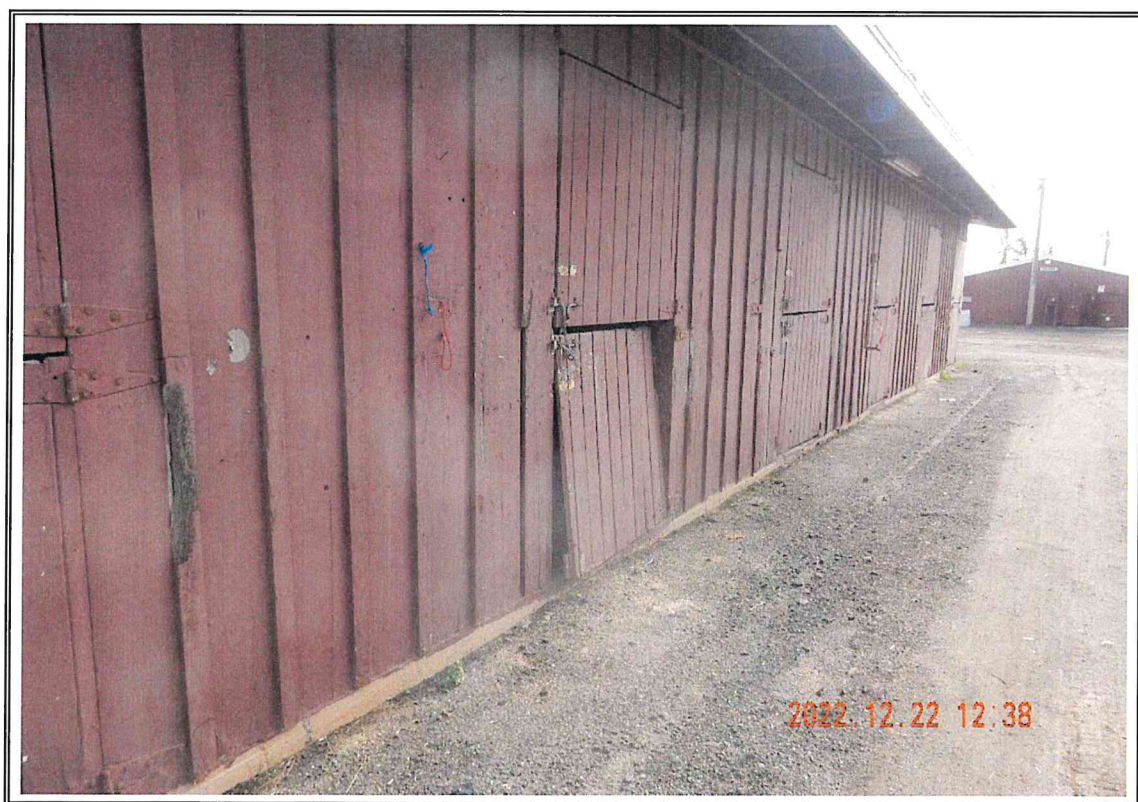
6. Door and siding repairs needed

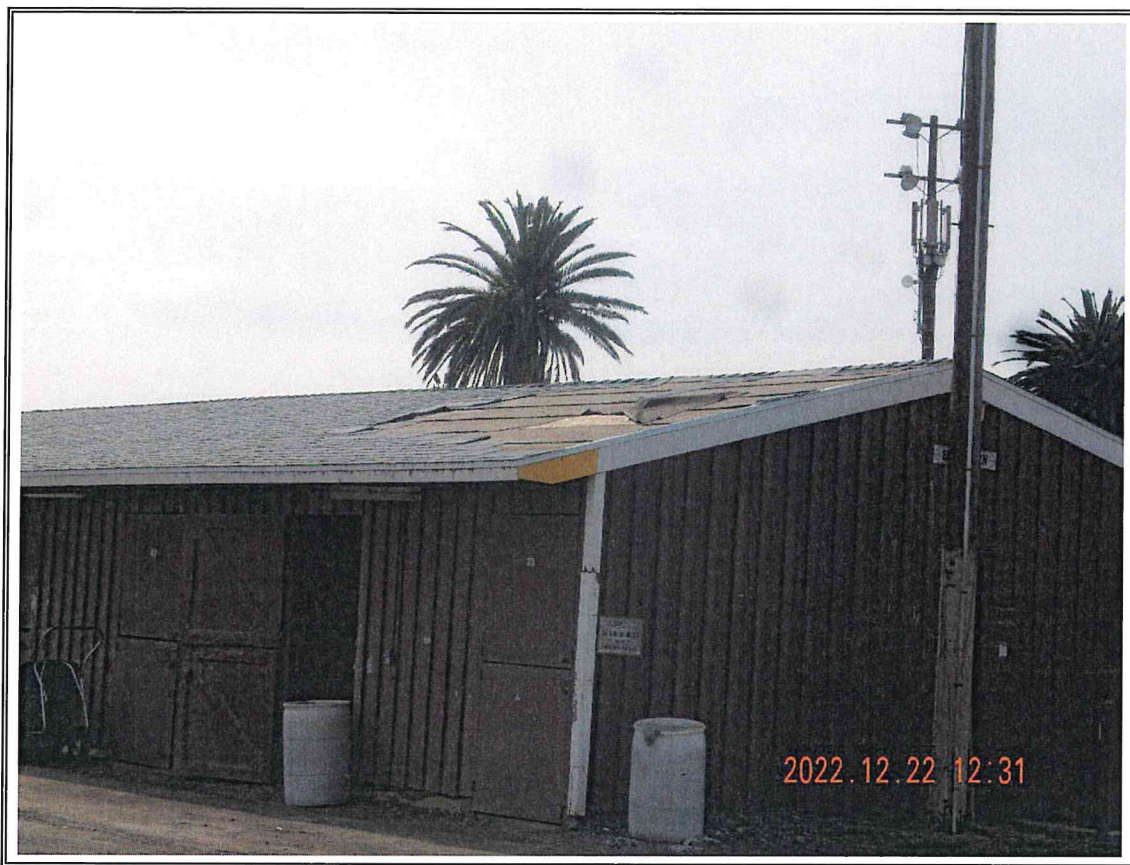
7. Roof repairs and/or renovation needed

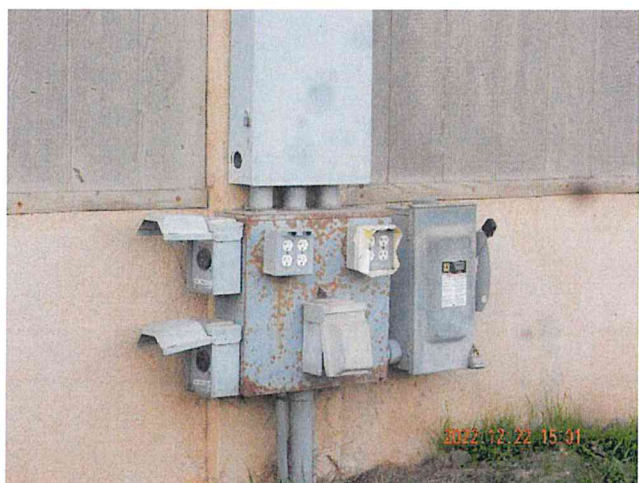
4. Area 3: electrical cabinets and outlets need continuing corrosion maintenance and repairs, and replacement

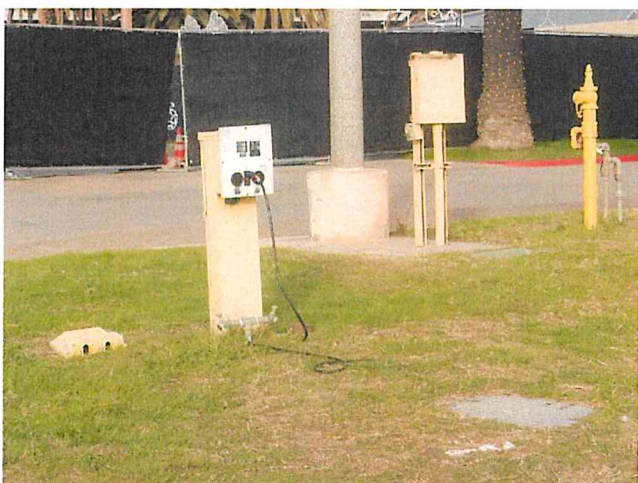
5. Area 3: typical aging and damaged electrical and underground galvanized plumbing

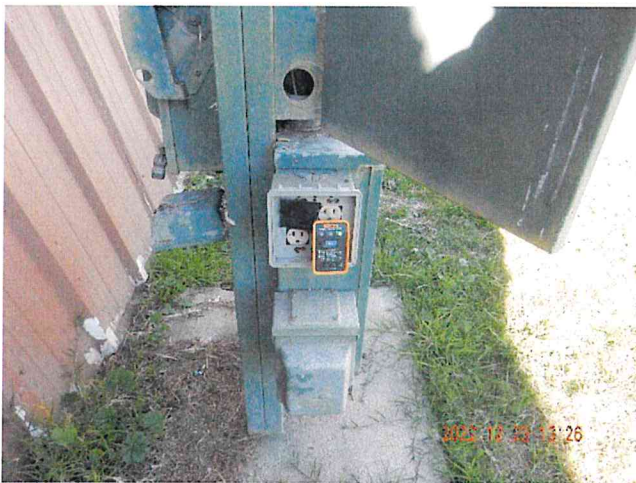
9. Area 1: typical aging and damaged electrical

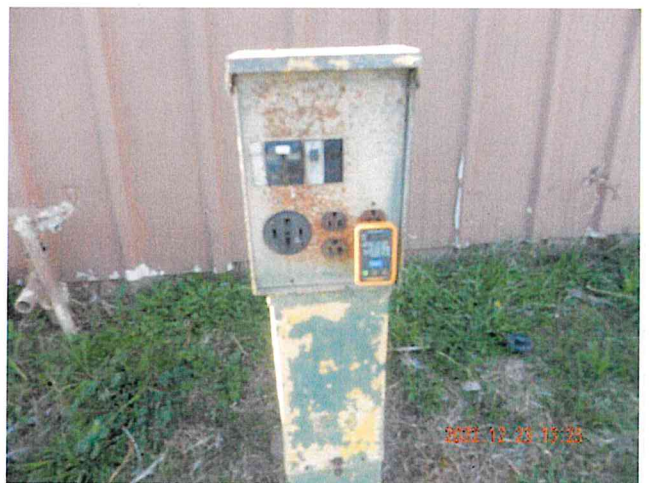
10. Area 1: typical aging and damaged electrical

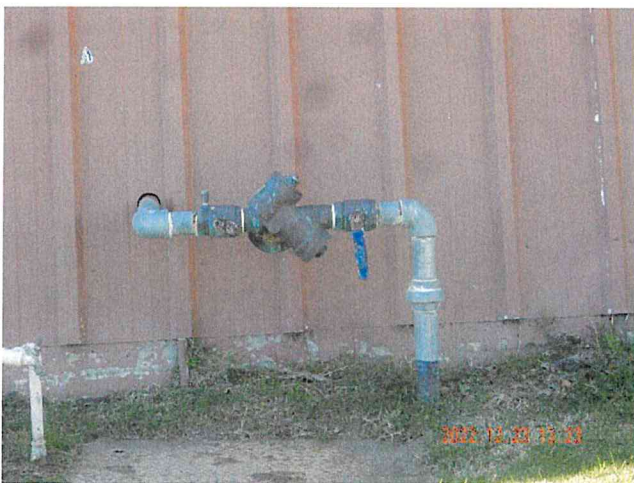
11. Area 1: typical aging galvanized plumbing

- The potable water piping was primarily galvanized, but shows indications of aged and corroded components. It is anticipated that increased continuing issues will occur with the aging pipe system.
- System evaluation warranted for repairs and/or renovation within the next one to five years
