CALIFORNIA CONSTRUCTION AUTHORITY

31st DAA Ventura County Fairgrounds Physical Assessment

CCA Project: 031-22-133

Date: December 21-22, 2022

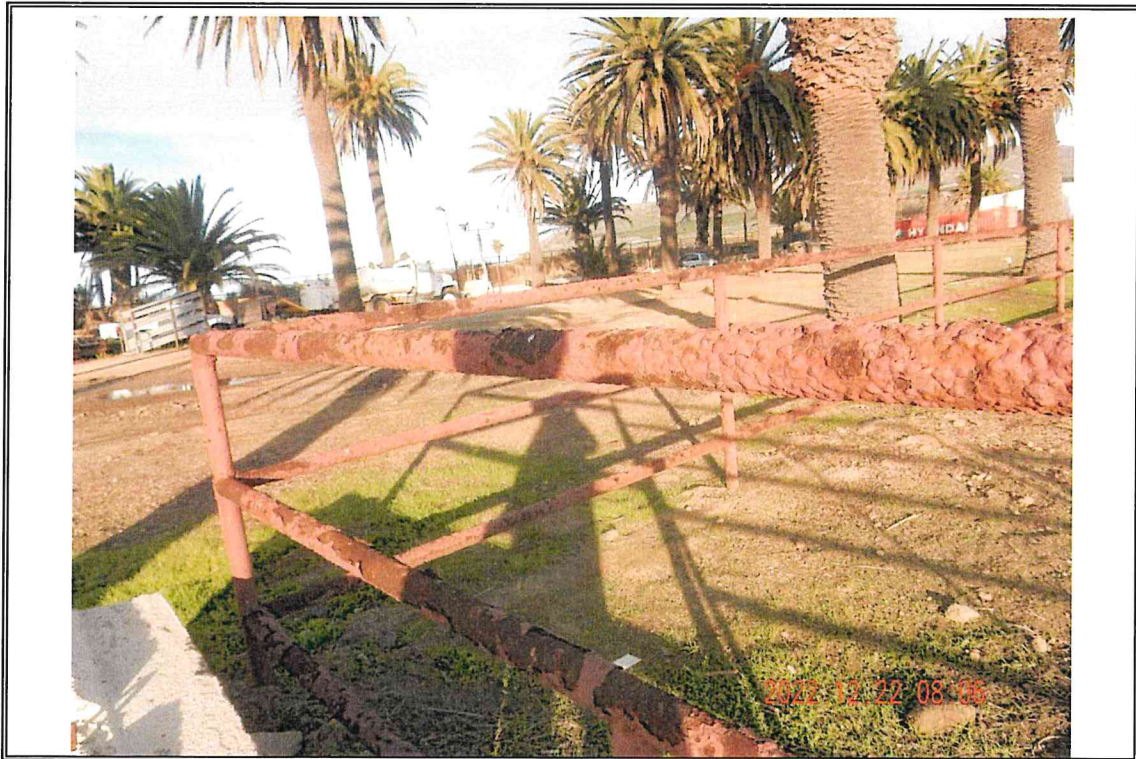
2. Corroded railing

- The Training Arena's metal components (railing) are severely corroded and in need of significant repairs and component replacement. Evaluation of repair or replacement is warranted.
- The condition of the corroded railing poses a safety concern if/when individuals climb or sit on the railing.

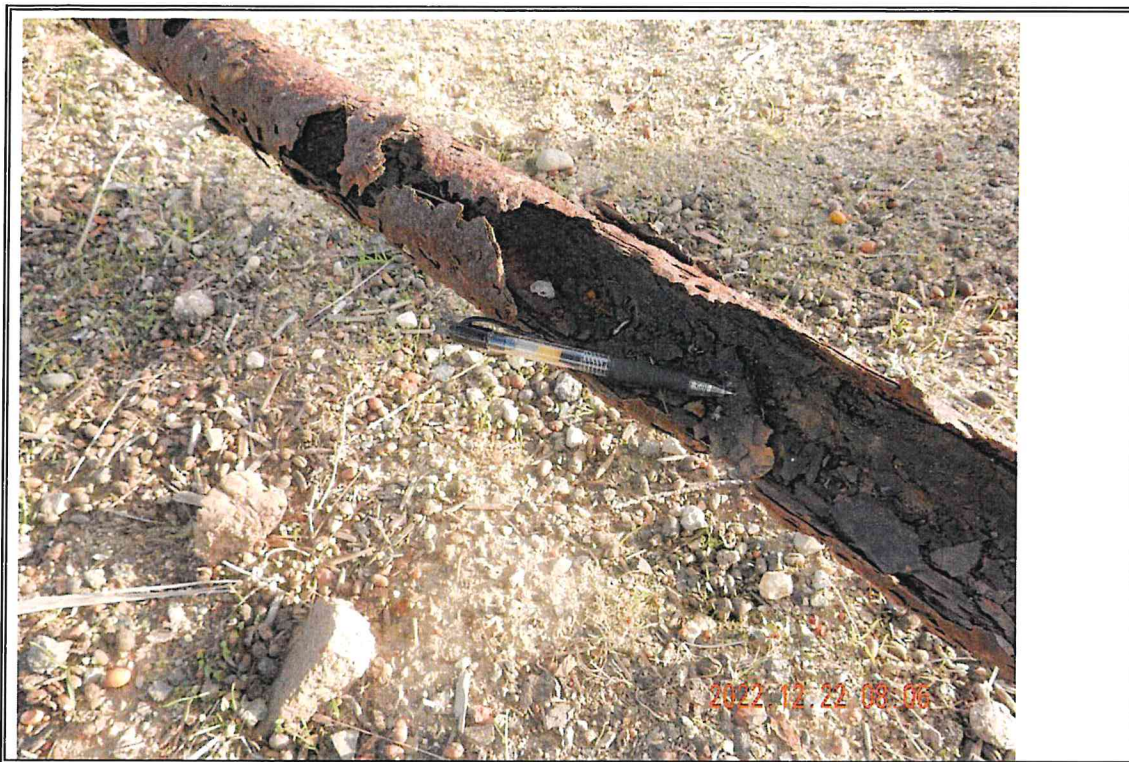
3. Corroded railing
