March 9, 2023

Subject: Ventura County Fairgrounds – Grandstand Inspection – Revision 01

On January 17, 2023, Dagley Engineering, Inc. (DEI) was on-site to perform a visual assessment of all grandstand seating within the racetrack area of the Ventura County Fairgrounds property, which include:

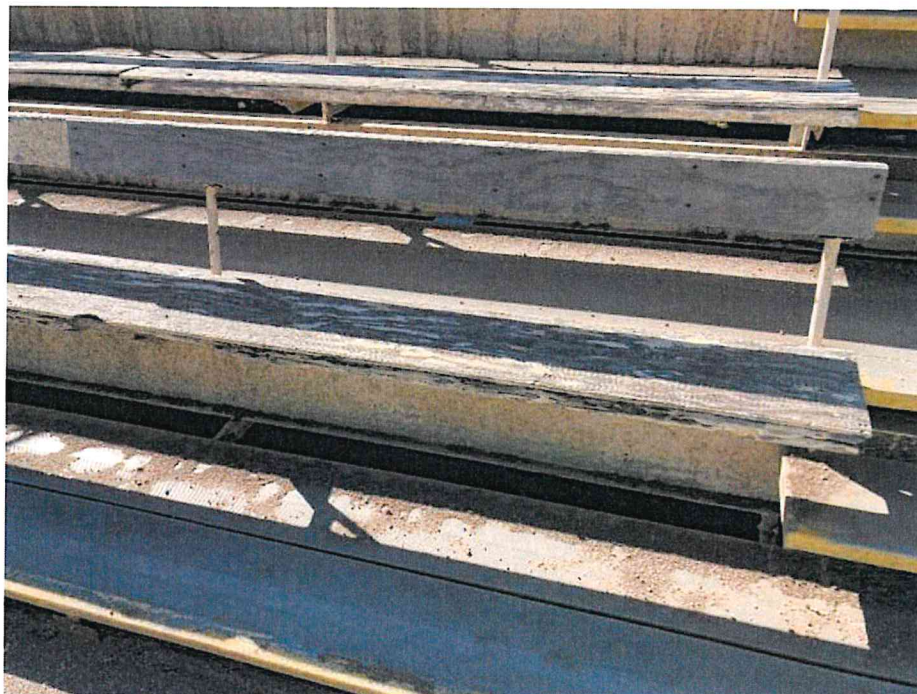
- ADA access ramp on south end and at front
- ADA access ramps consisted of cast-in-place concrete
- All bleacher seats were present
- All bleacher seats had been covered over with plywood as original seats were severely damaged/rotted

Figure 2 – Close-up photo showing aluminum steps and treads and wooden seats and seat backs (note plywood on top of original wood seat)

- Where cross-bracing members are buried in soil or are in standing water, remove soil or fill in low spots to prevent further standing water
- Where wood seats or seat backs are observed to be rotted/damaged, replace in kind with new wood seat or seat back

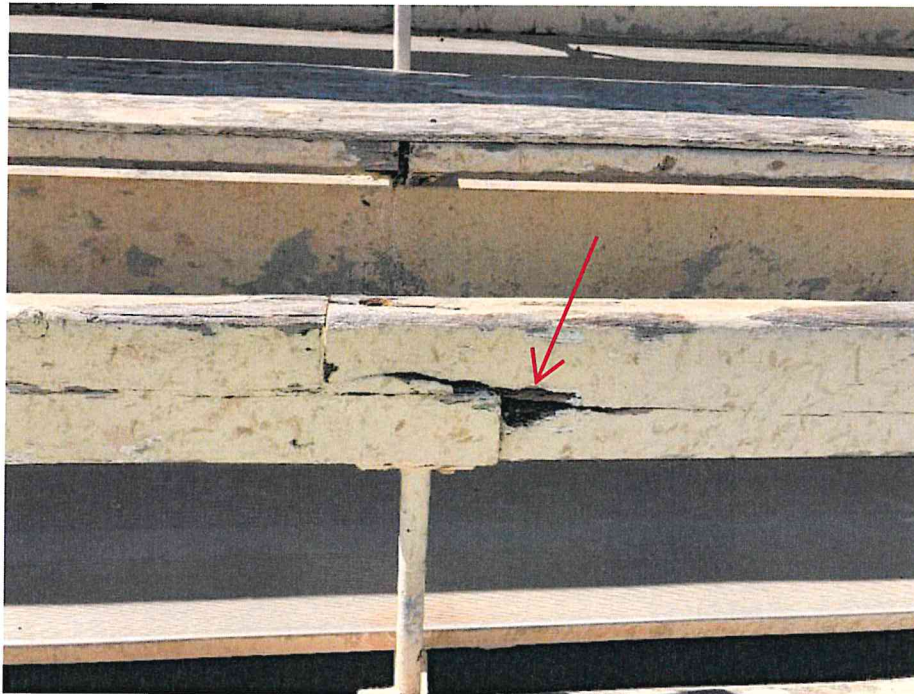
- Plywood topping at seats observed to be rotted/damaged in some areas
- Wooden seat back supports observed to be rotted/damaged in some areas
- Treads, seats and toe kicks, guardrails and hand rails all present

Figure 3 – Close-up photo showing wooden seats and rotted/damaged seat back (note plywood on top of original wood seat)

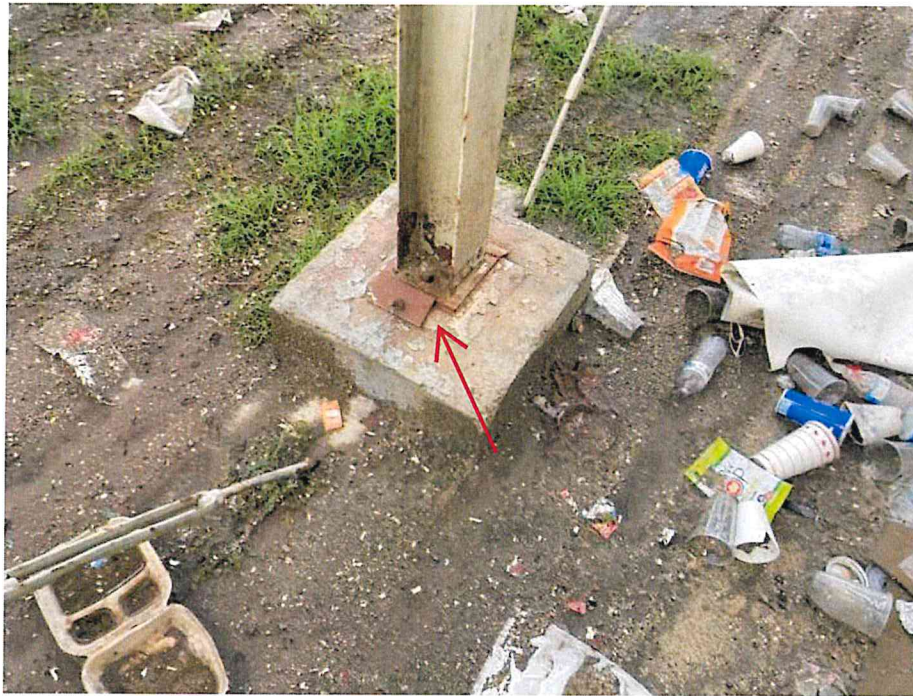
- At some locations, anchor bolts had corroded, or hardware was lost/stolen, so retrofit anchor "tabs" were welded to base plate through which new anchor bolts were installed into concrete footing

Figure 5 – Photo showing column base with retrofit base plate flanges and anchor bolts

- Tighten all loose hardware (bolts, nuts, washers, turnbuckles, anchor bolts, nuts at anchor bolts, etc.)
- Any missing/damaged hardware (bolts, nuts, washers, turnbuckles, anchor bolts, nuts at anchor bolts, etc.) to be replaced in kind

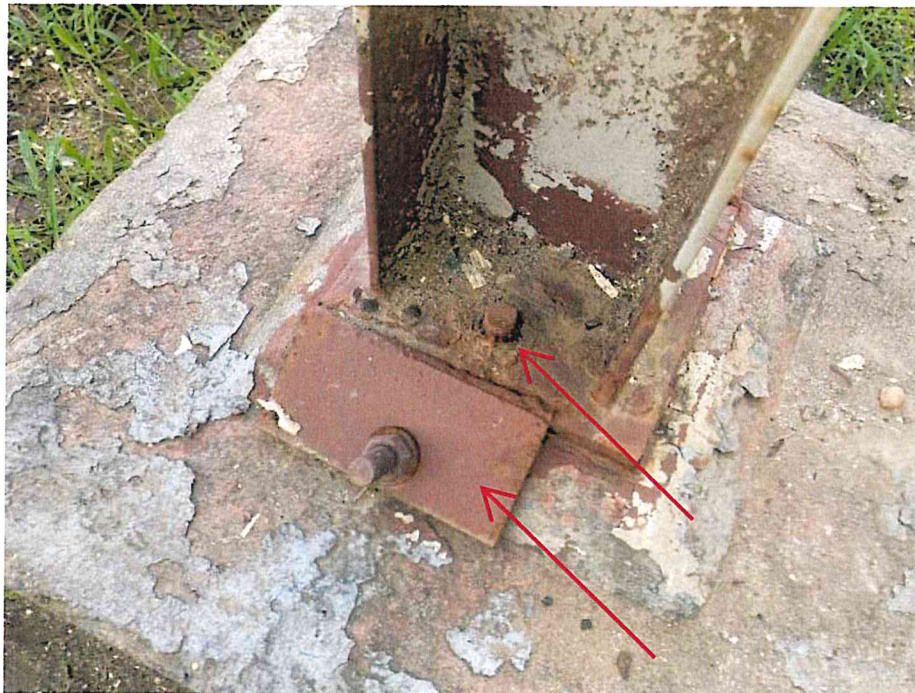
Figure 6 – Close-up photo showing column base with retrofit base plate flanges and anchor bolts

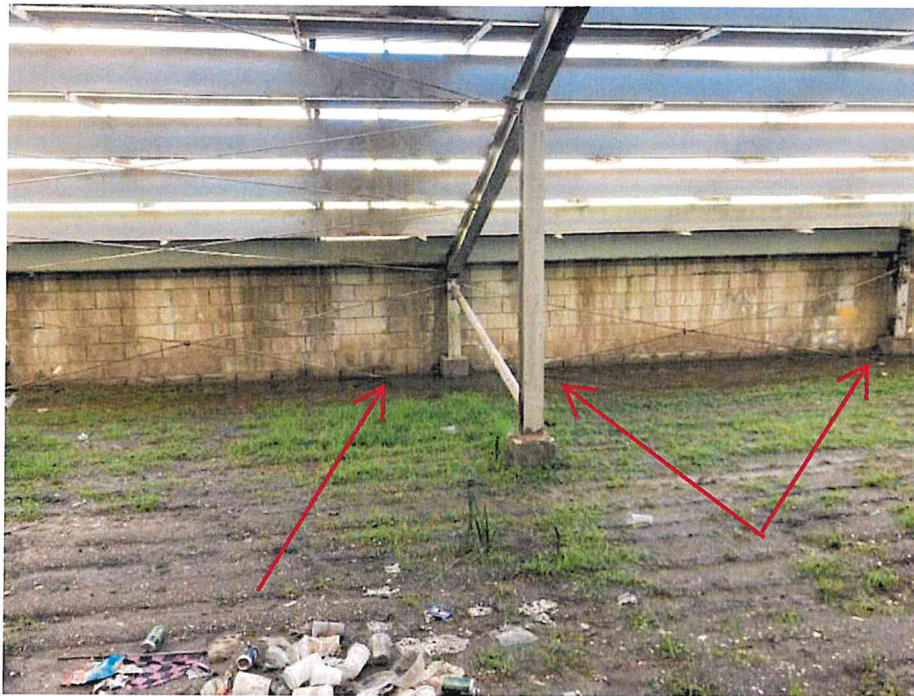
Figure 7 - Photo showing cross-bracing and hardware submerged in water

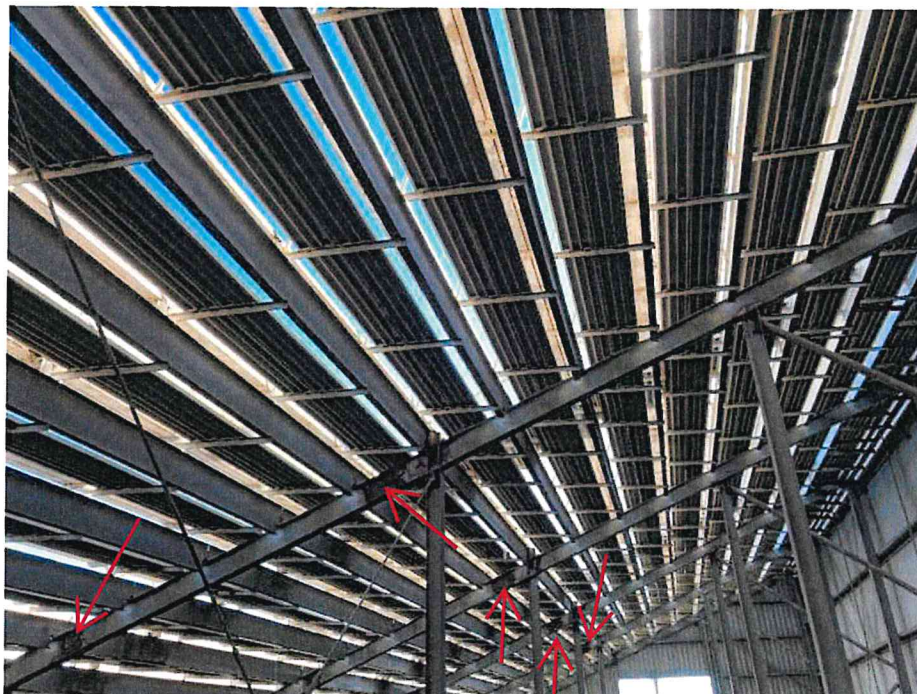
- Splice plates were observed to have significant corrosion at plate and at welds
- All cross bracing is comprised of tension-only steel rods that are connected to structure with turnbuckle hardware and nuts & washers

Figure 8 - Photo corroded splice plates (Indicated by red arrows)

- Tighten all loose cross-bracing rods
- Replace all damaged/bent cross-bracing rods in kind
- Where corrosion has caused metal to begin to “flake” or separate, remove corrosion at splice plates/vertical stiffeners/beam webs/beam flanges using mechanical means (grinder with wire wheel or flap disk, sand blasting, etc.). Where welds/plates/webs/flanges have lost section, install new steel plates (min ¼” thick) that extend minimum 3” beyond damaged area(s) and weld to steel member ensuring weld is to sound metal. Once steel is repaired with steel plate, prime/paint new metal, exposed existing metal and welds with two coats of paint/primer.

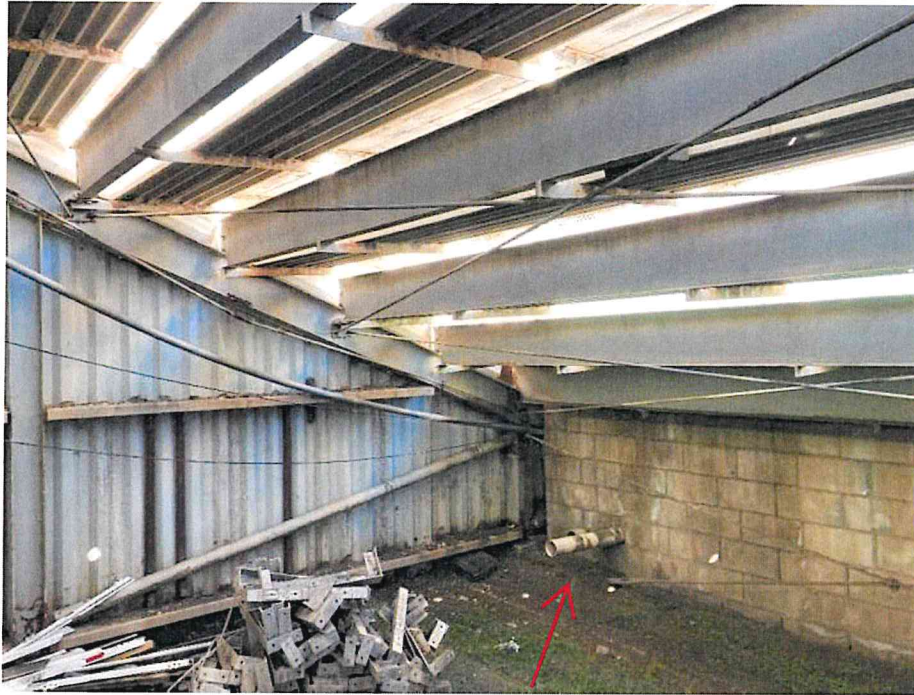
- Cross-bracing rods and/or cross-bracing hardware at front was observed to be nearly buried in soil
- Cross-bracing was also observed to be loose/bent in most locations

Figure 9 – Photo showing cross-bracing and hardware covered by soil

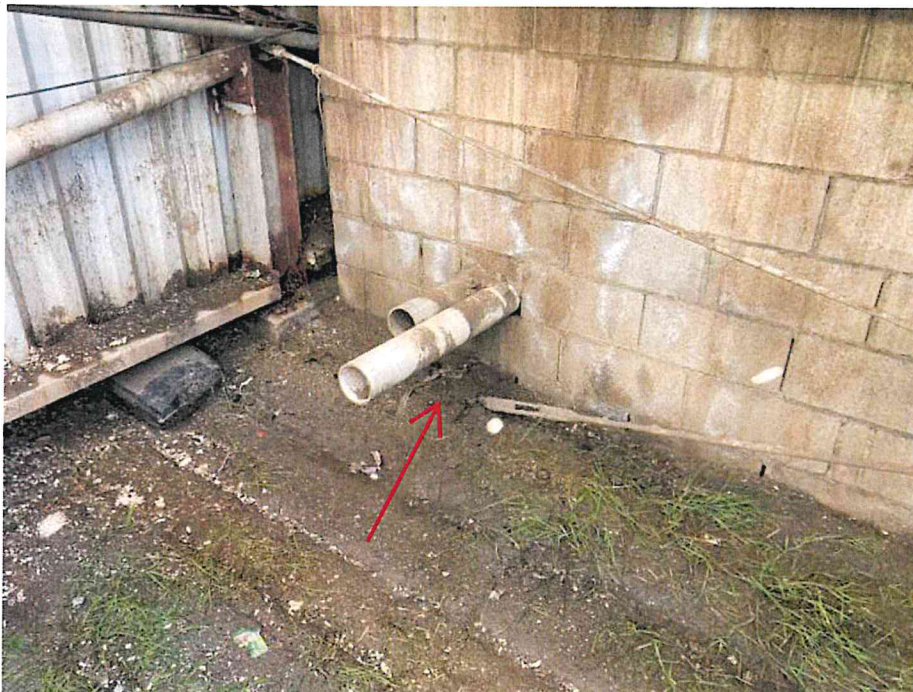
Figure 10 – Close-up photo showing cross-bracing and hardware covered by soil

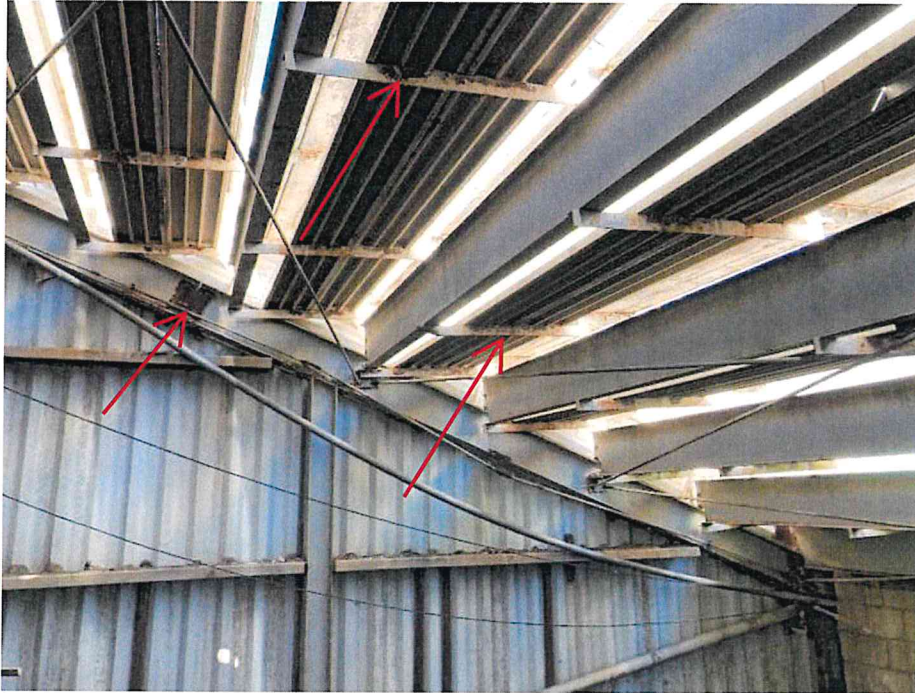
Figure 11 – Photo showing corroded splice plates and cross-members/tread supports (indicated by red arrows)

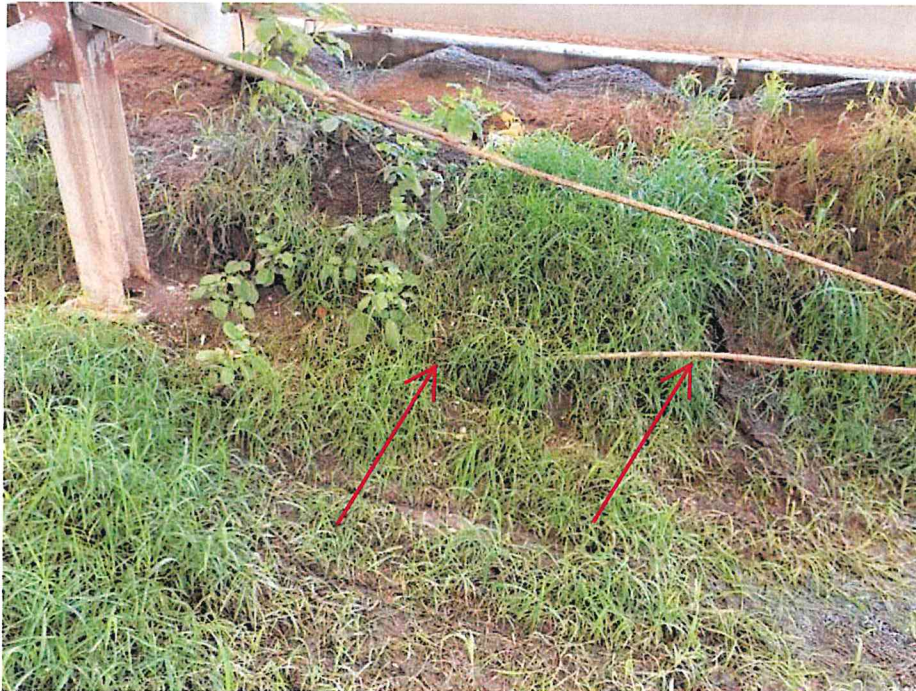
Figure 12 – Photo showing cross-bracing rods bent/damaged and covered by soil

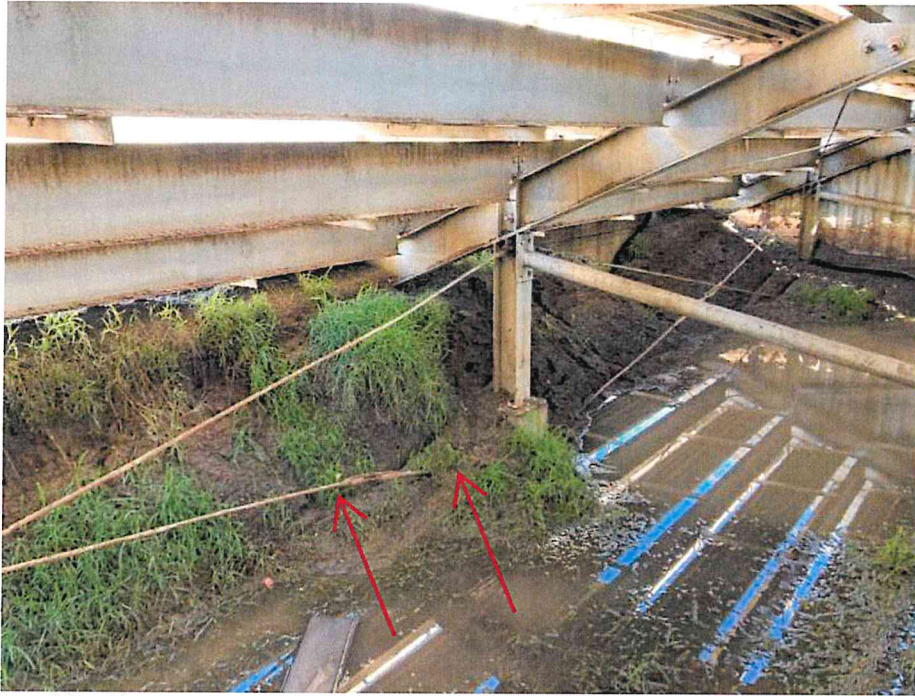
Figure 13 – Close-up photo showing cross-bracing rods bent/damaged and covered by soil

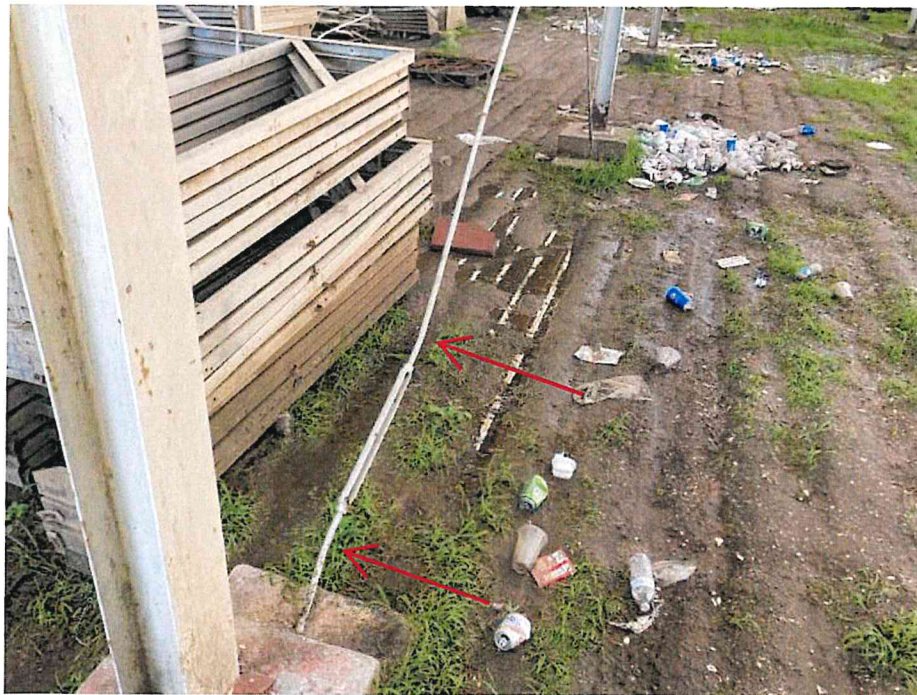
Figure 14 – Close-up photo showing bent/damaged cross-bracing rods

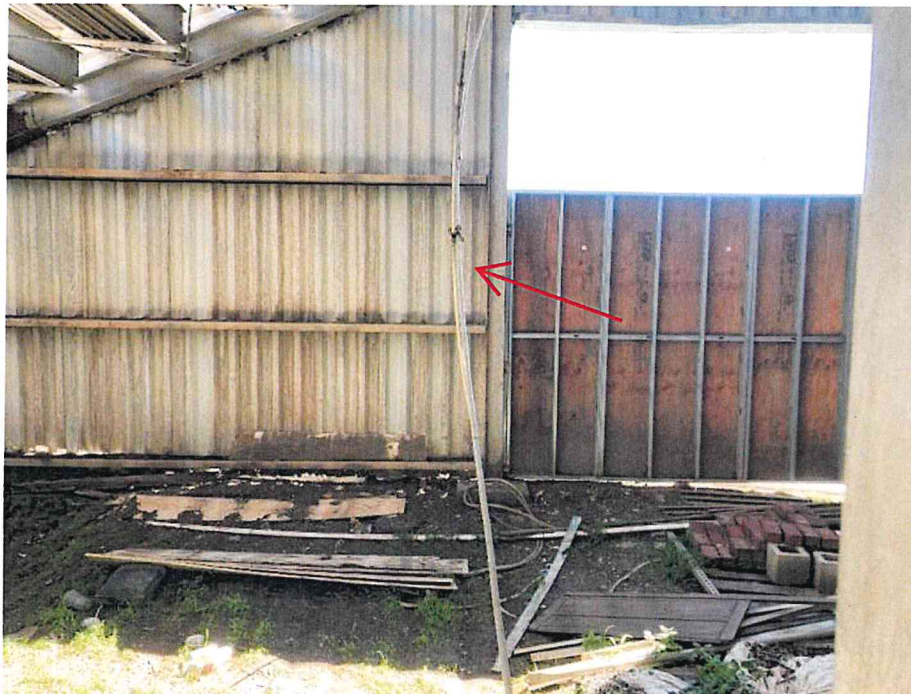
Figure 15 – Close-up photo showing bent/damaged cross-bracing rods

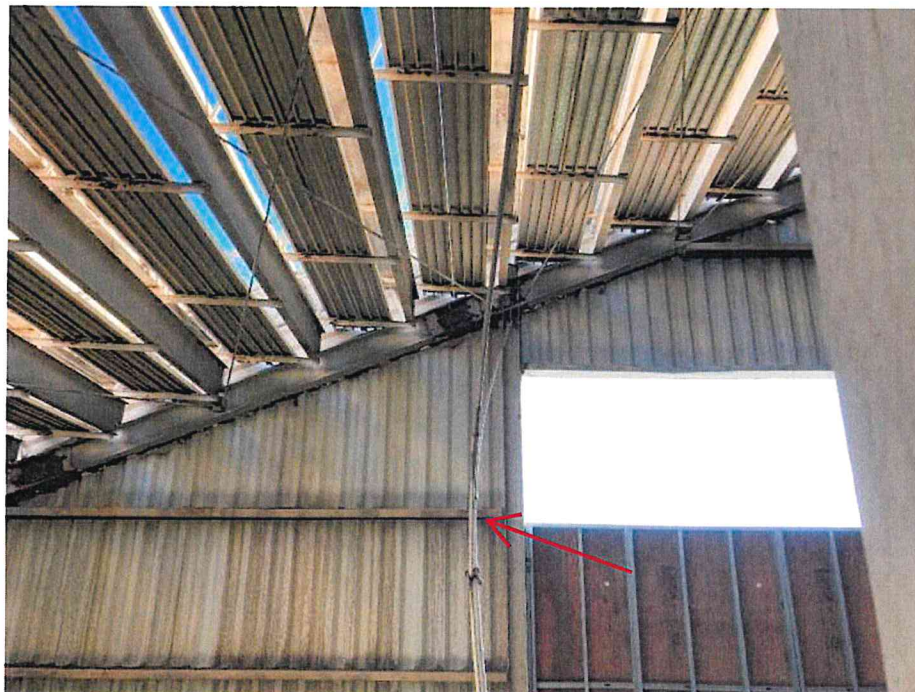
Figure 16 – Close-up photo showing bent/damaged cross-bracing rods

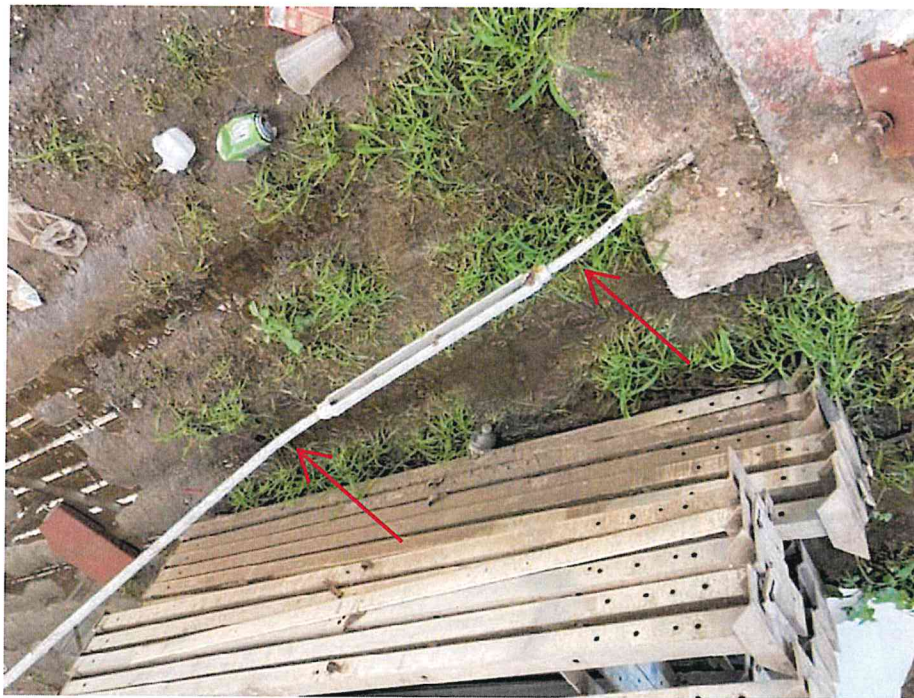
Figure 17 – Close-up photo showing bent/damaged cross-bracing rods

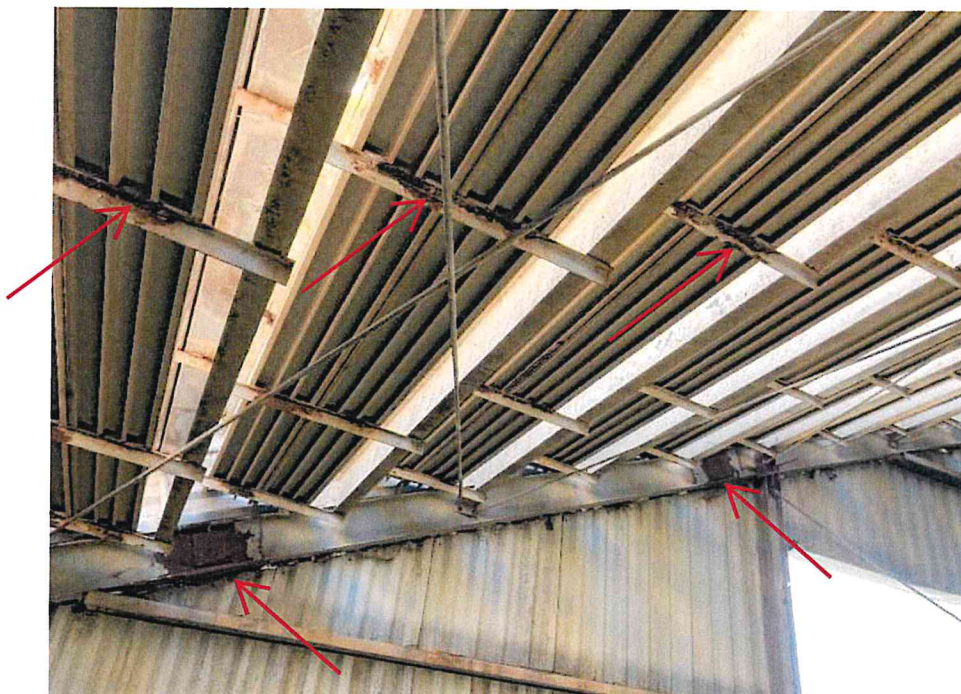
Figure 18 – Photo showing corroded splice plates and cross-members/tread supports (indicated by red arrows)

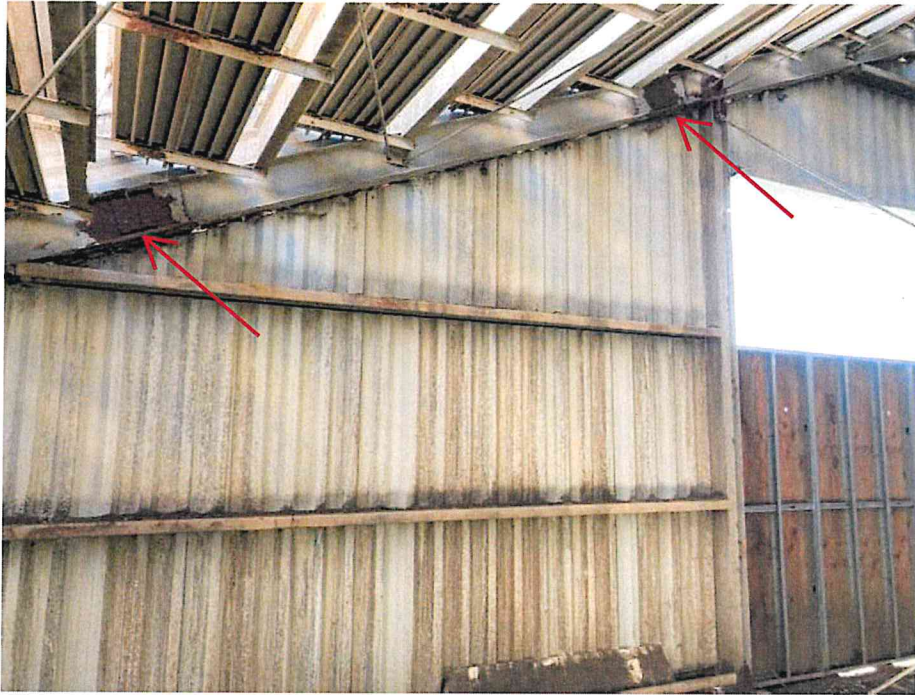
Figure 19 – Photo showing corroded splice plates and cross-members/tread supports (indicated by red arrows)

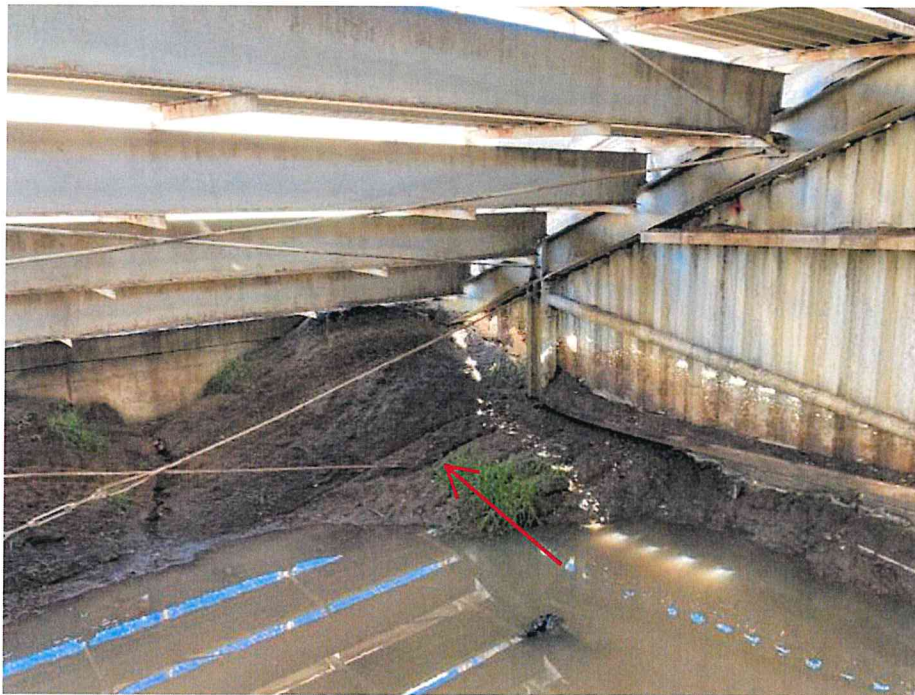
Figure 20 – Photo showing cross-bracing rods bent/damaged and covered by soil

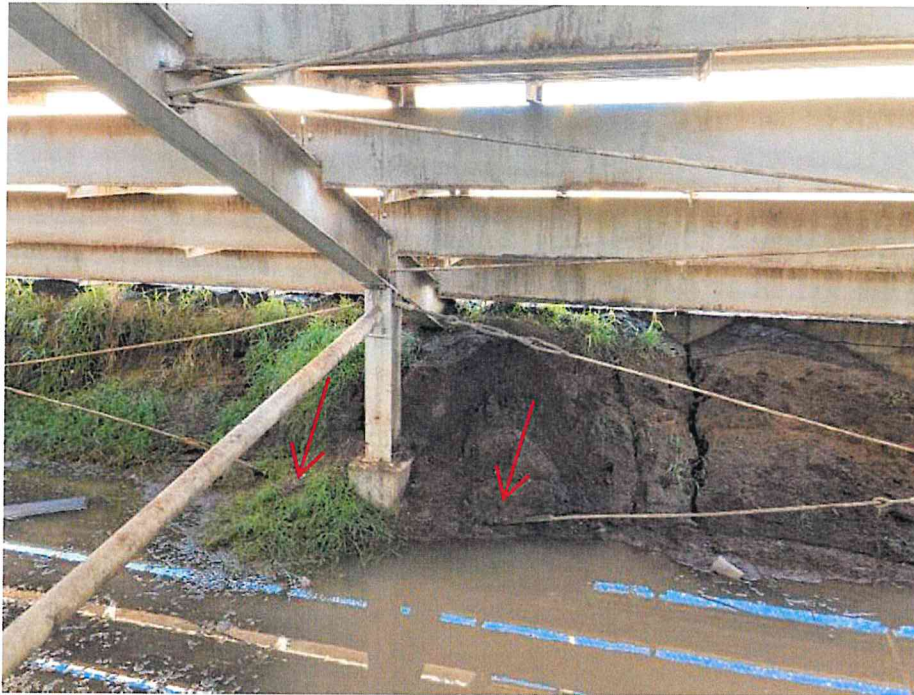
Figure 21 – Photo showing cross-bracing rods bent/damaged and covered by soil

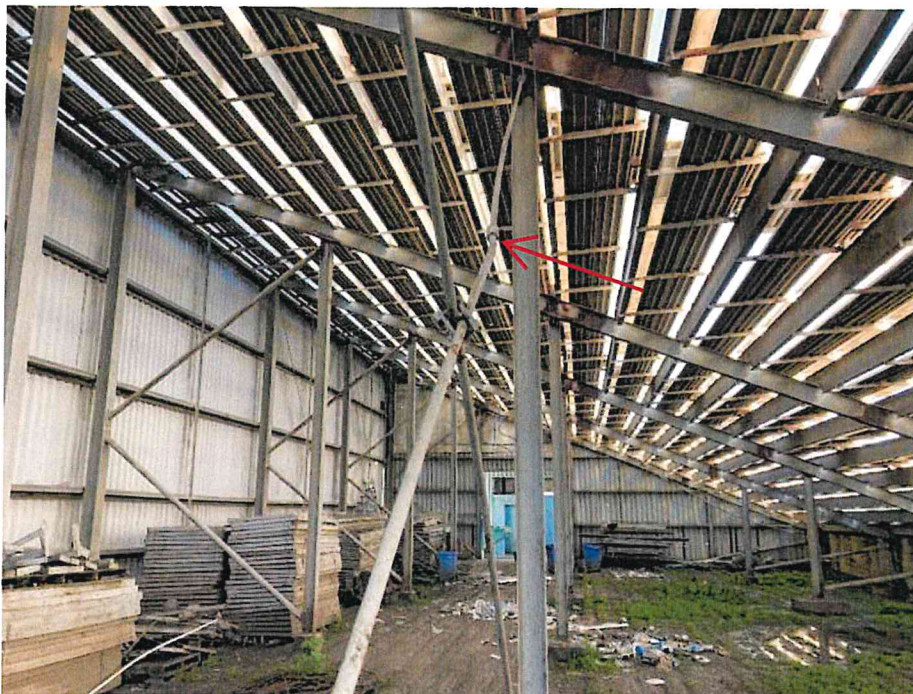
Figure 22 – Photo showing corroded splice plates and cross-members/tread supports (indicated by red arrows) and cross-bracing rods bent/damaged

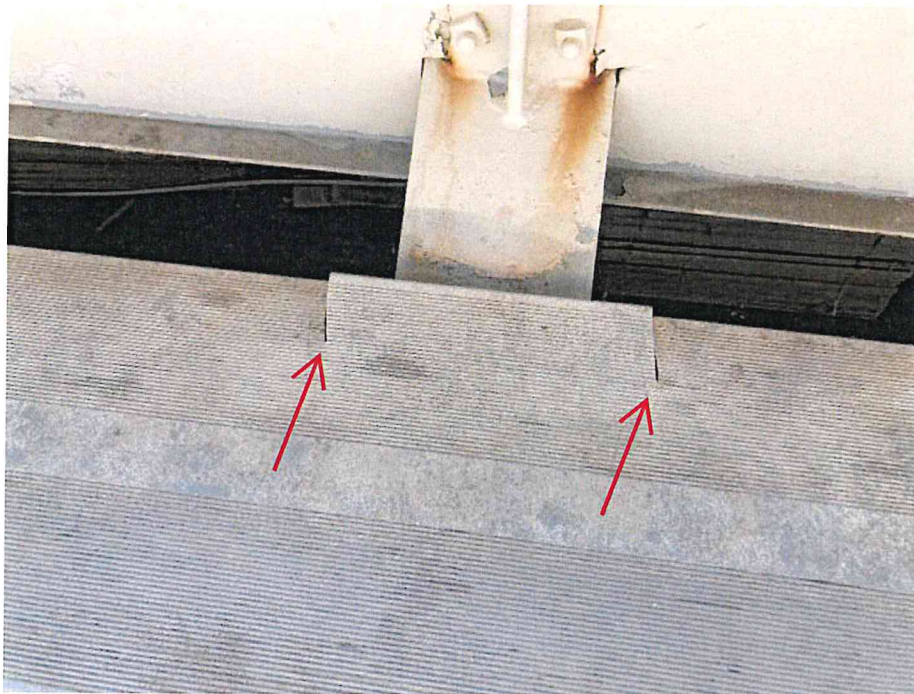
- Treads were comprised of aluminum
- Some tread members had small relief cuts to allow for tighter fit or to accommodate some slight misalignment in the members

Figure 23 – Photo showing relief cut in aluminum tread to accommodate misaligned steel framing

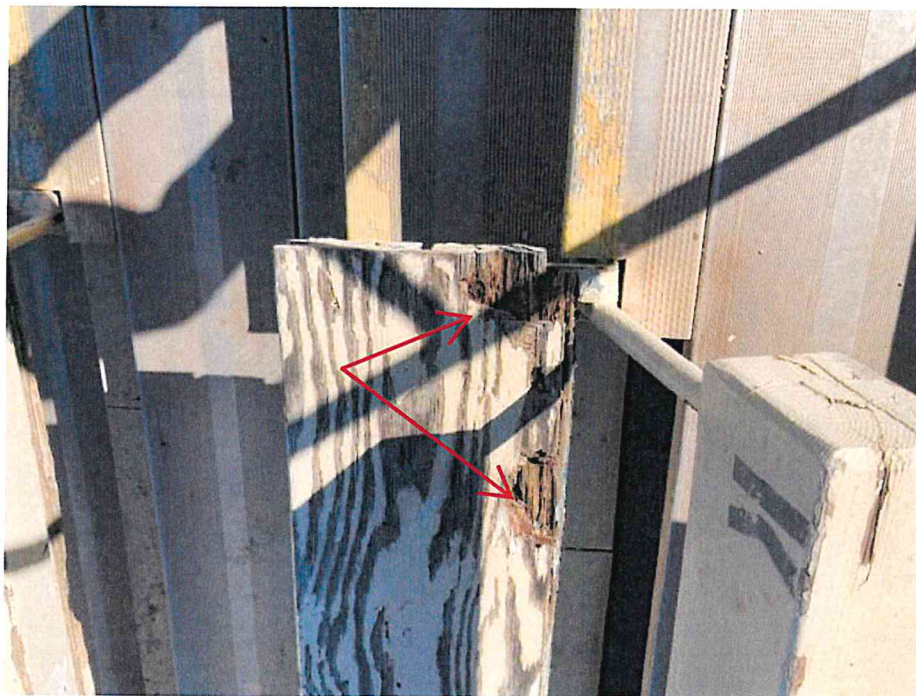
Figure 24 - Close-up photo showing rotted/damaged wooden seats (note plywood on top of original wood seat)

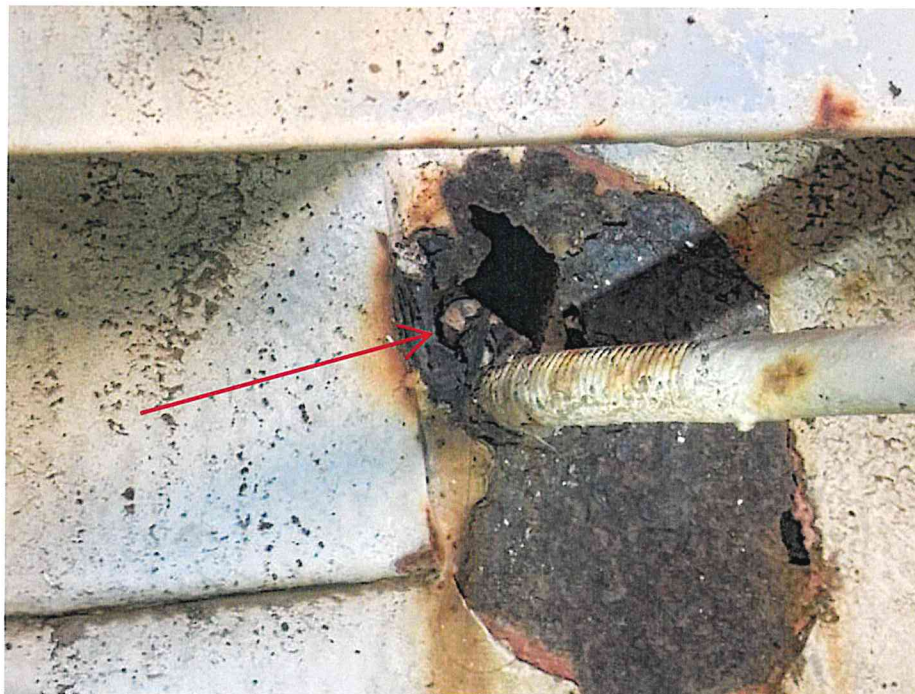
Figure 28 – Photo showing corroded column web at cross-bracing attachment

- Same as South Grandstand

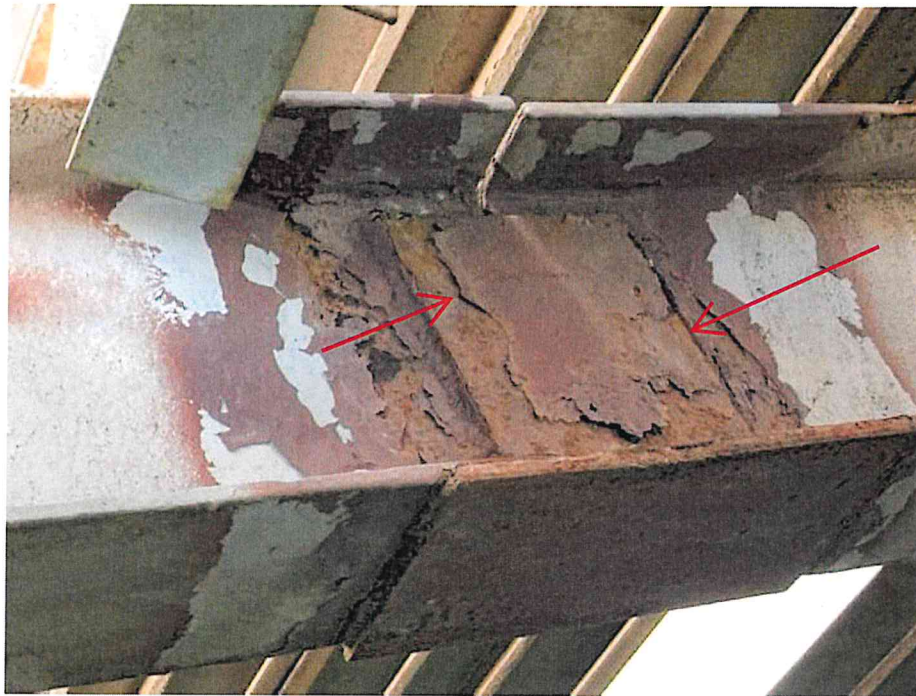
- Splice plates were observed to have significant corrosion at plate and at welds
- All cross bracing is comprised of tension-only steel rods that are connected to structure with turnbuckle hardware and nuts & washers

Figure 29 – Photo showing severe corrosion at splice plates (indicated by red arrows)

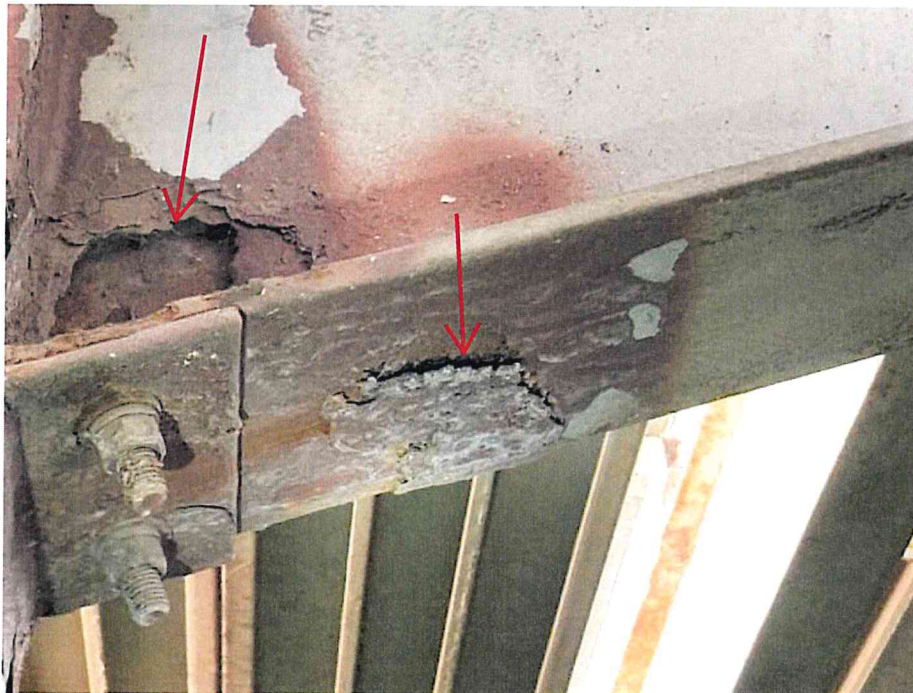
Figure 30 – Photo showing severe corrosion at beam web & flange near column cap plate (indicated by red arrows)

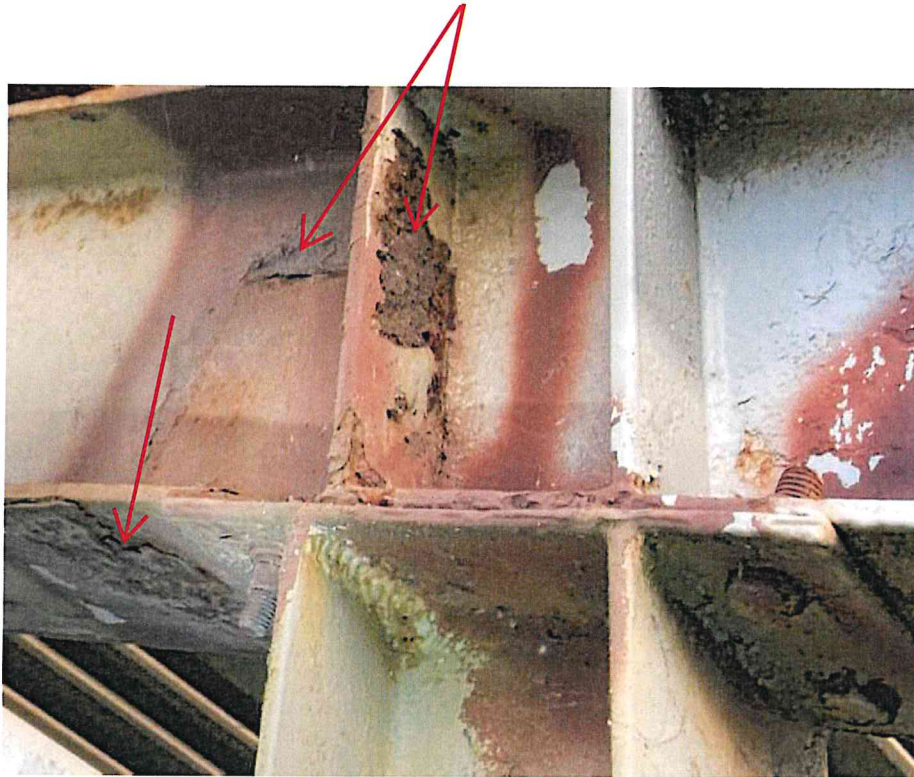
- Significant corrosion observed at the vertical stiffener plates where the sloped support beams bear on steel columns
- Steel "wide flange" beams support bleacher seating (depth = 10"; flange width = 6")

Figure 31 – Photo showing severe corrosion at beam web & flange near column cap plate (indicated by red arrows) and stiffener plates

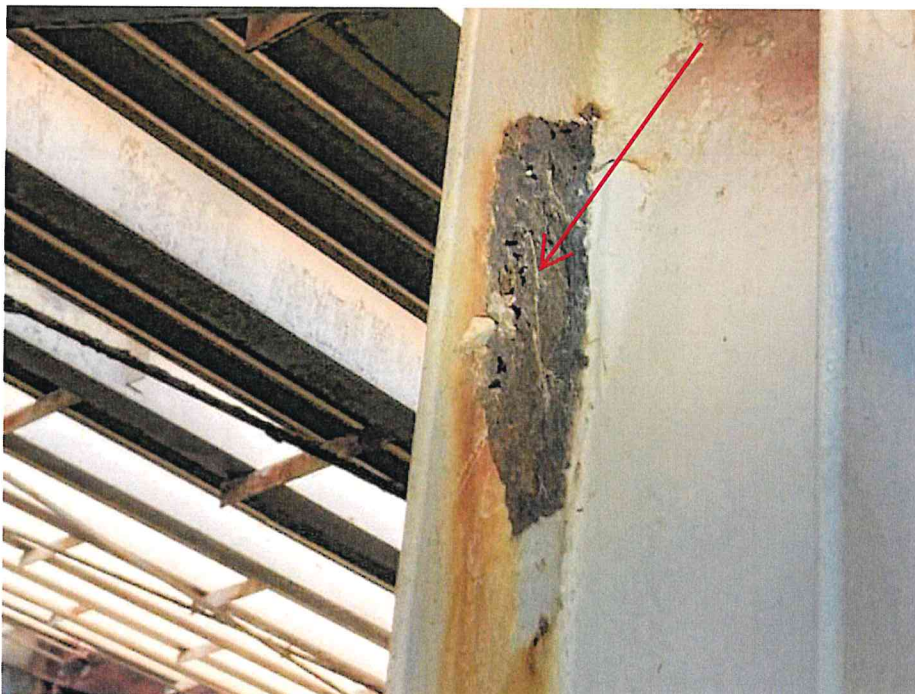
Figure 32 – Photo showing severe corrosion at column flange (indicated by red arrow)

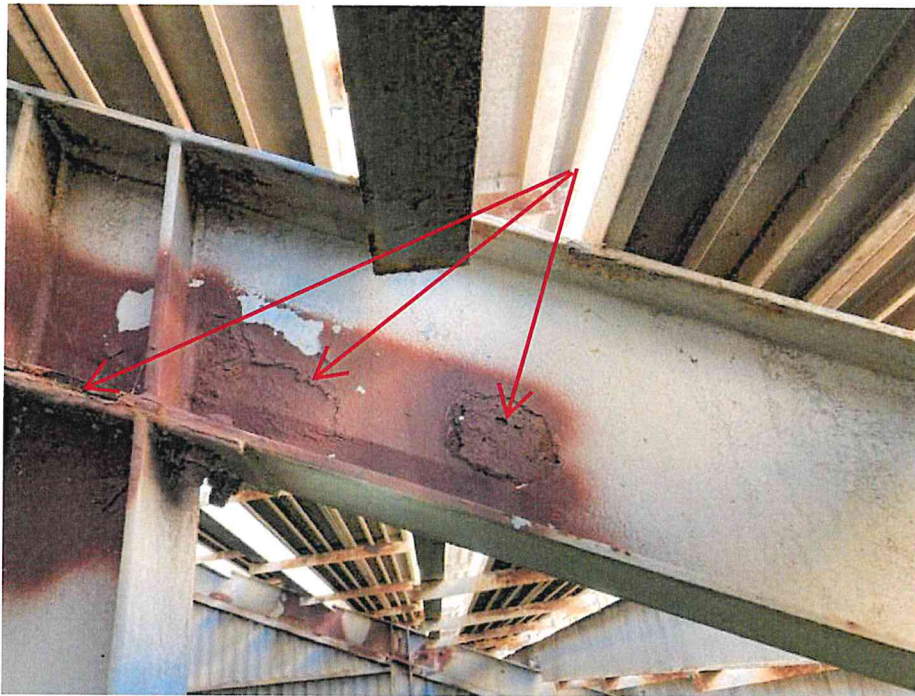
Figure 33 – Photo showing severe corrosion at column web & flange, column top plate, and steel beam web & flange (indicated by red arrows)

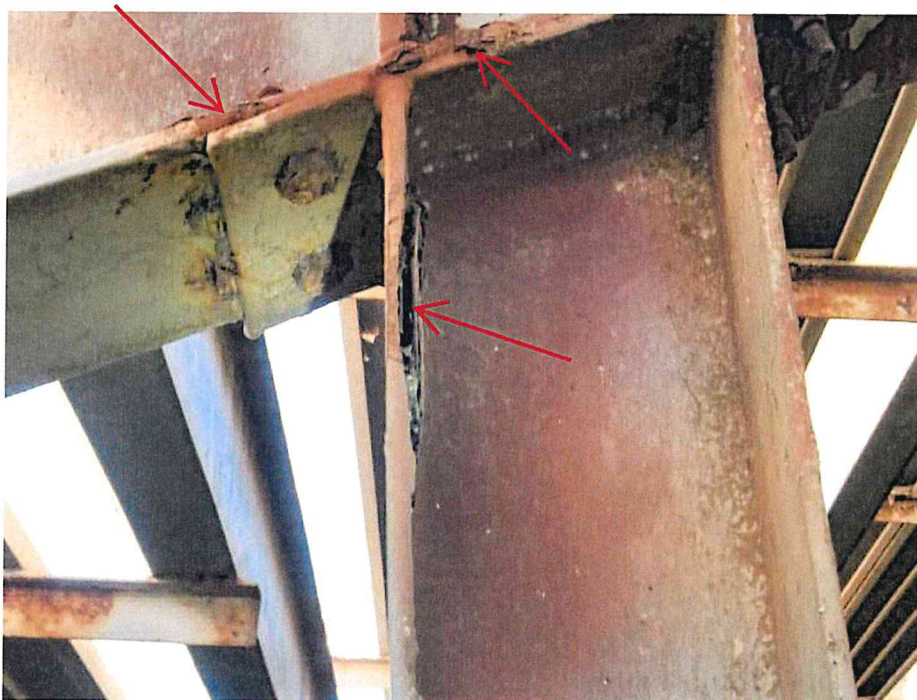
Figure 34 – Photo showing severe corrosion at column web & flange, column top plate, and steel beam flange (indicated by red arrows)

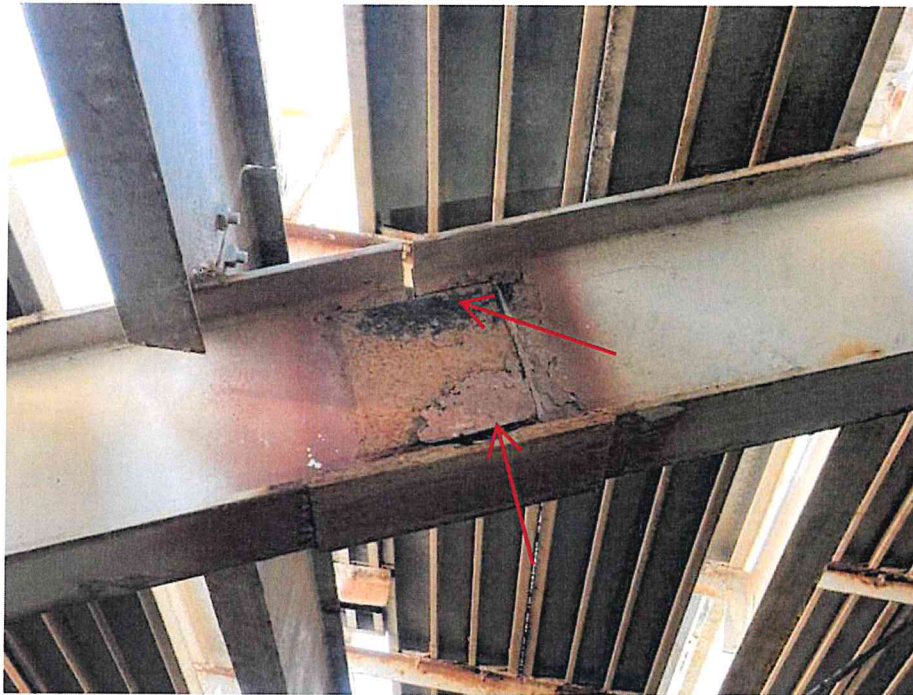
Figure 35 – Photo showing severe corrosion at splice plates (indicated by red arrow)

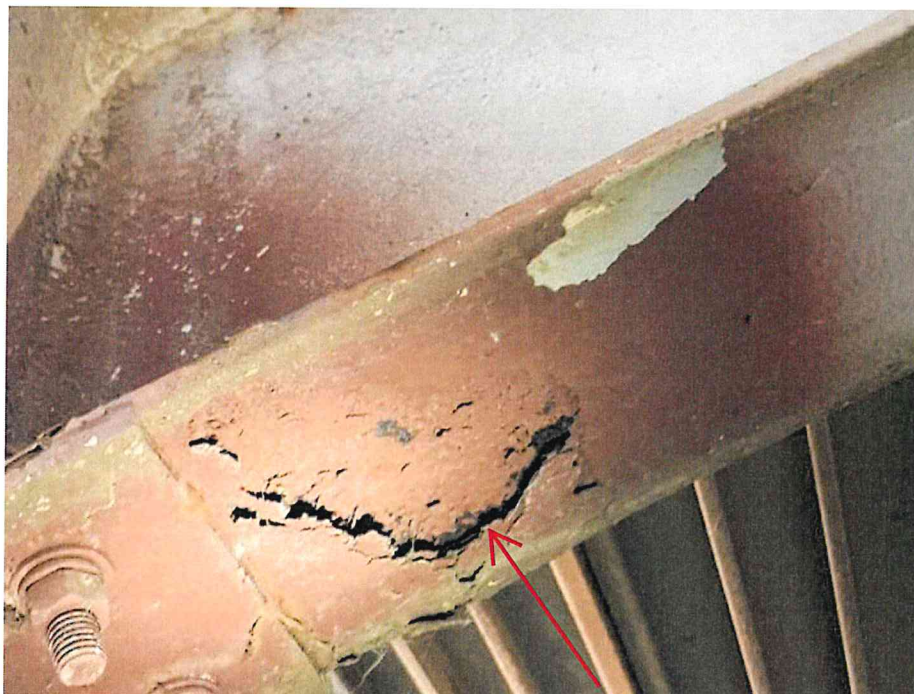
Figure 36 – Photo showing severe corrosion at beam flange (indicated by red arrows)

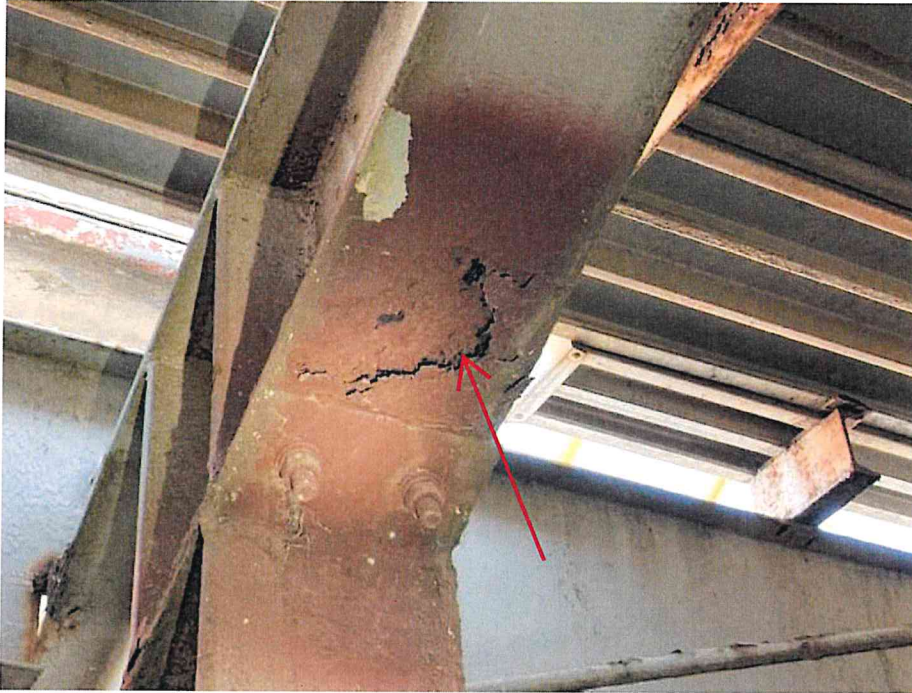
Figure 37 – Photo showing severe corrosion at beam bottom & top flange (indicated by red arrows)

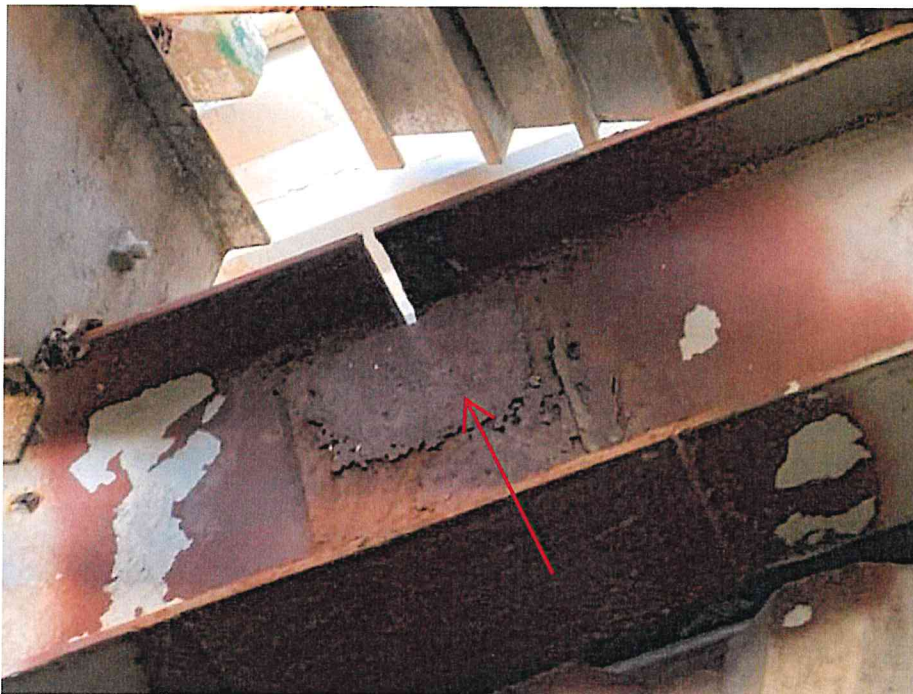
Figure 38 – Photo showing severe corrosion at splice plates (indicated by red arrows)
