March 9, 2023

Subject: Ventura County Fairgrounds – Grandstand Inspection – Revision 01

On January 17, 2023, Dagley Engineering, Inc. (DEI) was on-site to perform a visual assessment of all grandstand seating within the racetrack area of the Ventura County Fairgrounds property, which include:

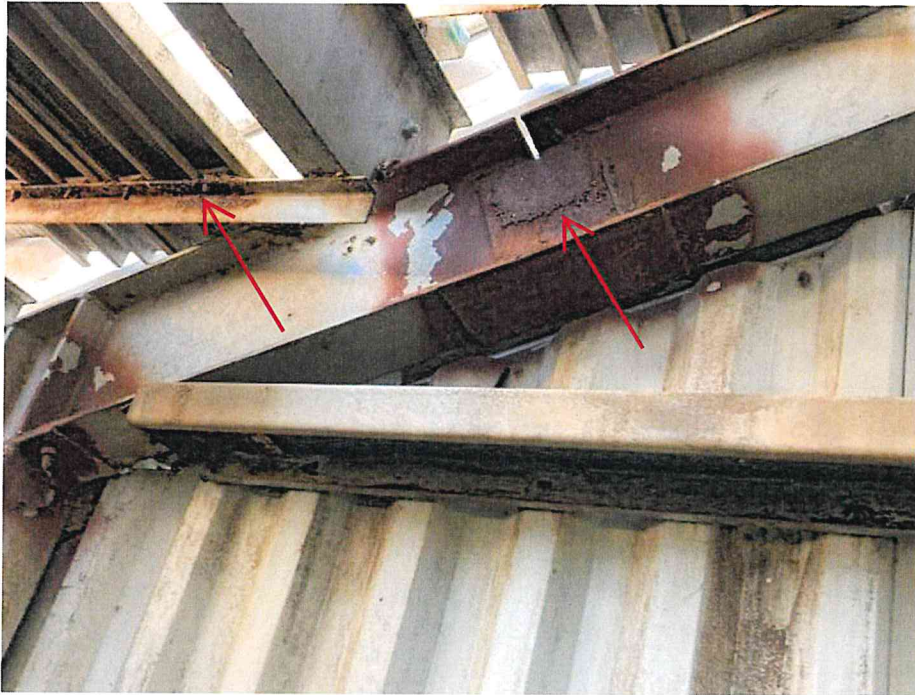
Figure 39 – Photo showing severe corrosion at splice plates and steel support members (indicated by red arrows)

- Same as South Grandstand

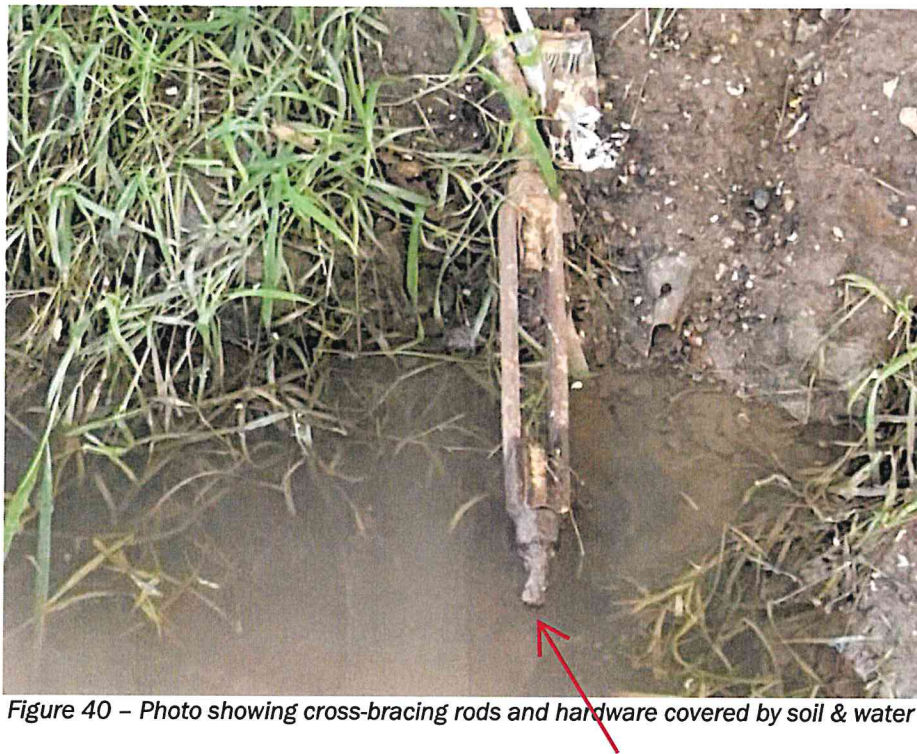
- Cross-bracing rods and/or cross-bracing hardware at front was observed to be nearly buried in soil
- Cross-bracing was also observed to be loose/bent in most locations

Figure 40 – Photo showing cross-bracing rods and hardware covered by soil & water

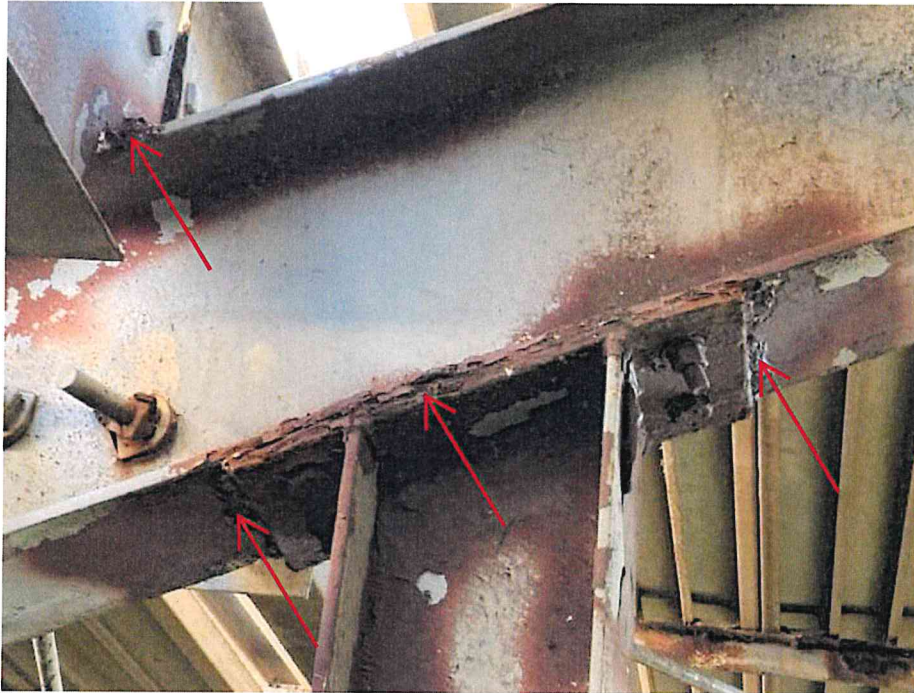
Figure 41 – Photo showing severe corrosion at column web & flange, column top plate, and steel beam flange (indicated by red arrows)

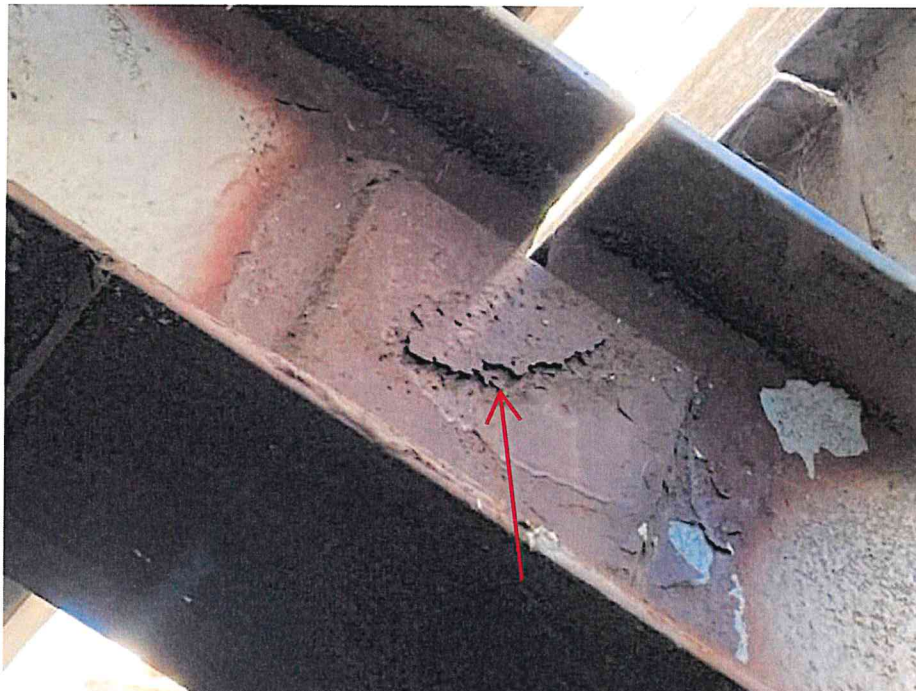
Figure 42 – Photo showing severe corrosion at splice plates (indicated by red arrows)

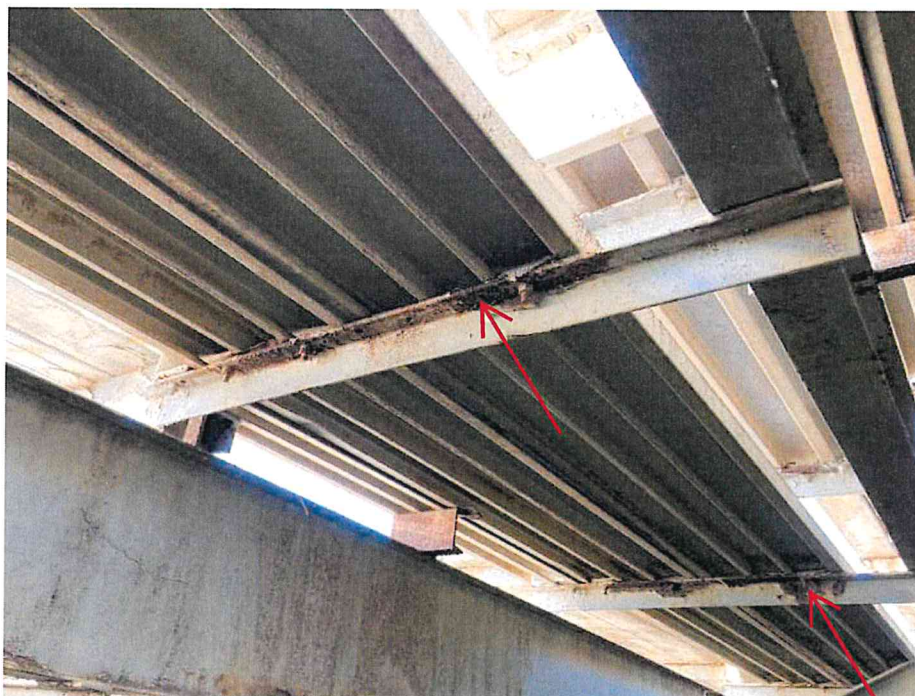
Figure 44 – Photo showing severe corrosion at steel seat support members (indicated by red arrows)

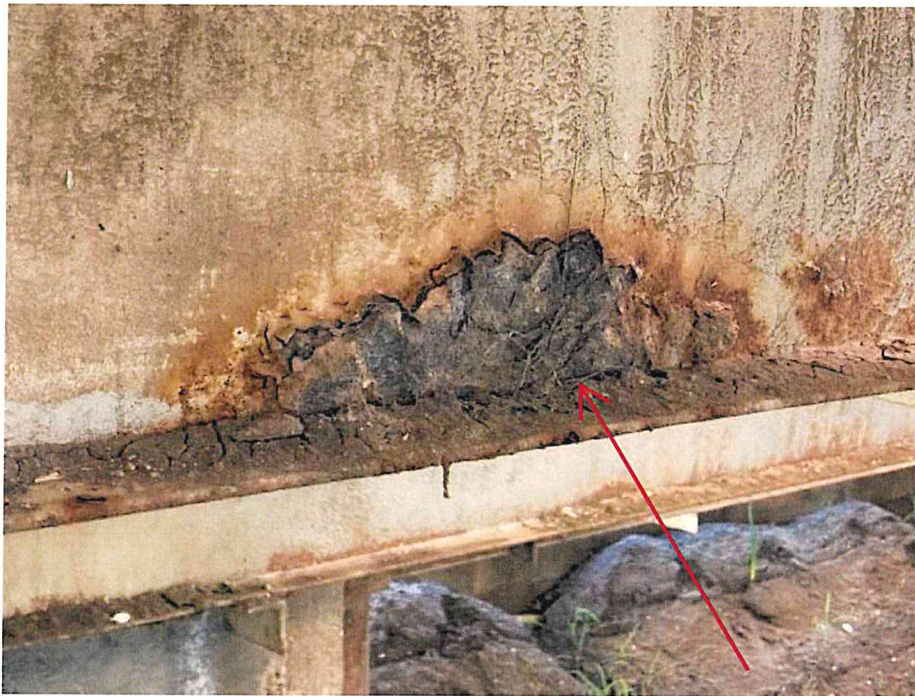
Figure 45 – Photo showing severe corrosion at beam web and flange (indicated by red arrows)

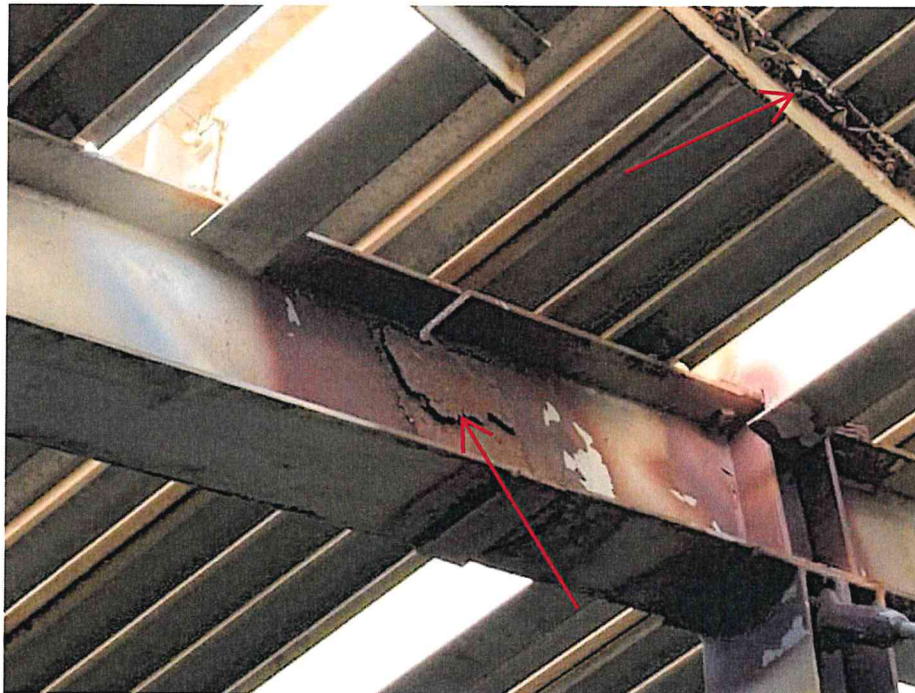
Figure 46 – Photo showing severe corrosion at splice plates (indicated by red arrows)

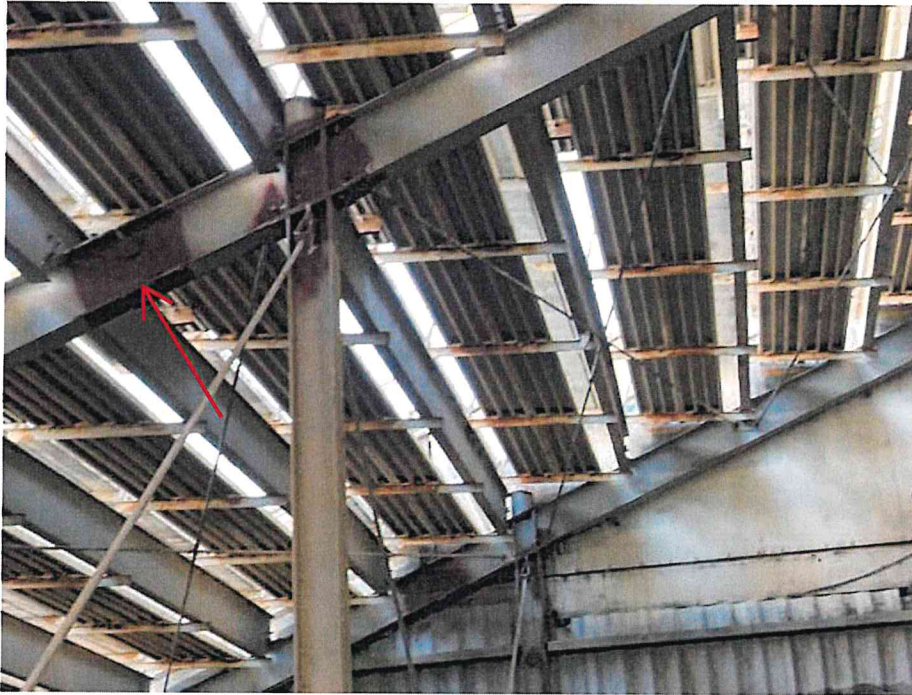
Figure 47 – Photo showing severe corrosion at splice plates and beams (indicated by red arrows)

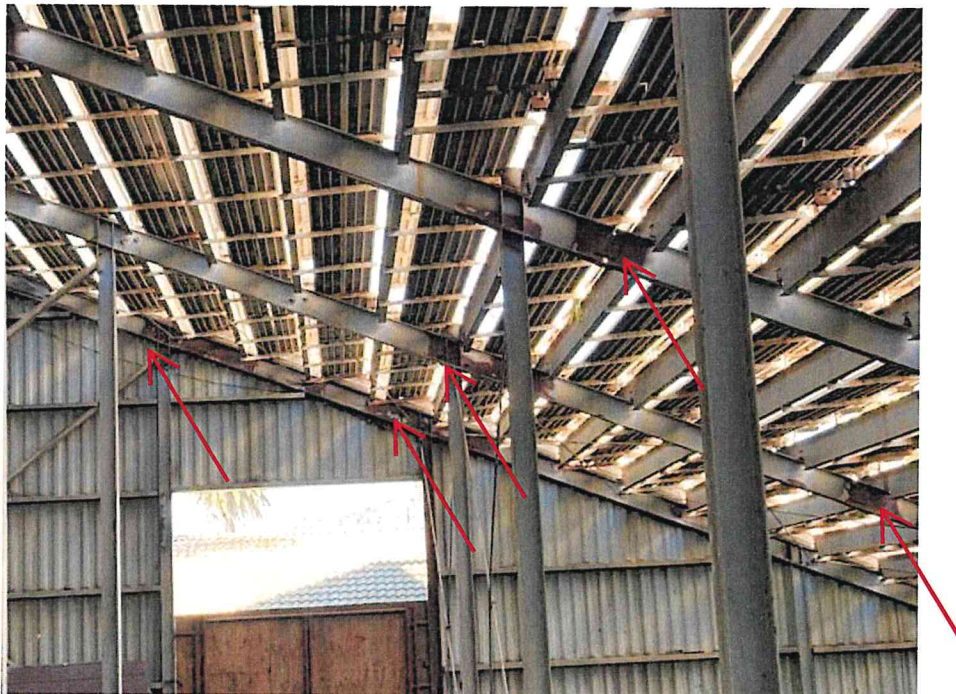
Figure 48 – Photo showing severe corrosion at splice plates and beams (indicated by red arrows)

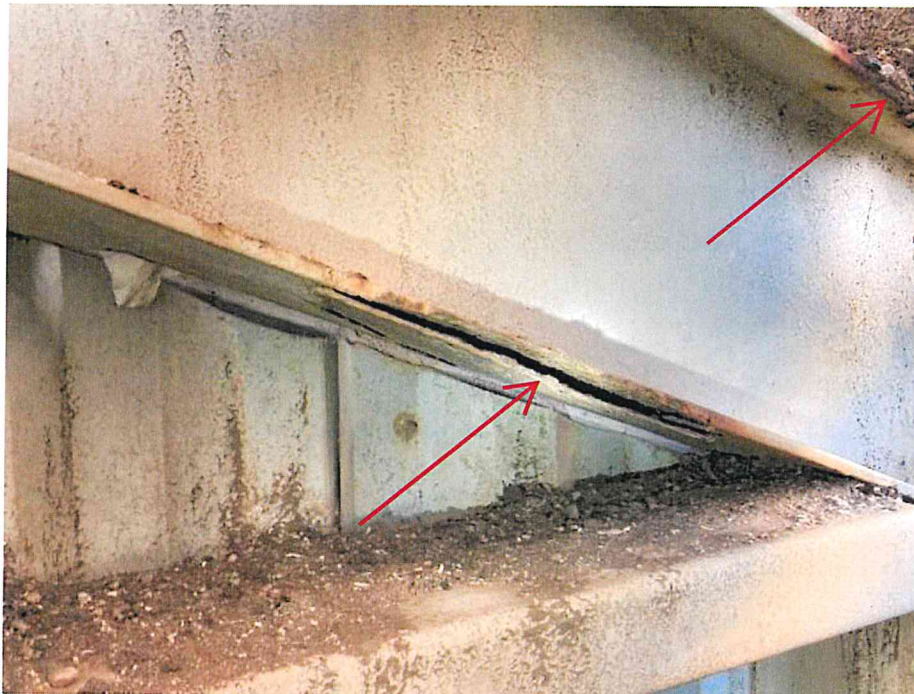
Figure 49 – Photo showing severe corrosion at beam flanges (indicated by red arrows)

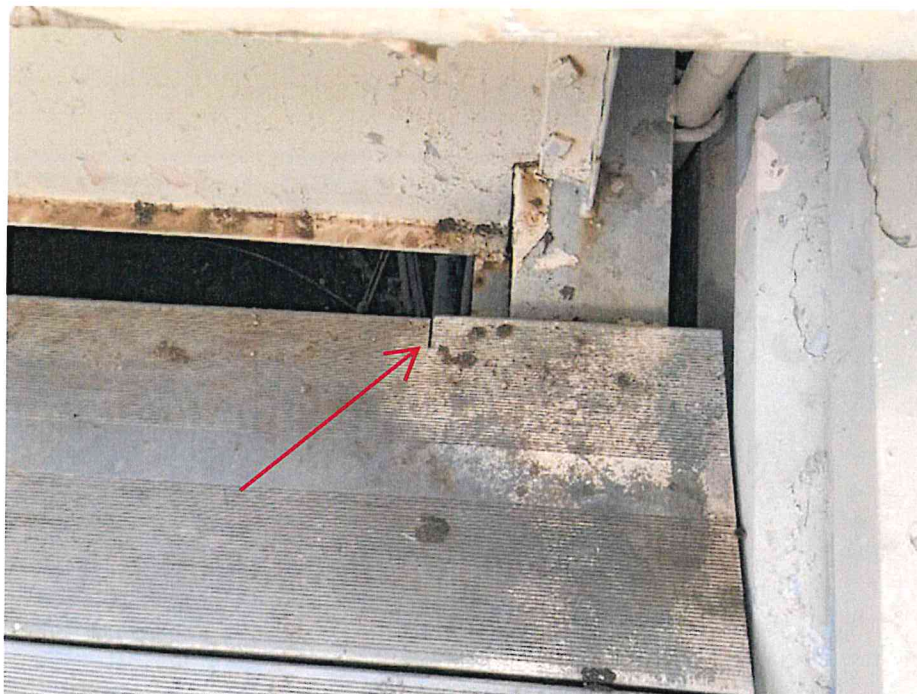
- Treads were comprised of aluminum
- Some tread members had small relief cuts to allow for tighter fit or to accommodate some slight misalignment in the members

Figure 50 – Photo showing relief cut at aluminum tread to accommodate misaligned steel framing

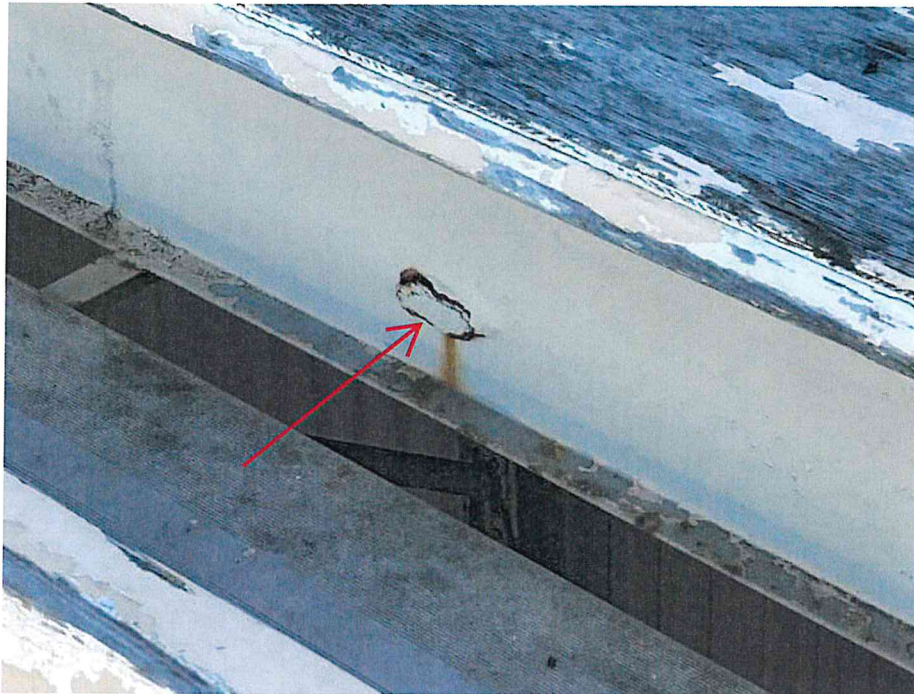
Figure 51 – Photo showing severe corrosion at beam web (indicated by red arrows)
