CALIFORNIA CONSTRUCTION AUTHORITY

31st DAA Ventura County Fairgrounds Physical Assessment

CCA Project: 031-22-133

Date: December 21-22, 2022

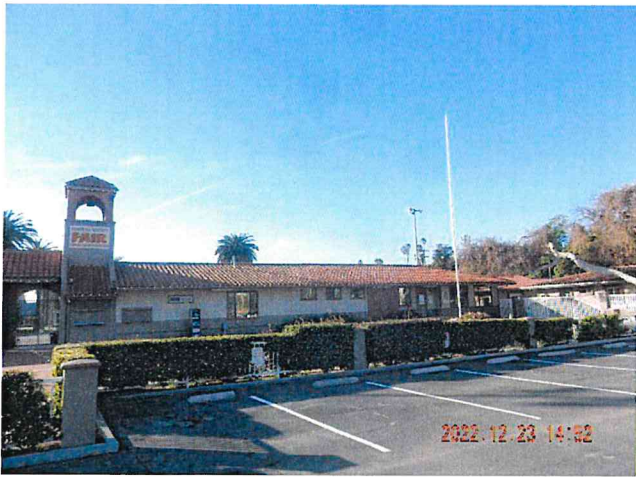
1. Administration Building east elevation

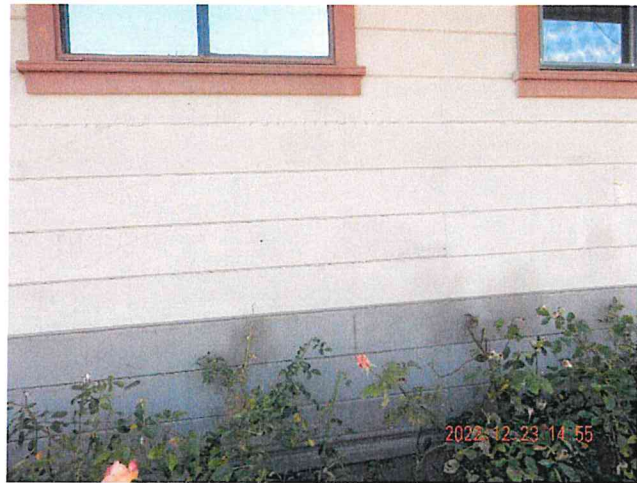
2. Administration Building east elevation wooden siding

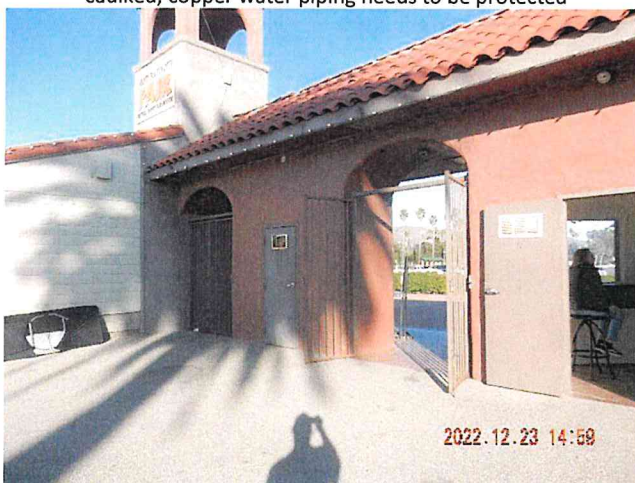
11. Ticket Booth gates to Fairgrounds

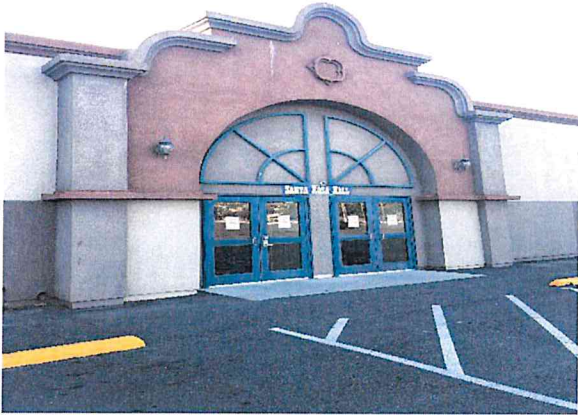
1. Santa Rosa Hall main entry

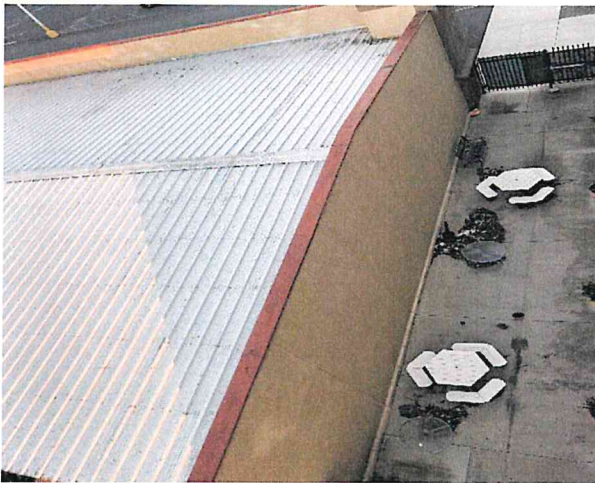
- Further evaluation of the roof is needed to determine estimated useful life for renovation within the next one to two years.
- Moisture-stained ceiling tiles noted; facility maintenance staff reported roof leaks.

2. Metal roof

3. Metal roof

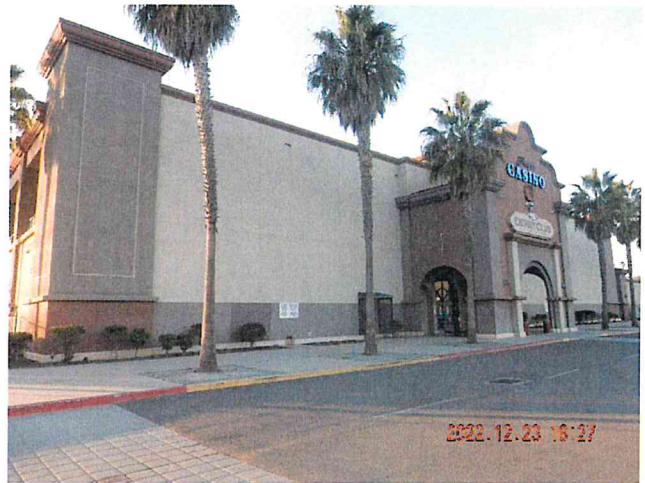
2. Derby Club east wall elevation

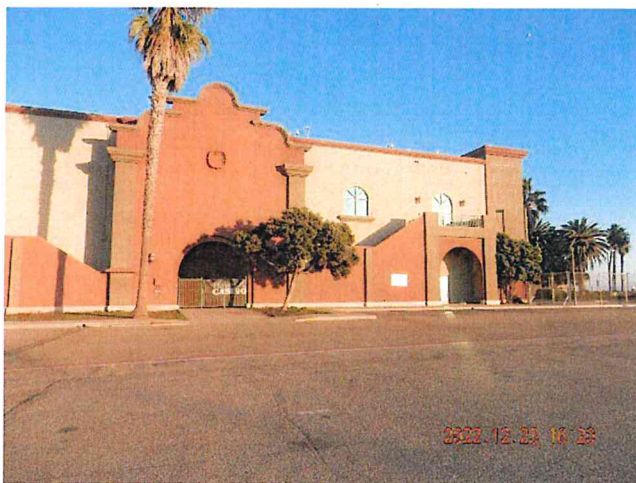
3. Derby Club west wall elevation

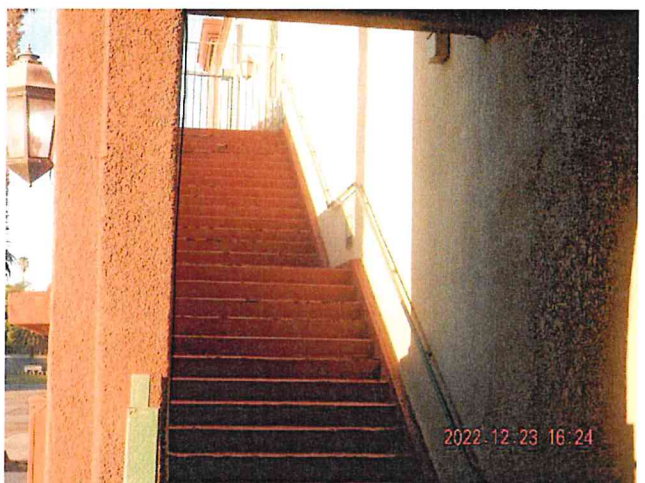
4. Derby Club west wall elevation exit stair

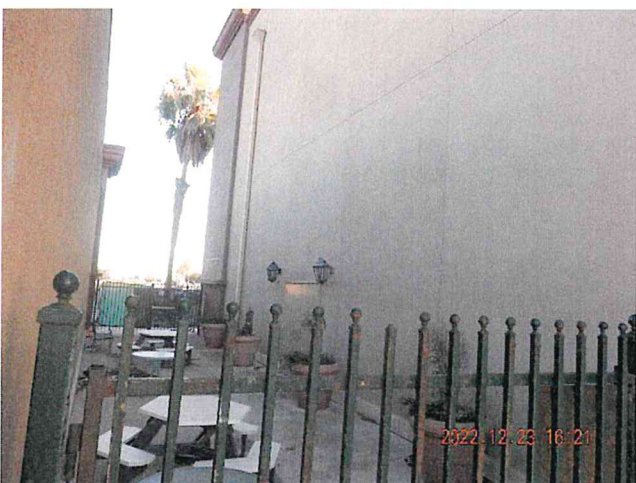
5. Derby Club north wall elevation

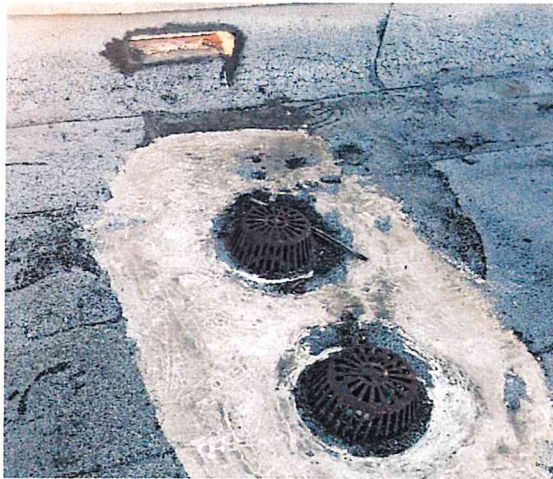
7. Derby Club aged roof drain and scupper, noted recent patches

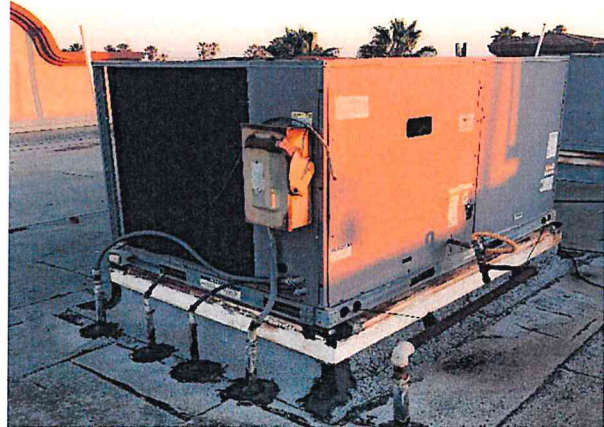
8. Derby Club roof mechanical aging and /or abandoned components

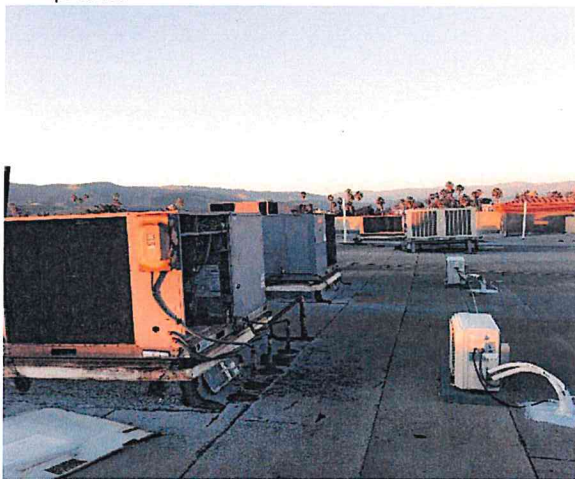
9. Derby Club roof mechanical aging and/or abandoned components

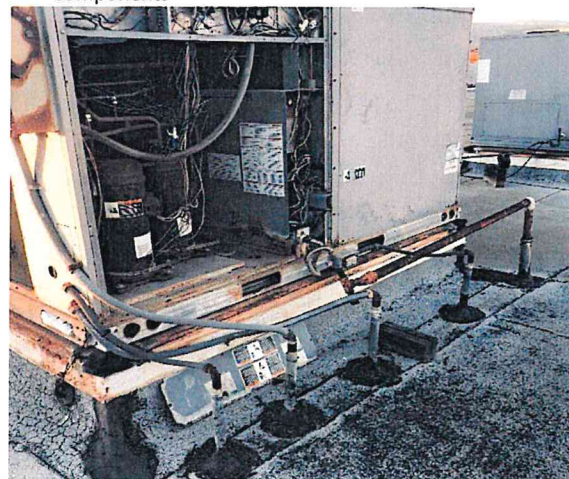
10. Derby Club roof mechanical aging and/or abandoned components

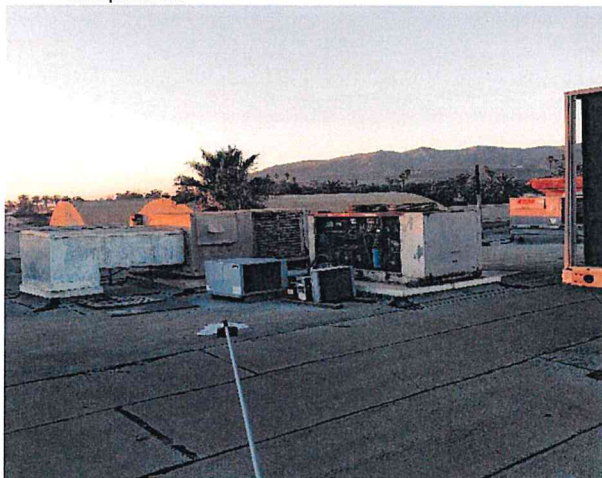
11. Derby Club roof mechanical aging and/or abandoned components

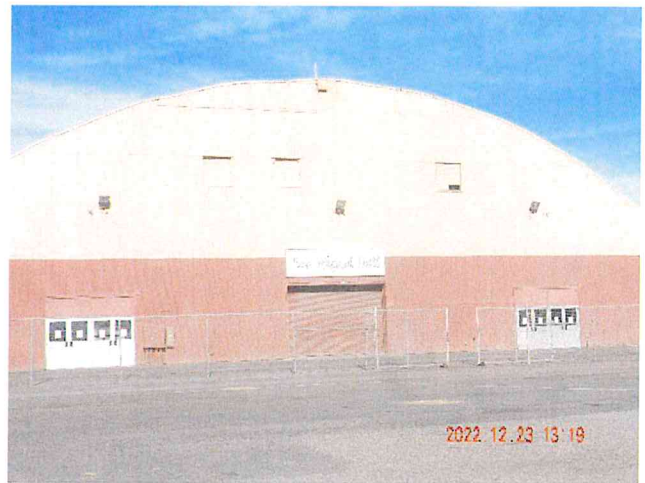
2. San Miguel Hall east elevation

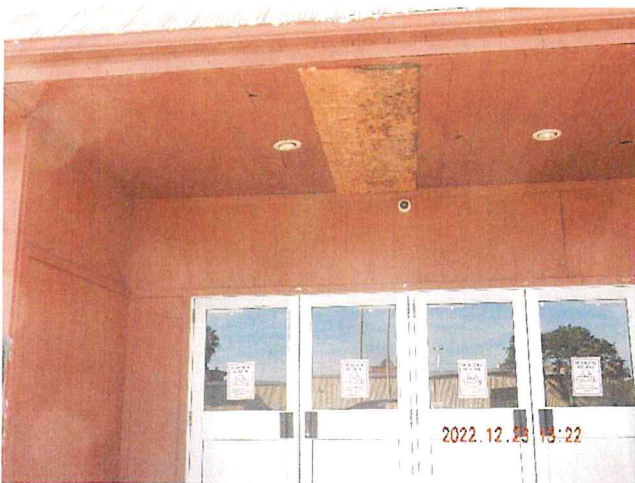
5. San Miguel Hall east entry

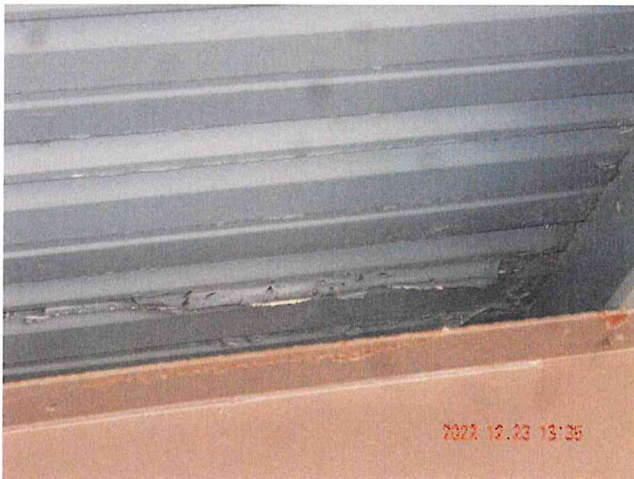
11. San Miguel Hall canopy at the north entry roofing material deteriorated

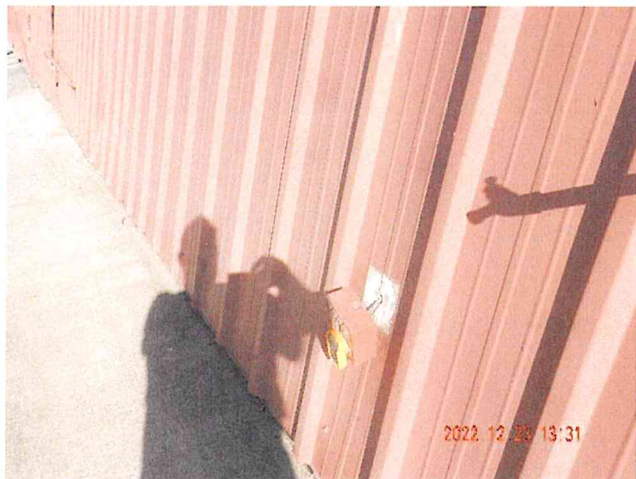
12. San Miguel Hall west wall elevation electrical damage

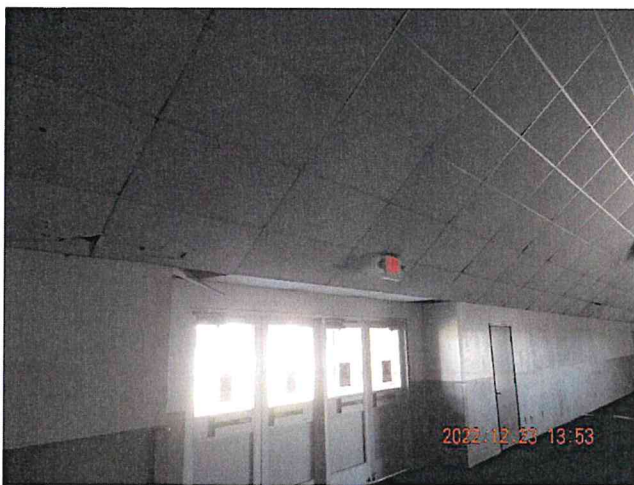
15. San Miguel Hall ceiling and wall staining and damage

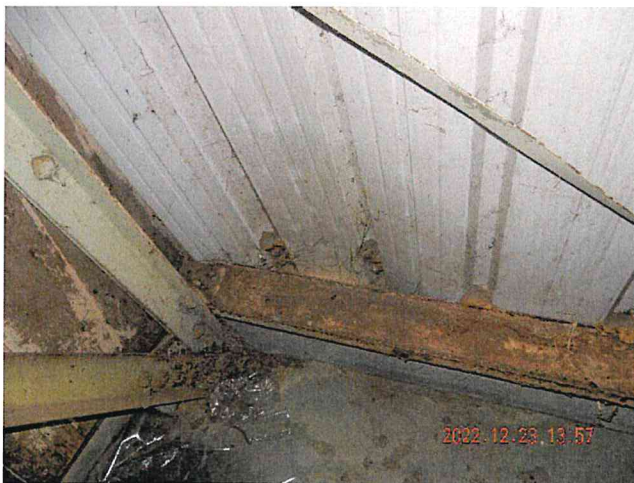
17. San Miguel Hall foundation plate corroded

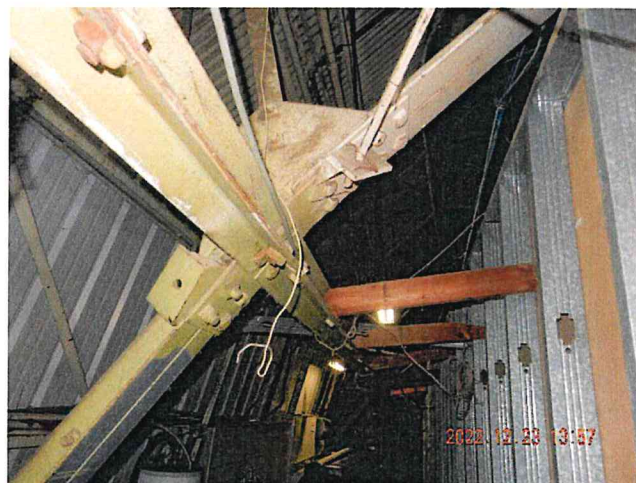
18. San Miguel Hall longitudinal runway

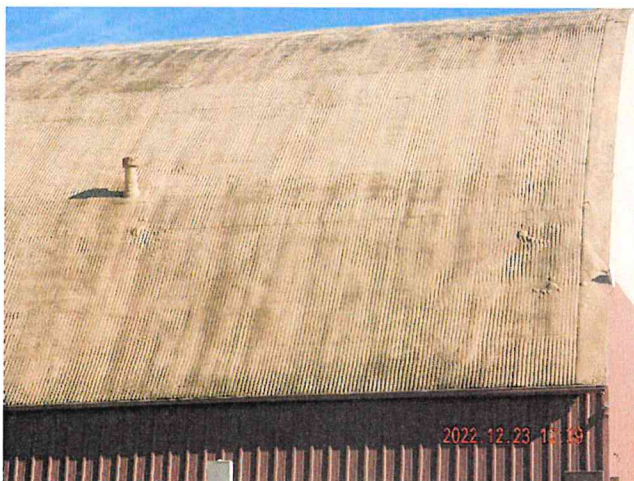
5. Anacapa Hall west elevation roof deterioration

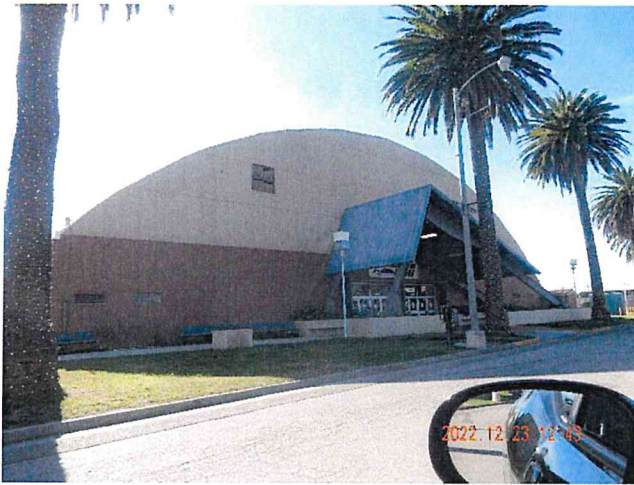
7. Anacapa Hall north elevation

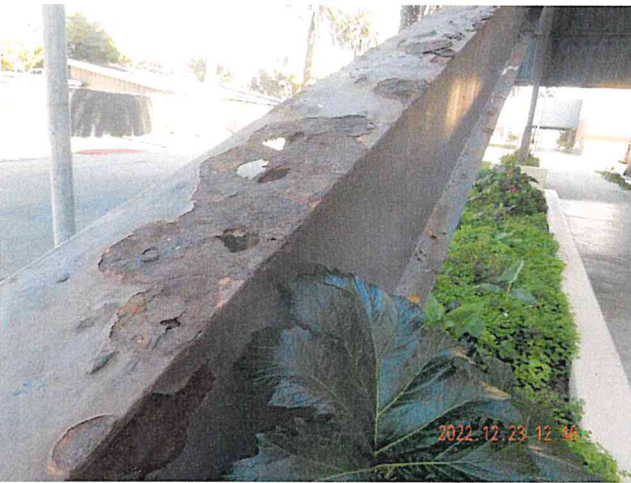
8. Anacapa Hall north elevation covered entry

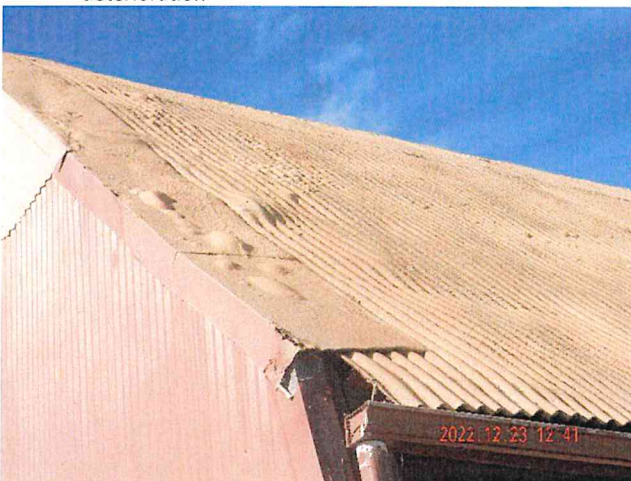
10. Anacapa Hall north elevation canopy beam structural connection delamination deterioration

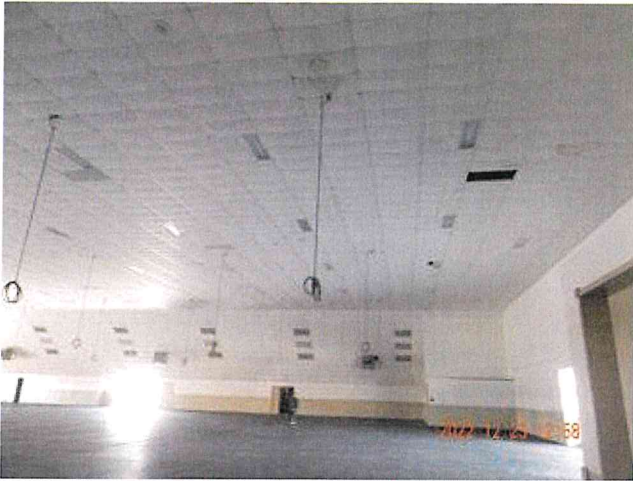
12. Anacapa Hall west elevation entryway deterioration

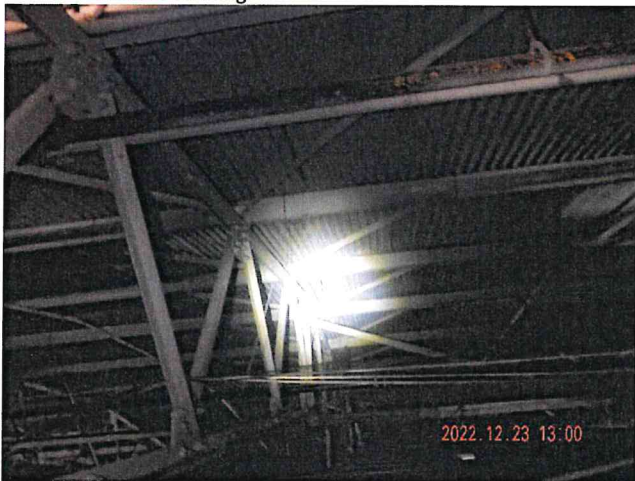
14. Anacapa Hall metal dome roof decking, moisture stained

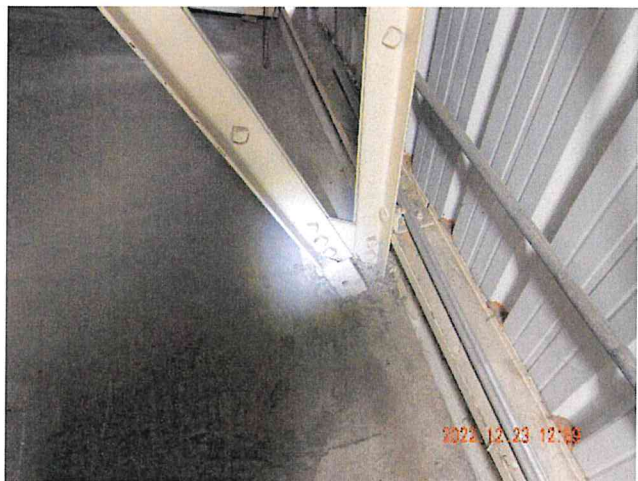
15. Anacapa Hall metal dome roof framing and decking, moisture stained

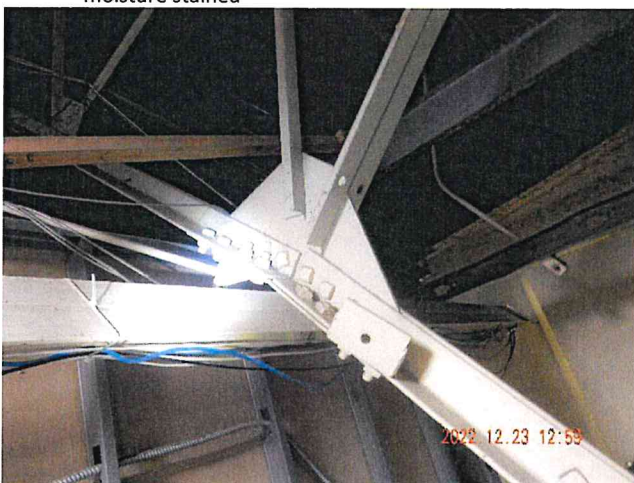
16. Anacapa Hall framing at foundation grade

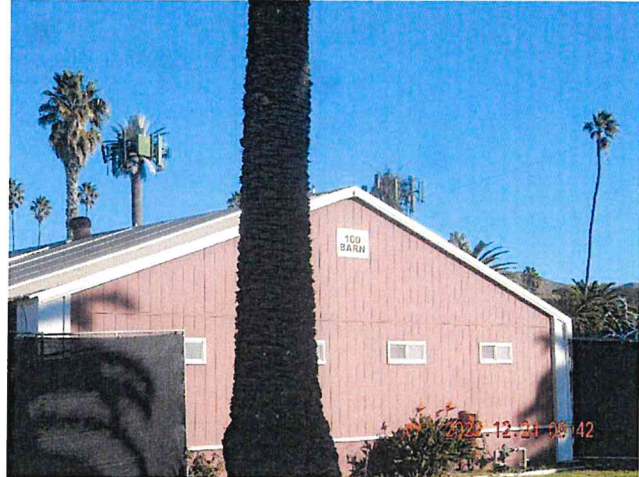
2. Barn 100 south elevation

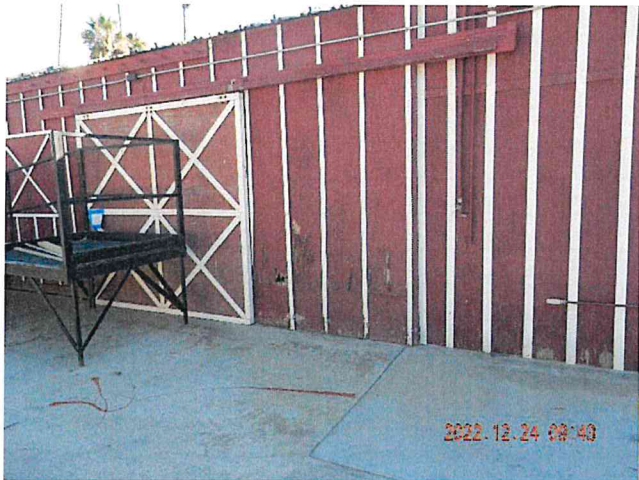
- Observation of the steel framed barns found corrosion and deterioration in need of corrosion mitigation (sandblasting and paint) of components within the open-air elements.
- The metal roof system found deteriorating components. Recommend evaluating within two to five years for significant repairs or renovation.
- The exterior wood siding needs maintenance repair and component replacement.
- The visible electrical system needs evaluation for immediate electrical repairs and/or renovation.
- Further evaluation of the buildings is warranted. The electrical system and components were not thoroughly evaluated and warrant further investigation.

3. Barns 100, 200, and 300 typical unmaintained wooden siding

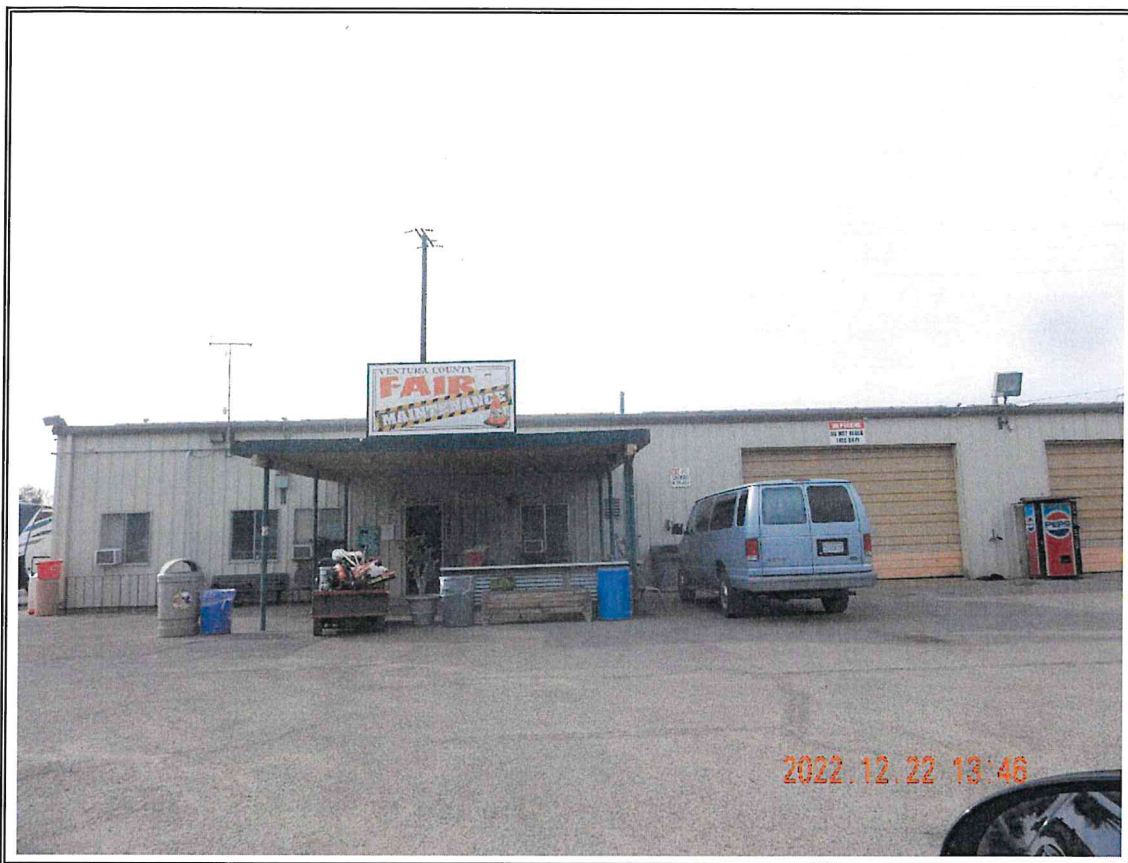
- The two maintenance buildings were found to be in reasonably maintained condition. Observed ceiling moisture stains and the occupant reported minor roof leaks.
- Roof warrants further evaluation for the remaining useful life.

1. Main Maintenance building

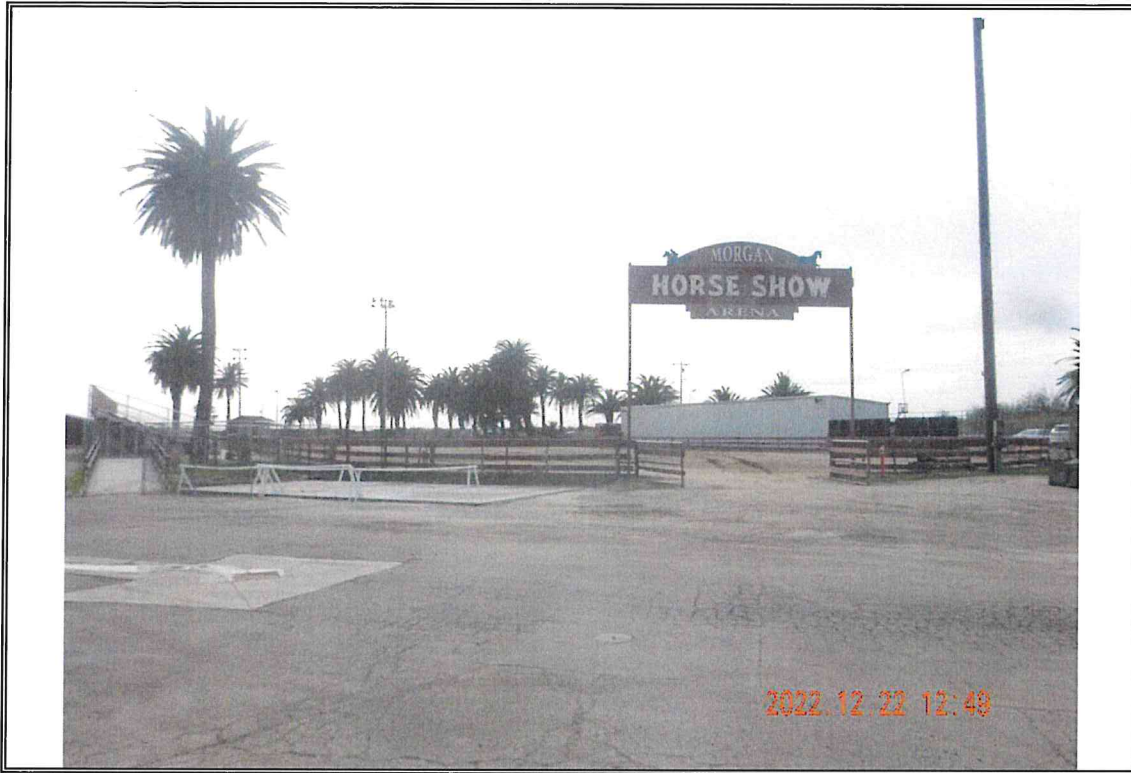
- Deferred maintenance in need of increased maintenance repairs and/or renovation or replacement.
- The Arena railing needs repairs or evaluation for replacement.
- The electrical system serving the Arena needs further evaluation for repairs and/or renovation.

1. Morgan Horse Arena

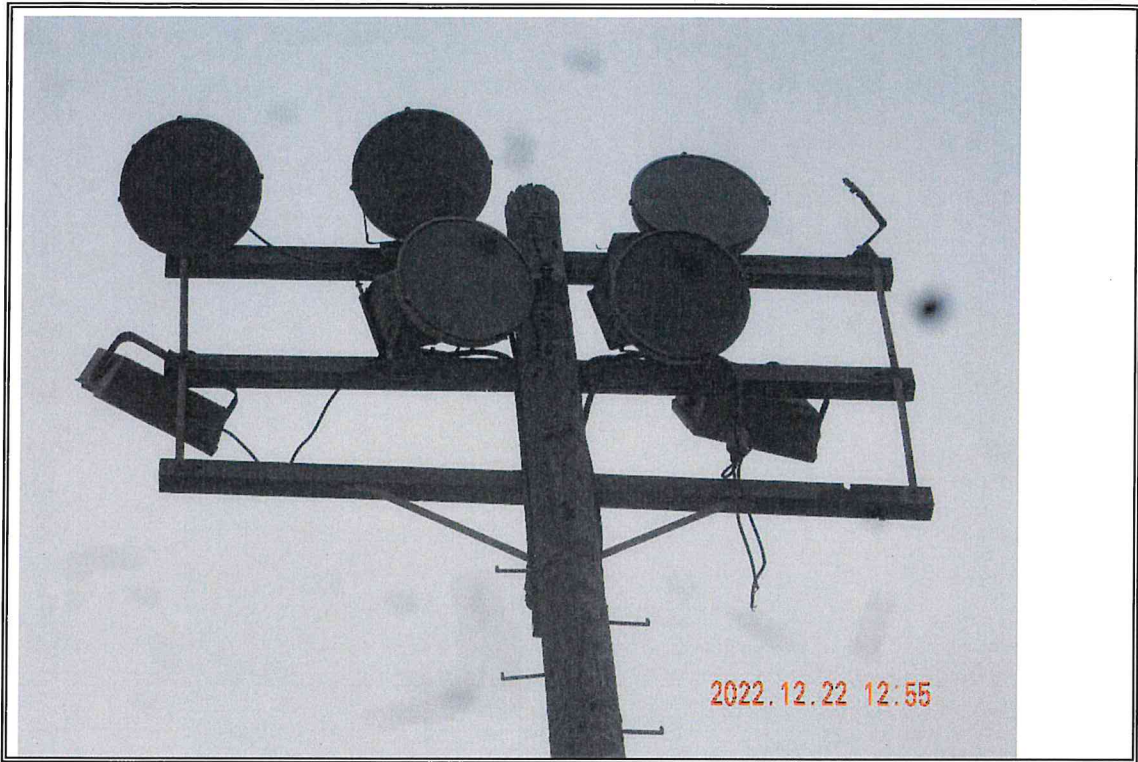
3. Morgan Horse Arena lighting

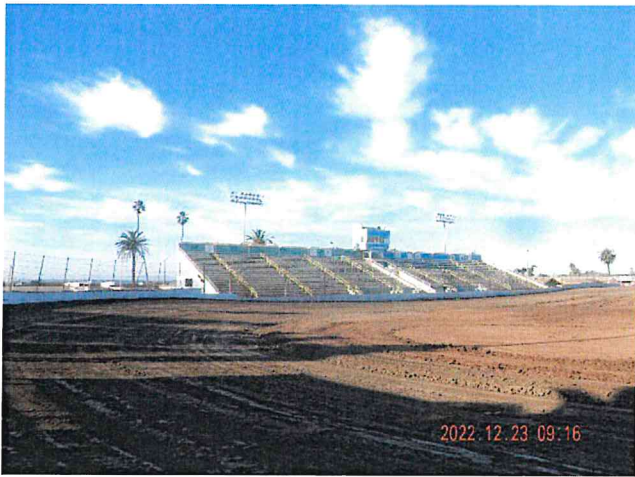
A visual inspection of the Grandstands infrastructure found a significant amount of corrosion, aluminum metal fatigue, and dry rot throughout the supporting structures.

1. Ventura Raceway Grandstands northeast elevation

- Evaluation by an engineer is warranted. A significant amount of corroded, worn, and aged components and connections has rendered the Grandstands hazardous and unsafe condition for public usage. Observation of corrosion-generated holes within the structural elements and throughout the supporting elements and delaminating structural elements warrant further evaluation by an engineer.
- Recommend further evaluation of the Grandstands concession booths regarding the noted moisture damage.
- An in-depth evaluation of the Grandstands electrical system is warranted for safety, due to observed corroded/deteriorated junction boxes and outlets face surfaces.

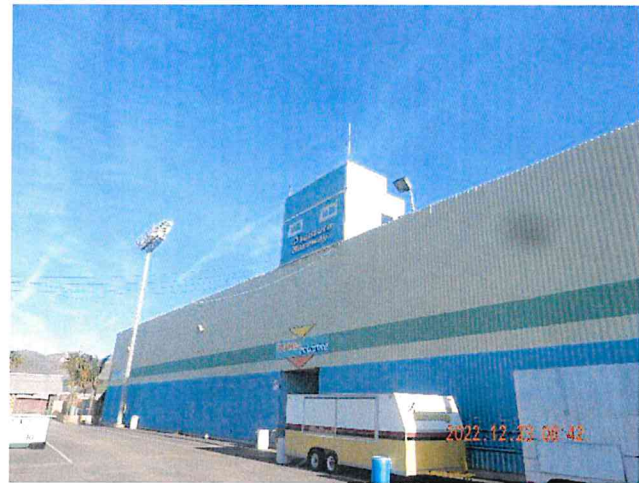
2. Ventura Raceway Grandstands southwest elevation

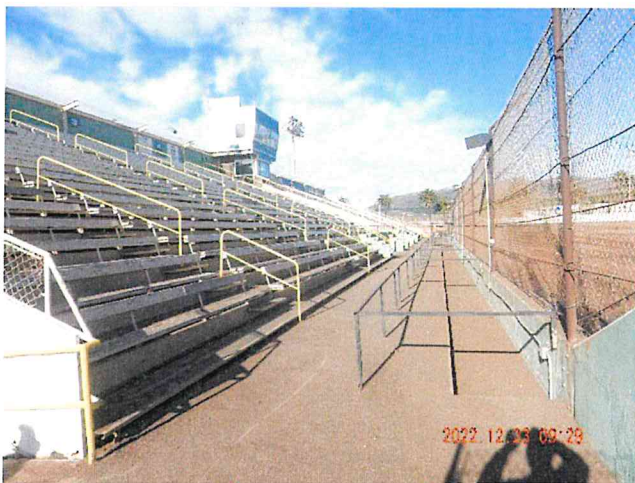
3. Ventura Raceway Grandstands walkway

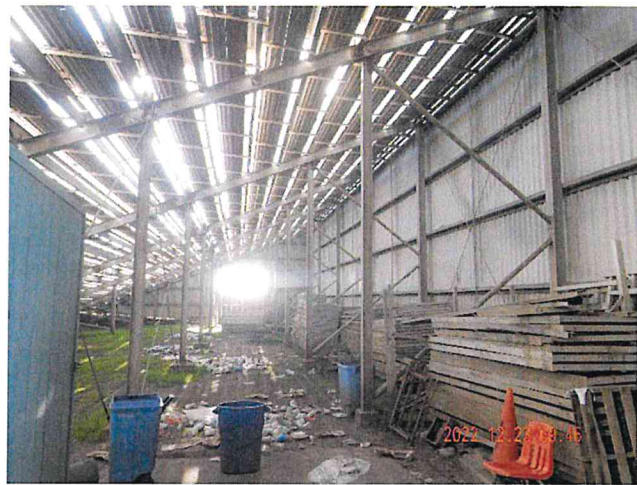
8. Under the Grandstands

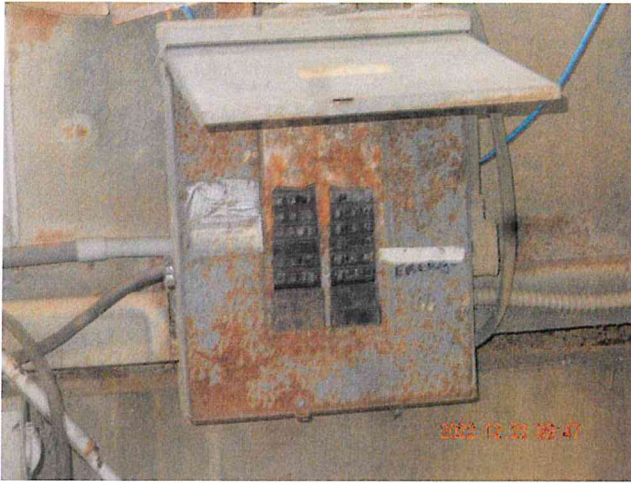
13. Under the Grandstands electrical box corroded

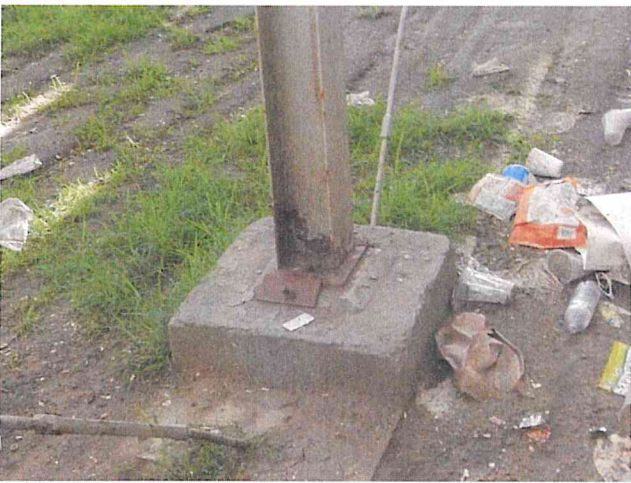
15. Possibility that column is not anchored to the foundation

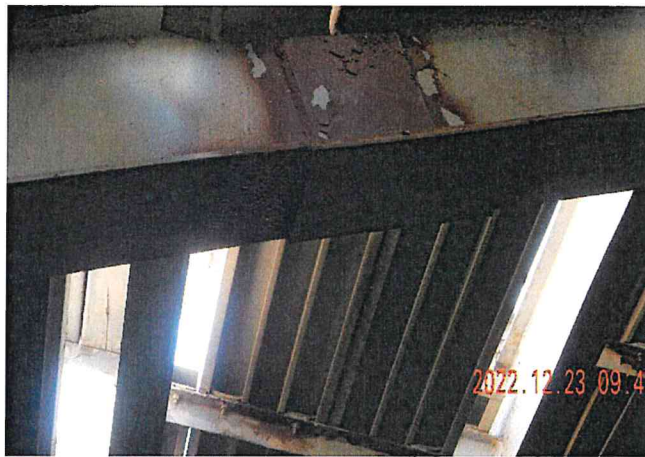
16. Beam spliced: Typical bleacher walkway support corroded

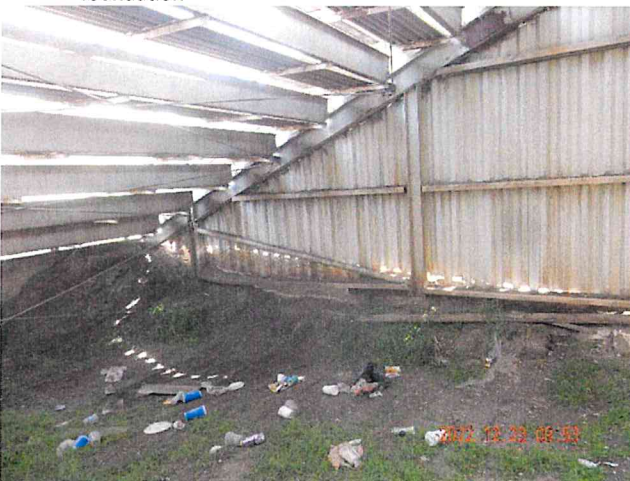
17. Grandstands southeast end wall

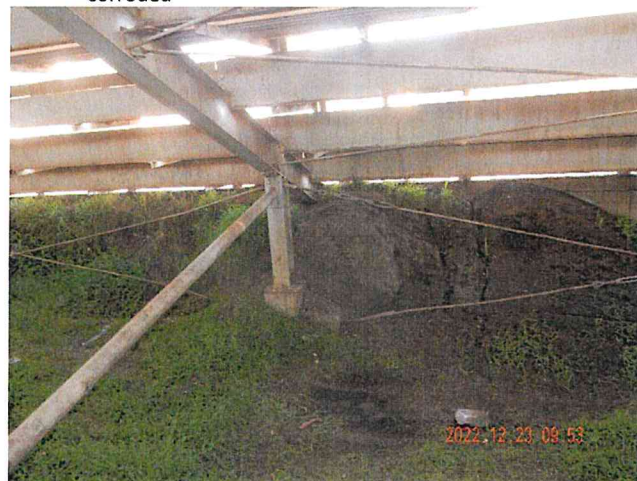
18. Grandstands northwest foundation

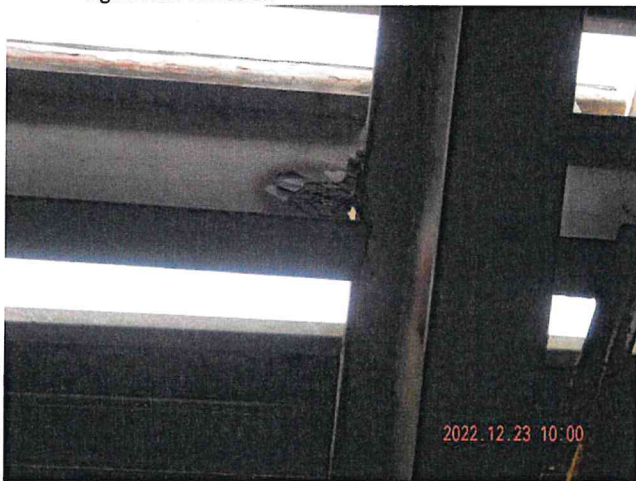
21. Under Grandstands bleacher support show indication of significant corrosion at the connection

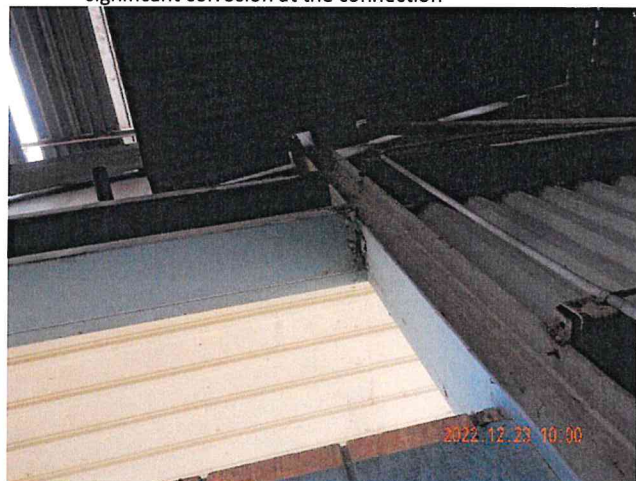
22. Under Grandstands bleacher support shows indication of corrosion at the connection

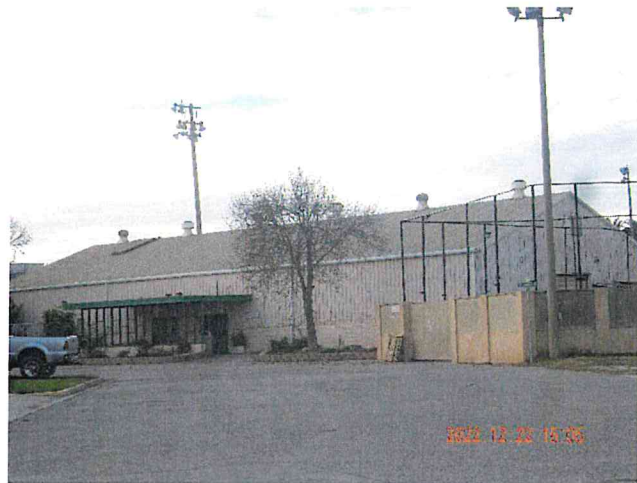
2. Floriculture southeast wall elevation and gate to the northeast open area

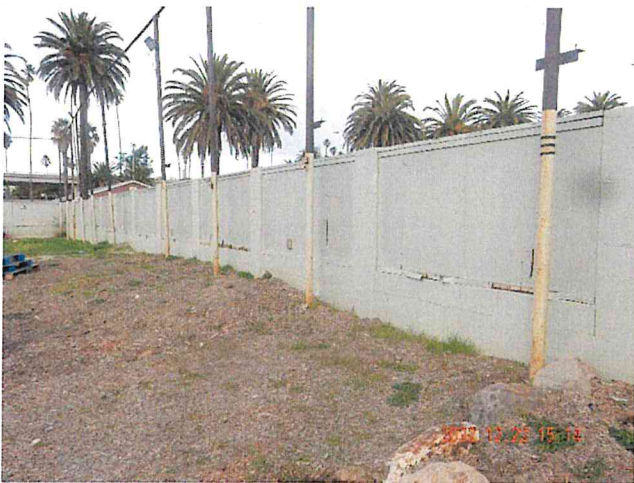
3. Floriculture open area fence separate separating Area 3

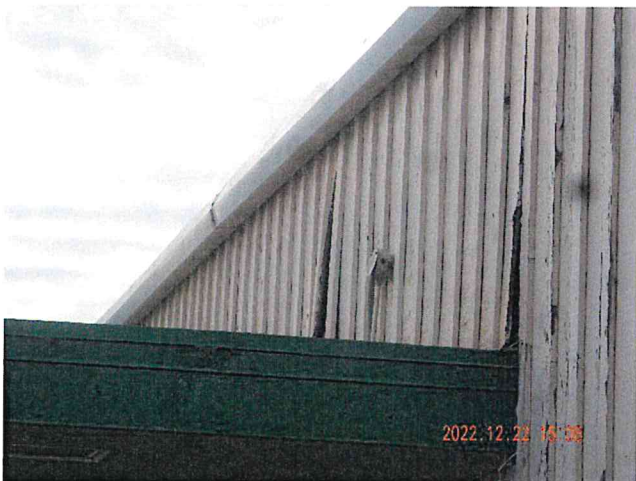
5. Floriculture southeast wall elevation cover at the main entry with typical wooden siding deterioration

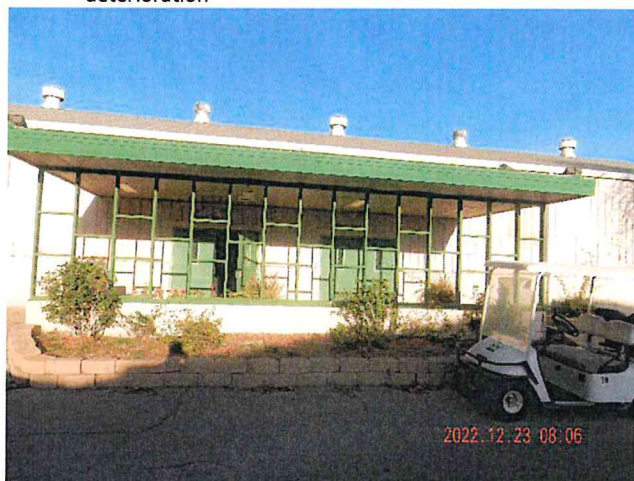
6. Floriculture southeast building main entry

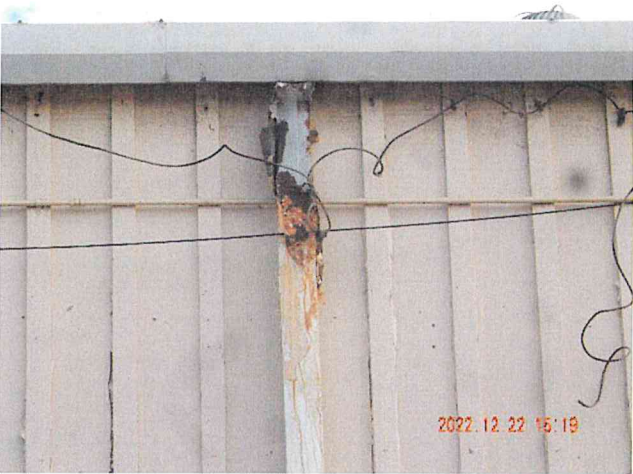
9. Floriculture northeast wall elevation rain gutter deterioration

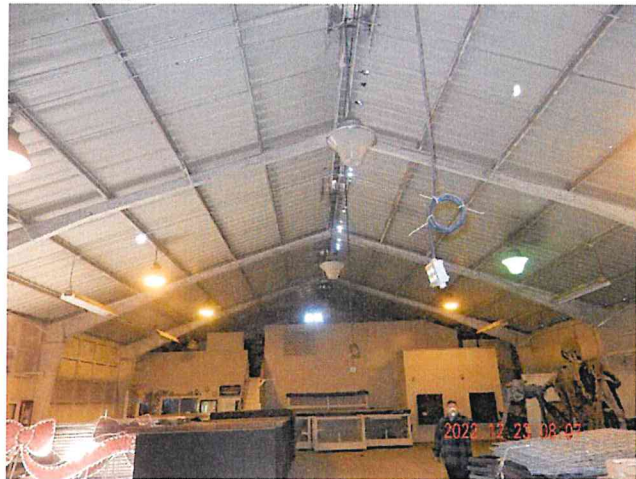
- The condition of rigid steel frame that was accessible, appeared to be in good condition.
- The metal roof has multiple significant penetrations and appears to be beyond repair and needs replacement.
- The exterior wooden wall siding has significant dilapidation throughout the wall and appears beyond repair and needs replacement. (The interior nonbearing walls were not readily accessible to view for evaluation).
- The exterior electrical components that were accessible, had multiple broken switch boxes and aging circuit breaker cabinets.
- Installed exterior conduit was found to be rated for interior use only. Evaluation for immediate electrical repairs and/or renovation recommended for life and safety.

10. Floriculture interior facing the northeast wall elevation hole in roof

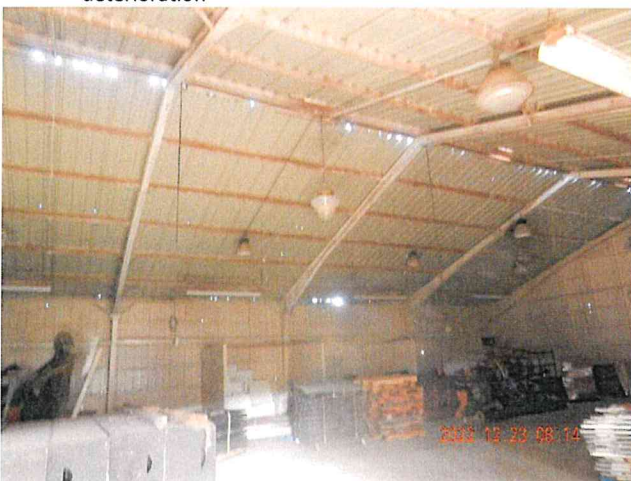
11. Floriculture interior north wall elevation roof and wall penetrations

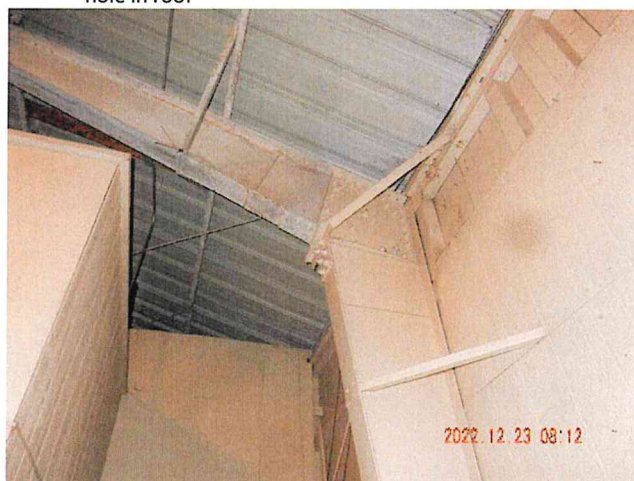
12. Floriculture structural steel ridged frame

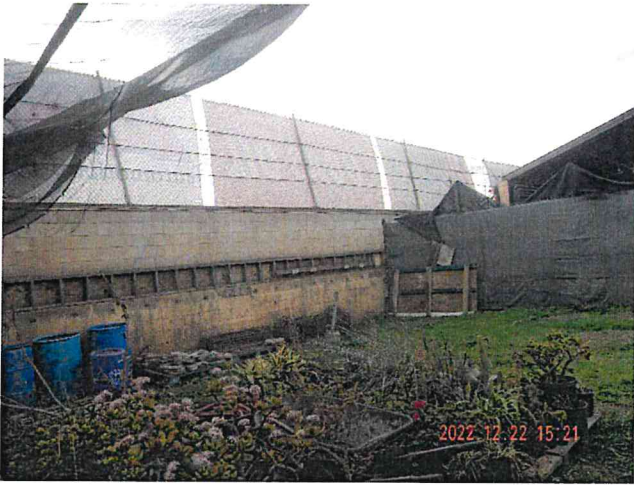
13. Floriculture southwest wall bordering the Raceway

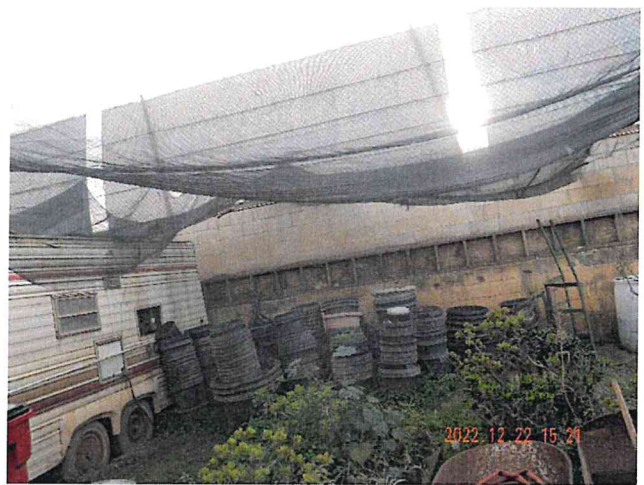
14. Floriculture southwest wall bordering the Raceway

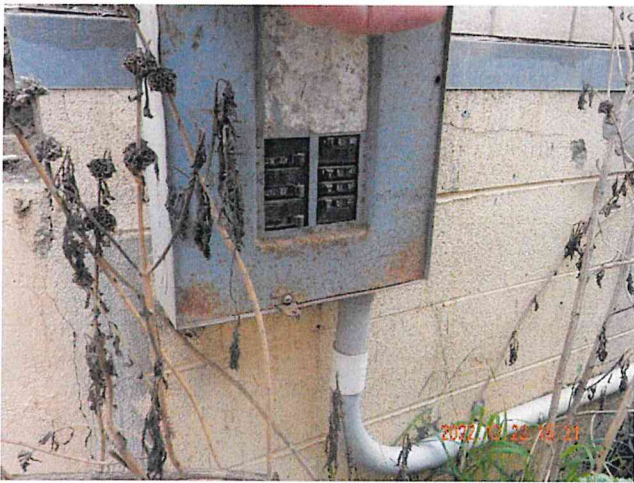
15. Floriculture exterior cabinet aging, no cover, and nonproper conduit (adjacent to the Raceway)

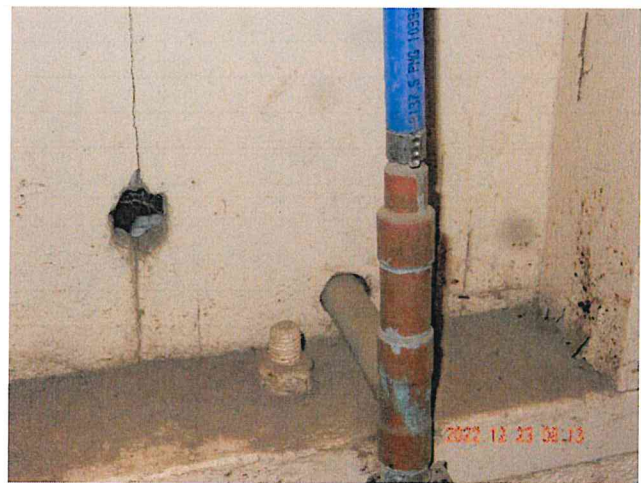
16. Floriculture provided with copper and Pex pipe

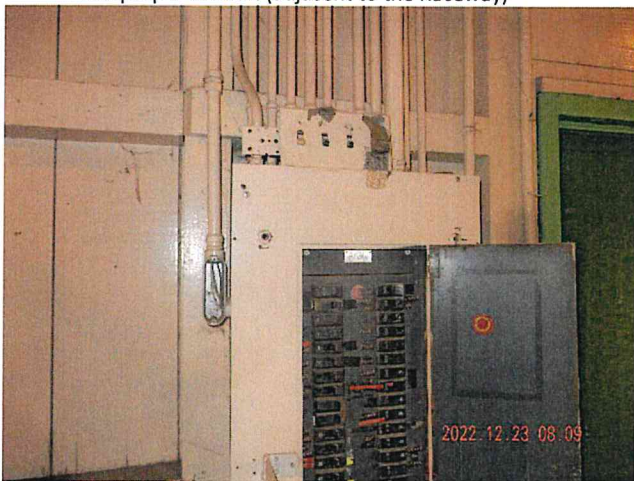
17. Floriculture interior electrical cabinet and above wall switches

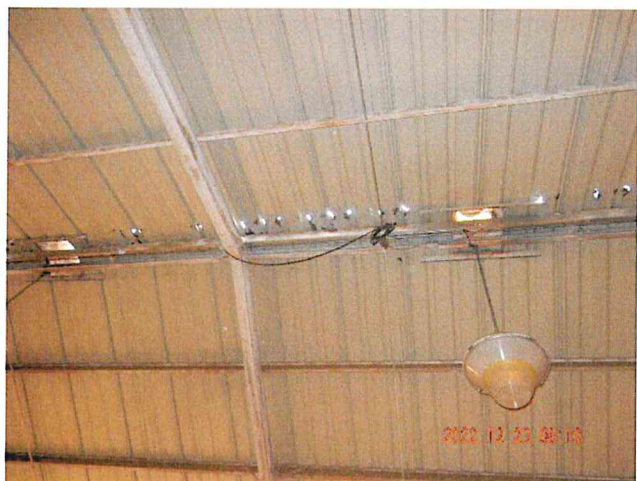
18. Lighting below roof penetration

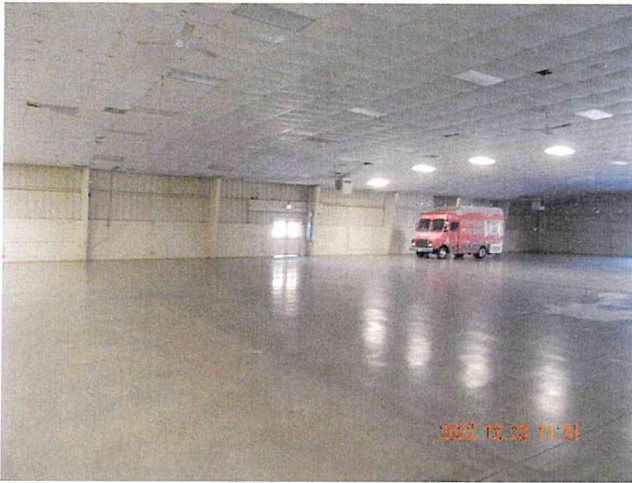
- The Hall appears to be currently undergoing a main electrical update.
- The ceiling tiles are severely moisture stained throughout the Hall which might indicate roof leaks.
- The wall components have damaged CMU blocks and exposed rebar at several locations and
- The metal siding material has multiple penetrations throughout the building that need repair.
- The structural steel framing members appear to be in good condition except for anchor bolts in several locations that appear to have some thread depth and corrosion issues. These warrant further evaluation by engineering for seismic consideration.
- The Hall's space heating system appears to be outdated and warrants further evaluation for functionality and safety.

7. Interior ceiling moisture staining, damaged and/or missing ceiling tiles

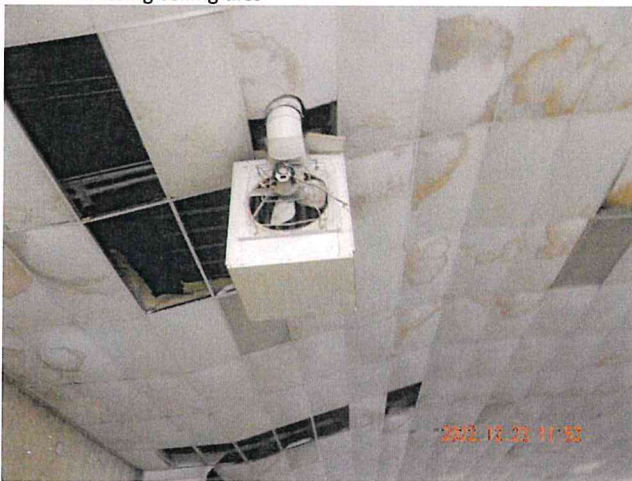
9. Interior ceiling moisture staining, damaged and/or missing ceiling tiles

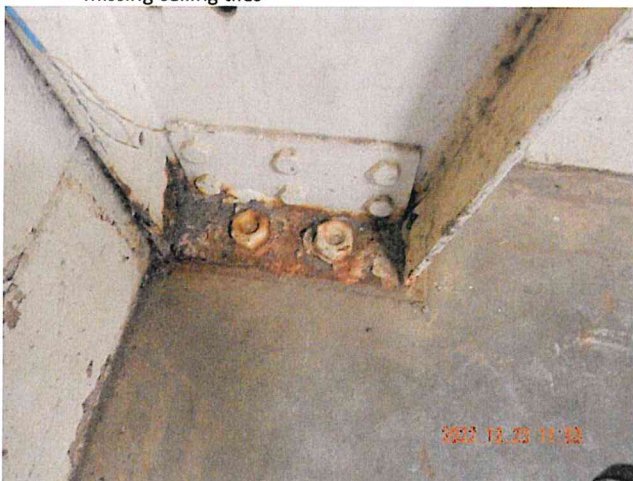
11. Anchor bolts with tread depth and corrosion issues

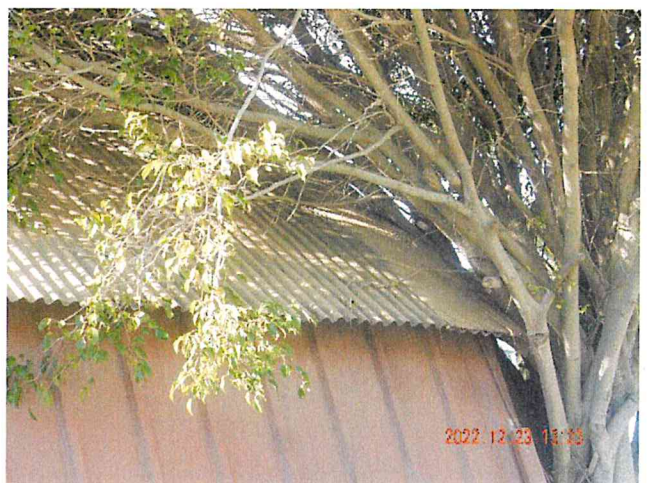
12. Area 1: typical grounds maintenance needed (tree resting on the adjacent San Miguel Hall roof)
