CALIFORNIA CONSTRUCTION AUTHORITY

31st DAA Ventura County Fairgrounds Physical Assessment

CCA Project: 031-22-133

Date: December 21-22, 2022

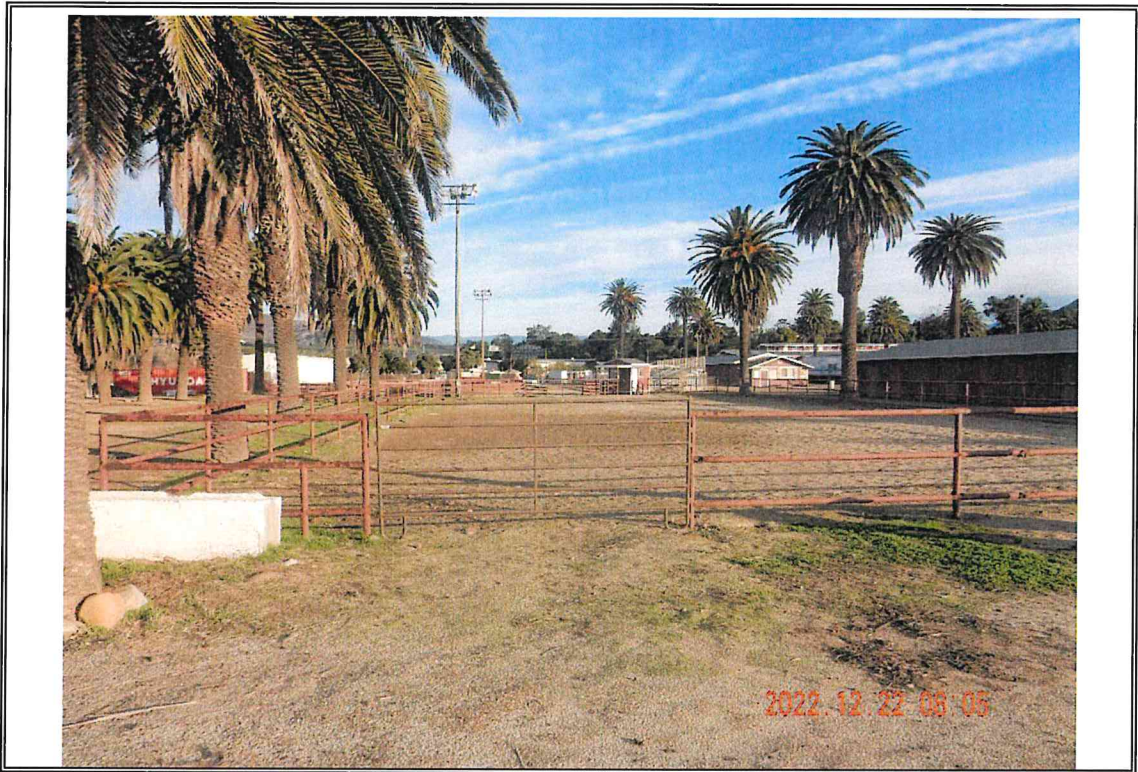
1. Training Arena

- The Training Arena's metal components (railing) are severely corroded and in need of significant repairs and component replacement. Evaluation of repair or replacement is warranted.
- The condition of the corroded railing poses a safety concern if/when individuals climb or sit on the railing.
